Inspections on Åland islands

Project Fungi and Beetles in Buildings on Islands of Baltic Sea (acronym FaB Bi)

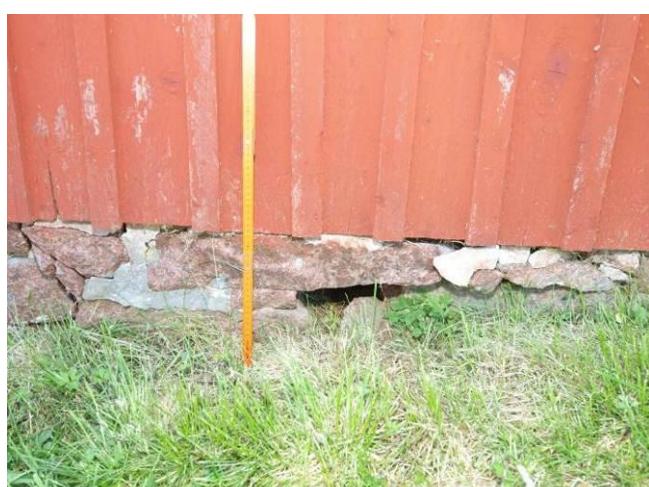
Fig. 1. The rainwater system is incomplete

In order to reduce the rainwater load to the exterior part of the walls, it would be necessary (if possible concerning the historical value) to install complete rainwater system. As there were traces of water passages and the southern roofside undulates, the attic should be inspected thoroughly. Although there were no visual traces of damages to the timber floors in room No 2 and 3, there should be made additional incitement holes to the socket in the western part of the building in order to assure the ventilation beneath.

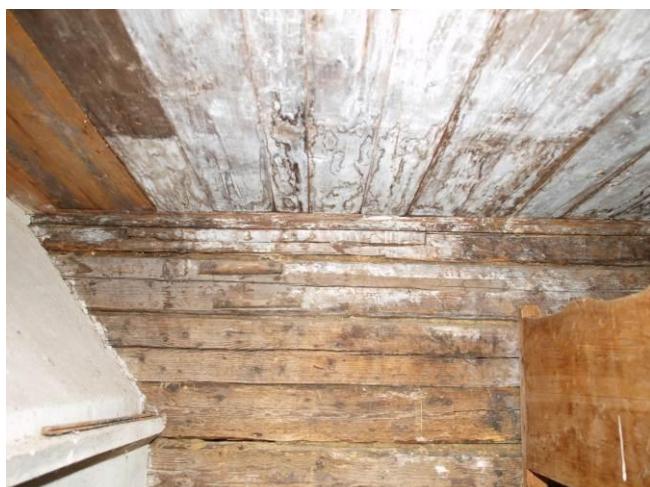
The building has timber floors, which are ventilated with incitement holes in the socket only in the eastern part of the building (rooms No 1 and 4). Interior inspection revealed some old traces of water passages in rooms No. 3 and 4 (Appendix B).

Fig. 4. Traces of water passages in room No. 3

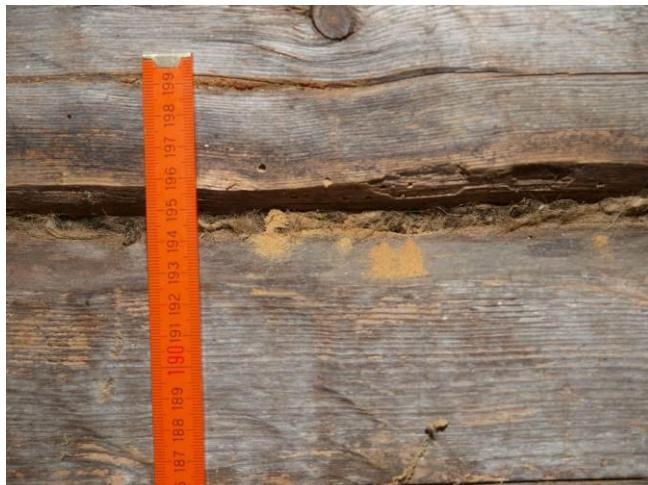
A few of the beetle damages were found outside, but most damages were inside the building. Precisely, all the wall constructions and handlooms in room No. 4. Walls and handlooms had massively attacked by the common furniture beetle (*Anobium punctatum*) (Fig. 6, 7, 8 and 9). Besides beetle exit holes we found holes on the floors, which were made by rodents.

Fig. 6. Bore dust on the damaged wall in the room No. 1

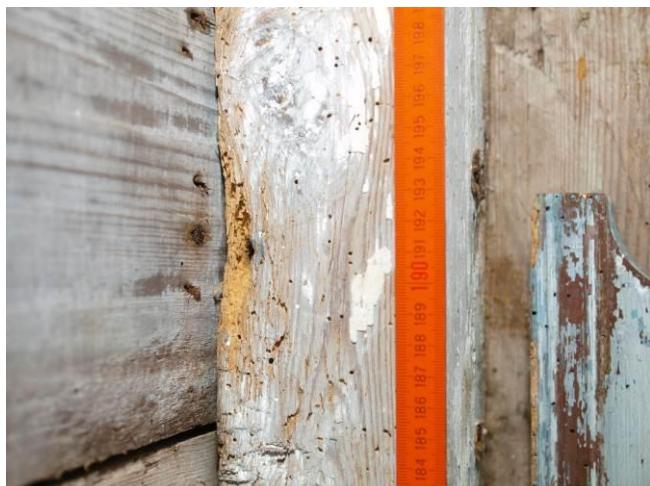
Fig. 7. Exit holes of the common furniture beetle on the wall

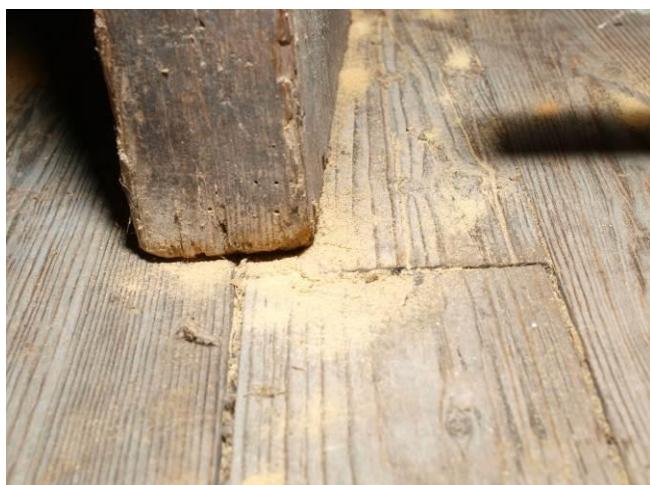
Fig. 9. Bore dust all around handlooms, which indicates active attack

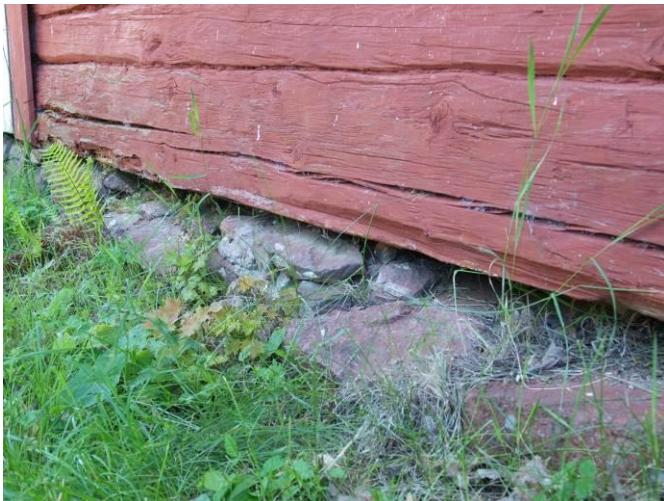
Fig. 3. Missing quarrystones in the socket

Some parts of socket, that have missing quarrystones, should be remounted, in order to assure the load bearing to the walls. In order to assure the ventilation beneath the timber floors in room No. 1 to 3, additional incitement holes should be made to the socket in the southern part of the building. All the damaged logs in the socket area should be replaced.

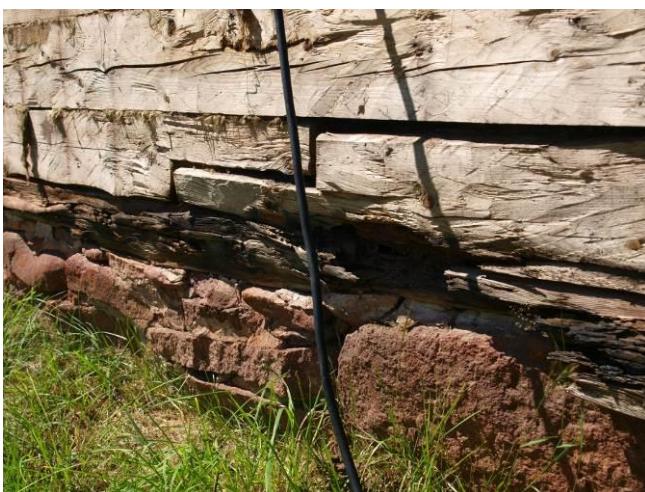
Fig. 4. There is a lack of hydro-insulation between the logs and quarrystoned socket

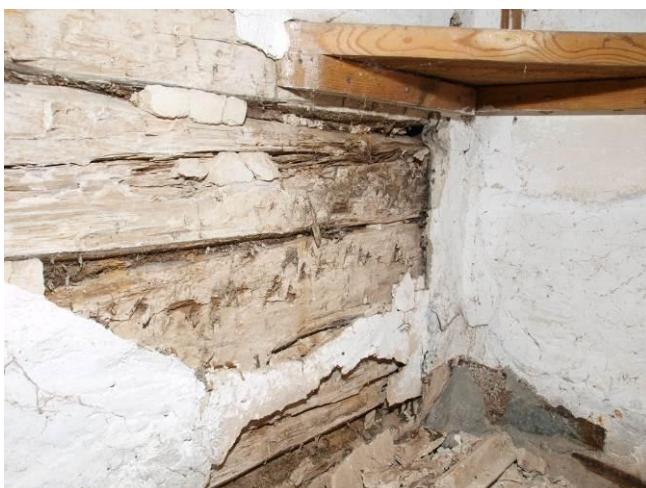
In room No. 6 the walls have loose and missing plaster, which indicates severe moisture damage (Fig. 8 and 9). In room No. 3 there has been already removed the lowest part of the damaged logged wall, but the problem consists in the absence of hydro-insulation – the socket is on a direct contact to the timber (quarrystones damps the timber element).

Fig. 9. Loose and missing plaster on the wall in room No. 6

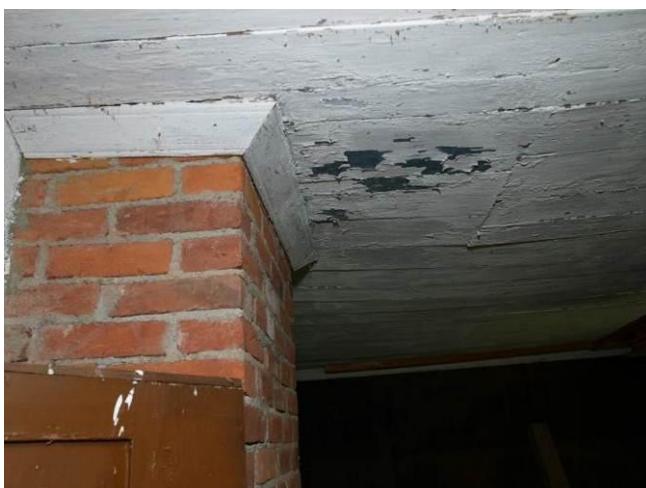
In room No. 8 the paint is peeling from the ceiling, which can indicate either to a water passage or a high humidity (Fig. 10). In room No. 2 there are some salt damages in the ceiling-beam (Fig. 11), this is due to the dairy, which was above the room.

Fig. 10. Peeling paint from the ceiling in room No. 8

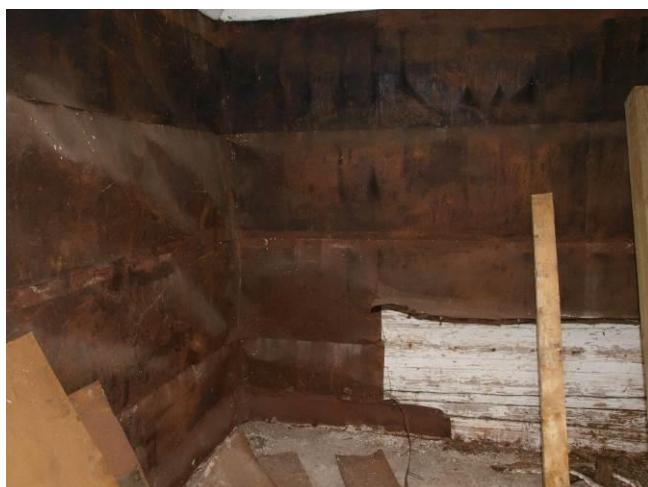
The walls of room No. 8 are partially covered with sheet metal that may condensate the logged walls behind (Fig. 12).

Fig. 12. Sheet metal covered walls in room No. 8

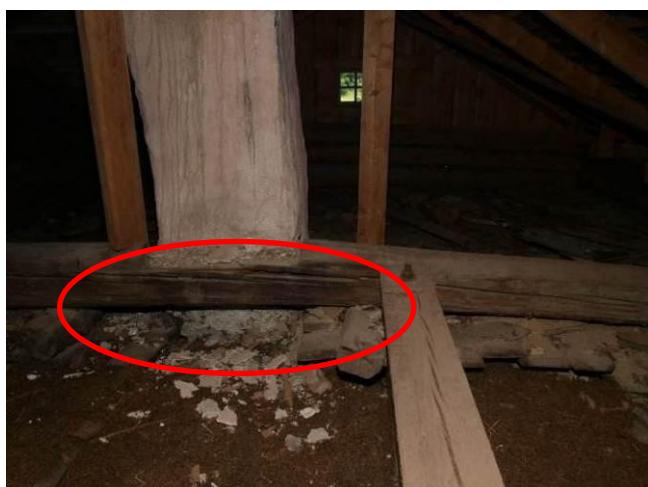
Near the chimney we identified ceiling-beam in bad condition (Fig. 13). The roof's timber structure has a loose connection (Fig. 14), which needs to be fixed immediately.

Fig. 13. The ceiling-beam has signs of losing its strength (cracks in tensile zone)

The plaster on the wall between rooms 3 and 4 should be removed, because the logged wall beneath is damaged. In the attic the timber structures must be fixed (Fig. 13 and 14). The metal plates must be removed in room No. 2.

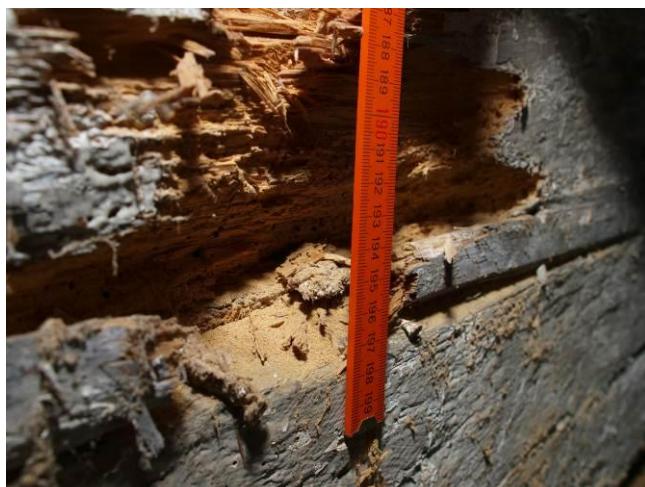
Fig. 15. Insect damages on the wall of room No. 4.

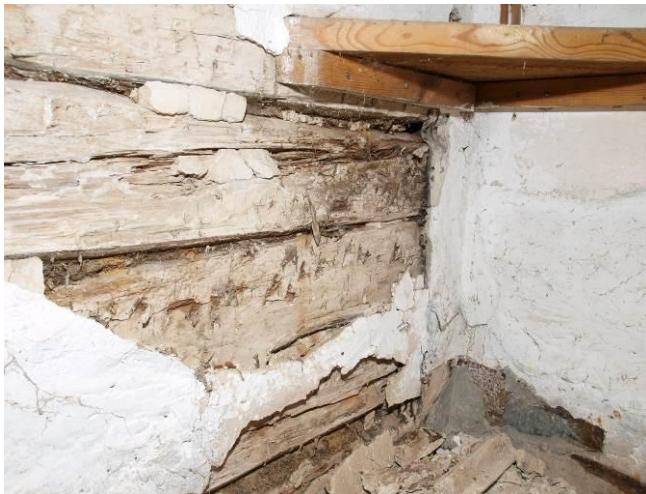
Fig. 16. Old fungal damages in room No. 6

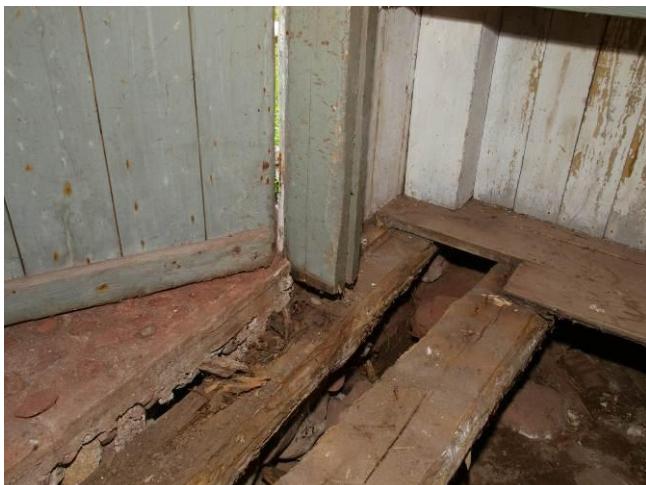
Fig. 17. Old fungal damage in room No. 3

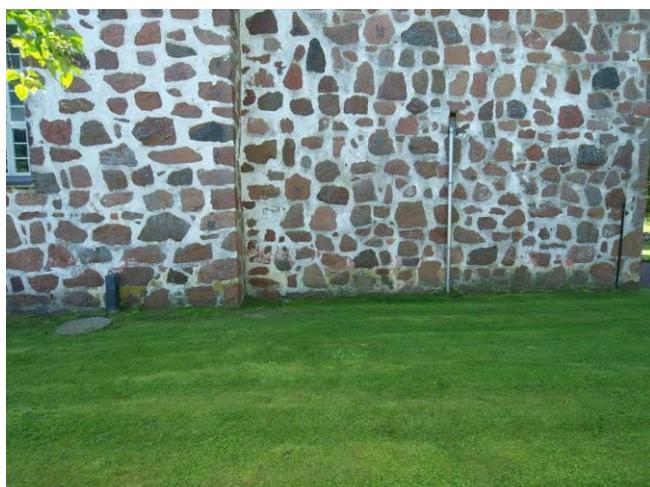
Fig. 2. Biodamages on the walls near the ground

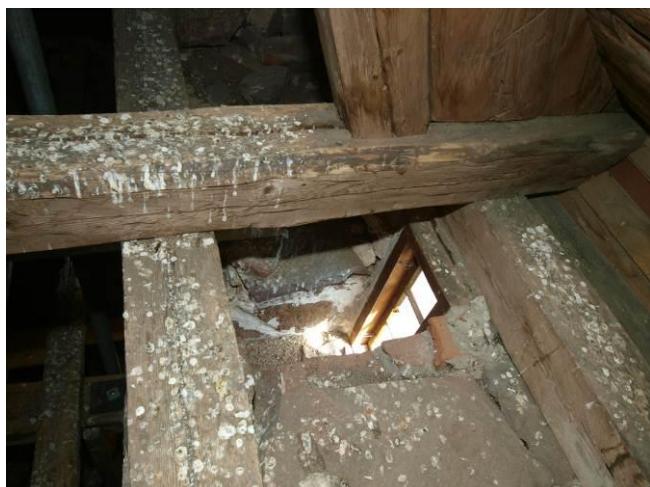
There were a lot of birds' excrements (biodegradation) on the timber elements (Fig. 4 and 5). Some load-bearing timber elements had traces of water passages, but the damage's extent was not severe (Fig. 6). There are also numerous cases, where the timber beams bear on the masonry walls without any hydro-insulation (Fig. 7).

Fig. 4. Timber elements covered with birds' excrements.

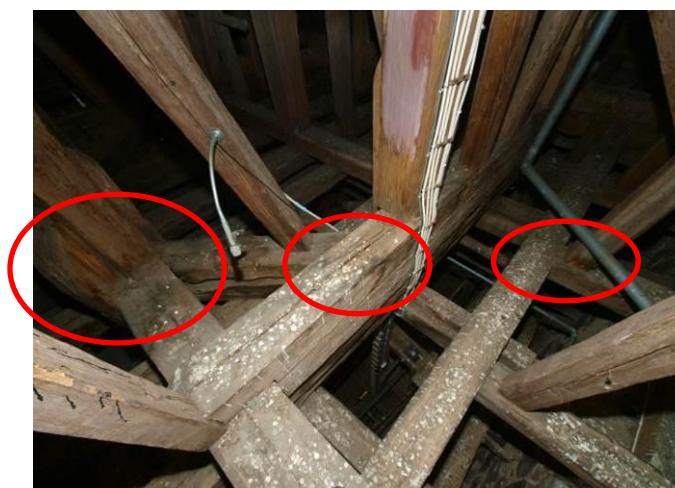
Fig. 6. Traces of old water damages and timber elements covered with birds' excrements

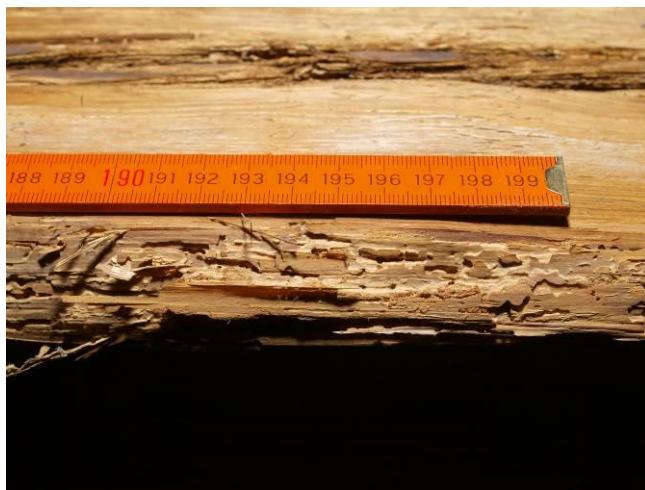
The altar in this church had active insect damages. We identified bore dust inside the altar, mainly in the corners (Fig. 8 and 9). In the attic few timber elements had old insect damages caused by bark beetles (Fig. 10).

Fig. 10. Damages by the bark beetle

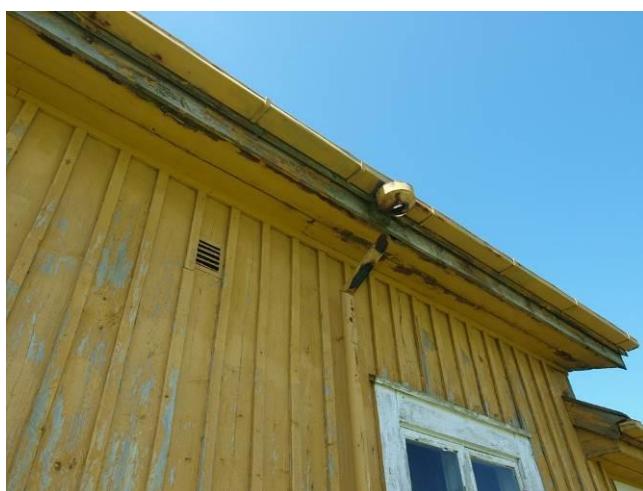
Fig. 2. Corroded and malfunctioning rainwater pipe

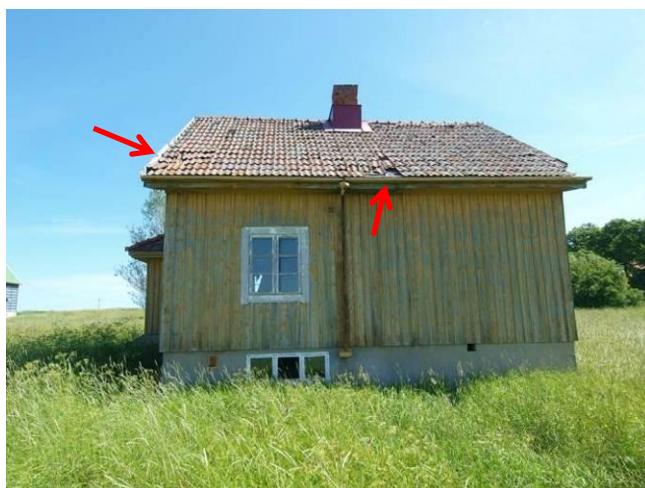
Fig. 7. Some roofing tiles are missing and broken on the western side

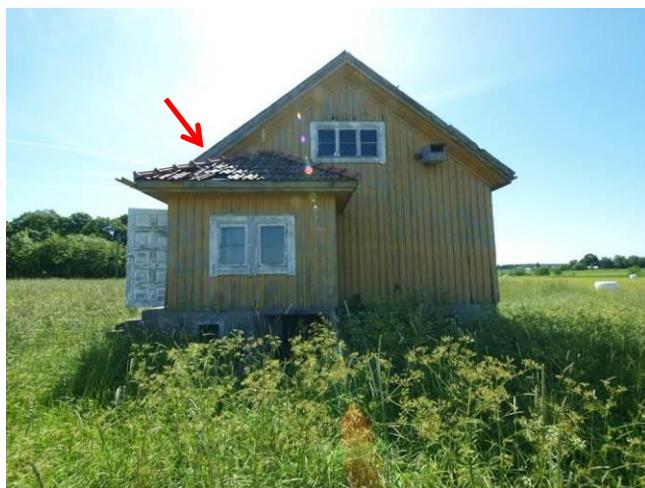
Fig. 8. Some roofing tiles are missing and broken on the northern side

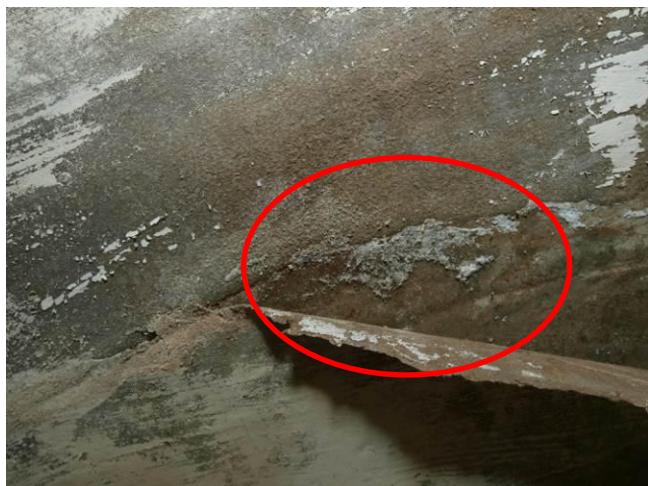
Fig. 11. Salt damages in the ceiling

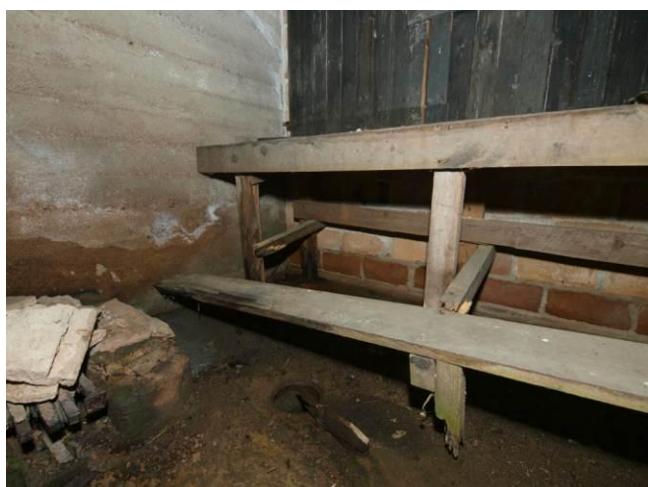
Fig. 13. Degraded timber elements in sauna

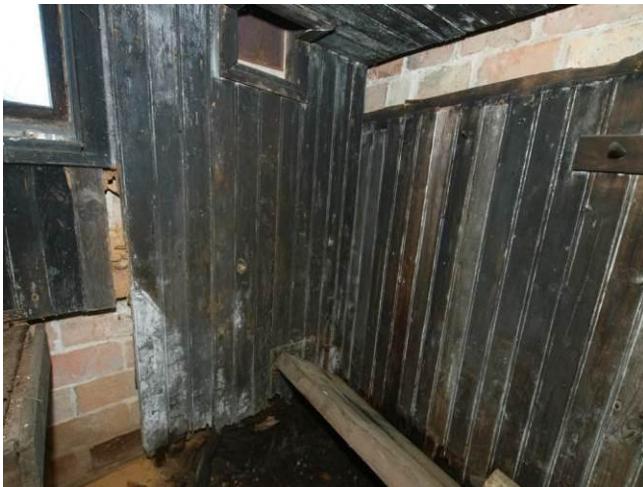
Fig. 14. Degraded timber elements in sauna

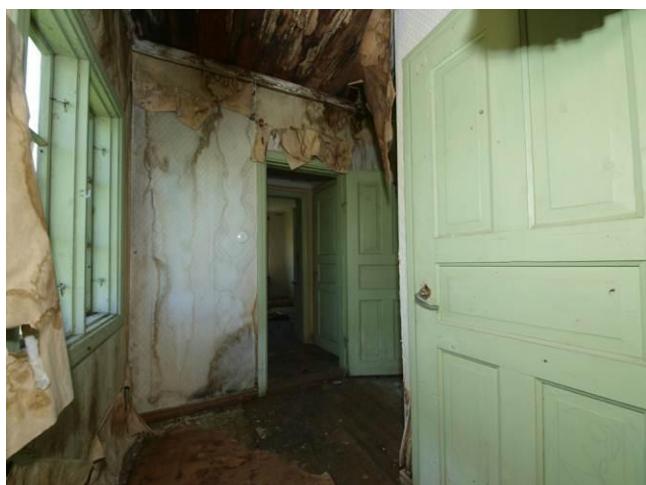
Fig. 18. Severe water damages in the hall room

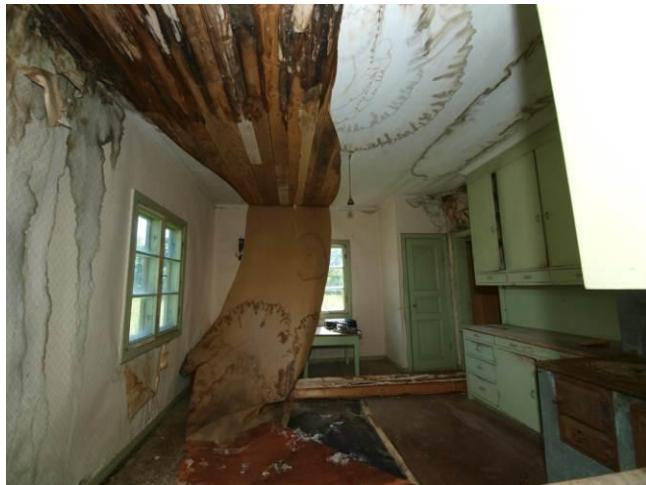
Fig. 19. Severe water damages in the kitchen

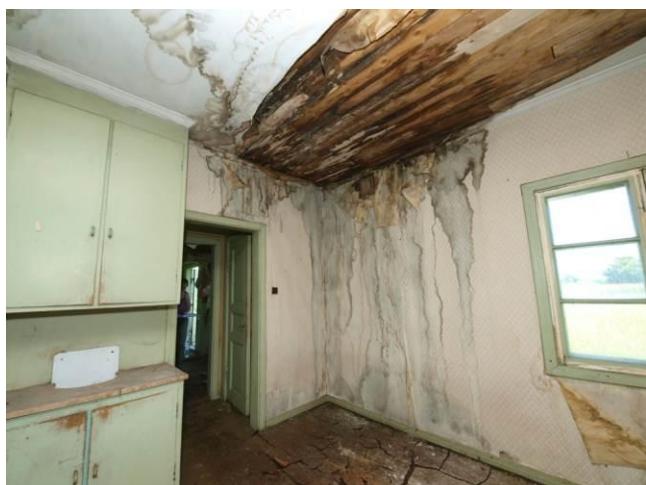
Fig. 20. Severe water damage in the kitchen

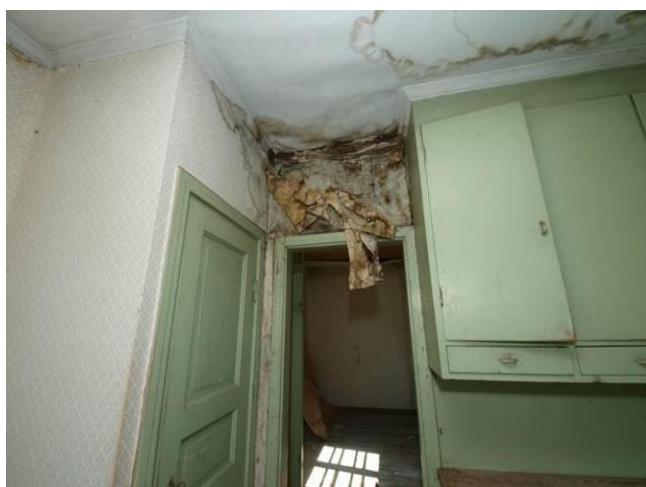
Fig. 21. Severe water damages in the kitchen

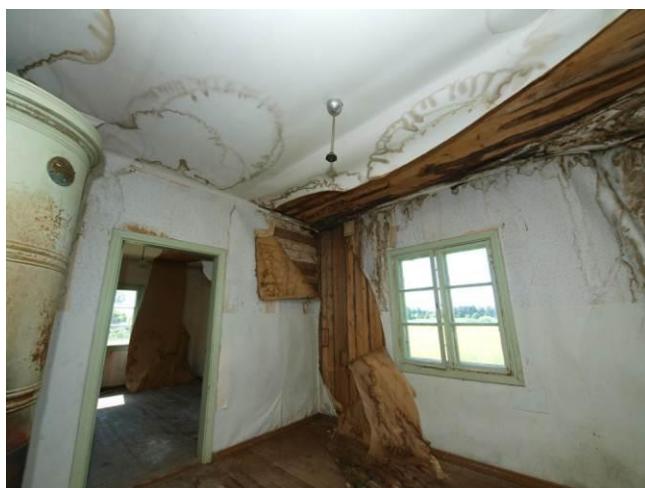
Fig. 23. Severe water damages in the livingroom

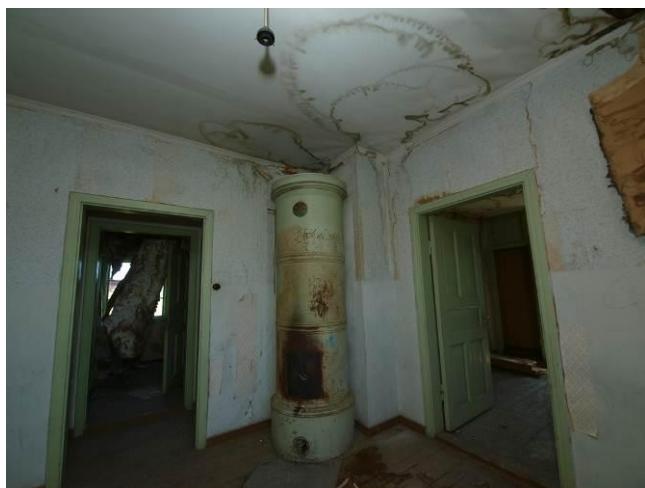
Fig. 24. Severe water damages in the livingroom

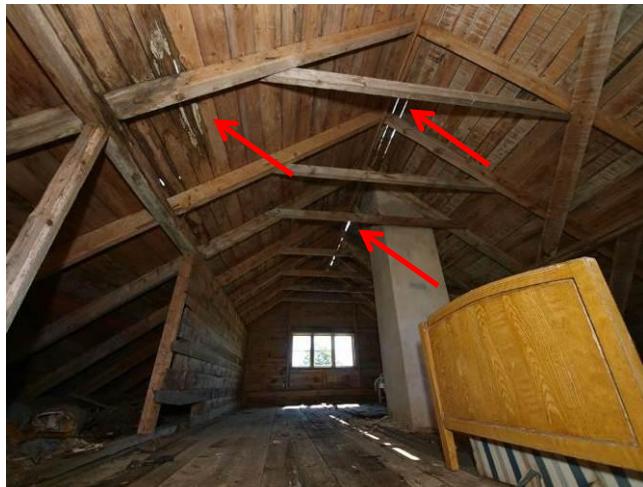
Fig. 25. Water leakages and degratation of timber elements in the roof structure

The most important is to repair the roof along with its timber structure to save the building structure from being completely collapsed. The roof's degraded rafter and wind beam should be immediately replaced, because in winter with heavy snowloads it may lose its load-

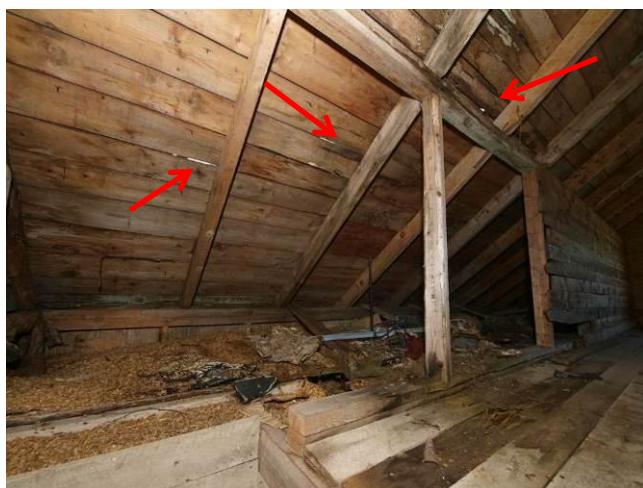
Fig. 26. Water leakages in the roof

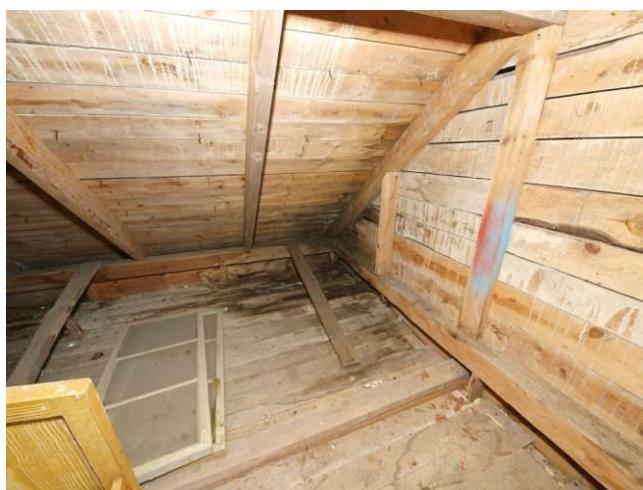
Fig. 27. Waterdamage in the attic's northwest corner

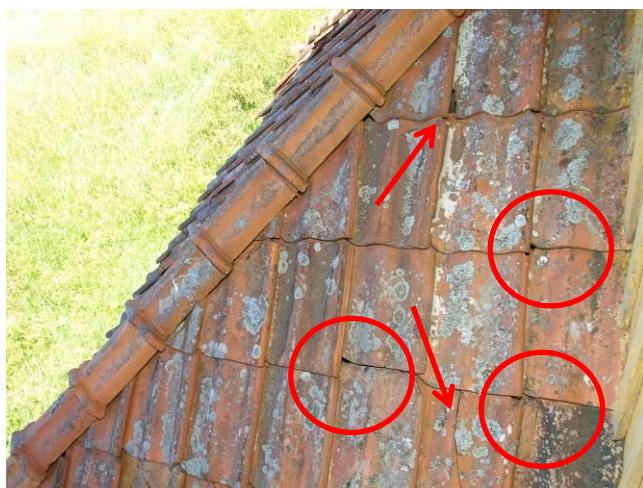
Fig. 30. Many of the rooftiles are broken and covered with lichens

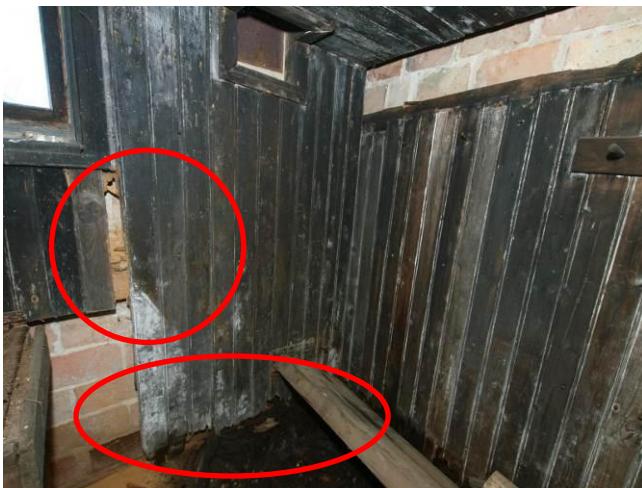
Outside of the building we did not discover any beetle damage. There were some fungal damages on the walls and some mosses and lichens grew on the rooftiles and staircases. Inside the building, we saw severe beetle attack on the timber wall of sauna (Fig. 31). There

Fig. 31. Beetle attack on the timber of sauna wall

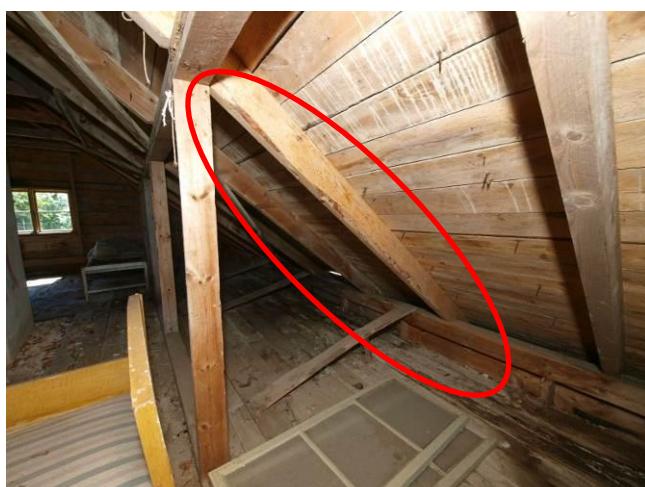
In the attic we found several beetle and fungal damages. Firstly, longhorn beetle (*Callidium violaceum*) had attacked the attic's roof timber (Fig 35). Also the upper part of the roof was damaged by Corticiaceae fungal species (Fig. 36). The floor beams had both the fungal and insect damages. Fungal damages were made by *Antrodia* species and Myxomycetes fungus and insect damages by anobiid beetle (Fig. 37 to 39).

Fig. 35. Longhorn beetle (*Callidium violaceum*) damage on roof's timber structure

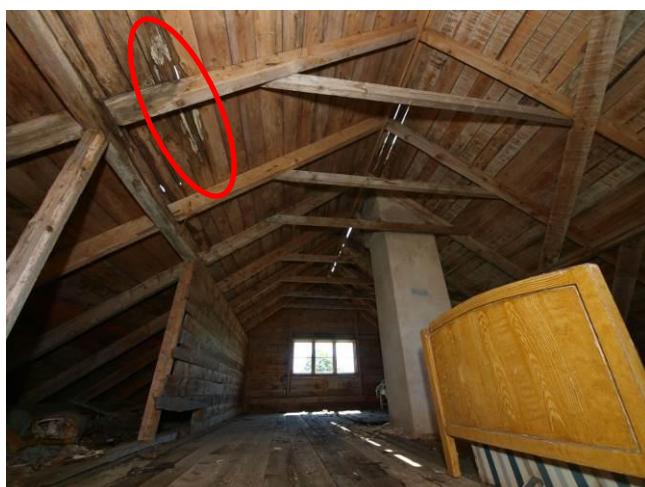
Fig. 36. Fruitbodies of Corticiaceae species on the roof's timber structure

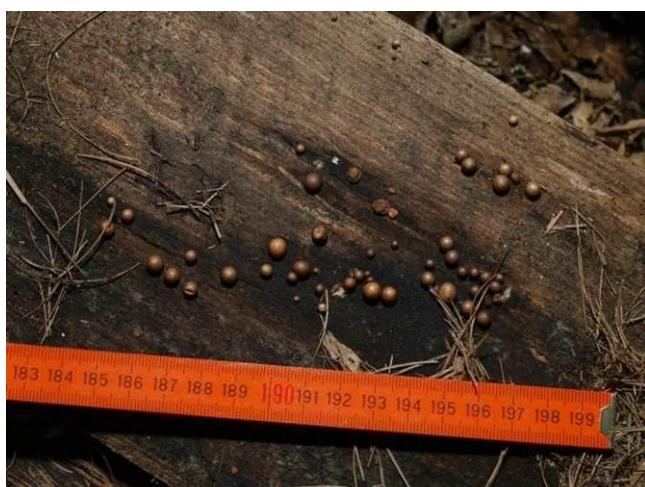
Fig. 38. Fruitbodies of Myxomycetes fungus

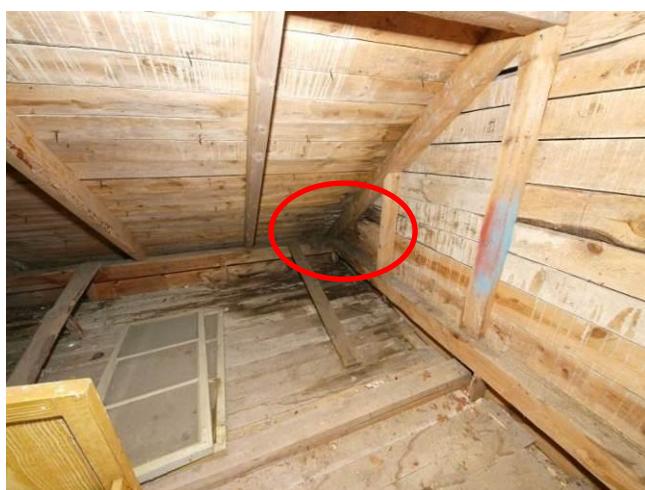
Fig. 39. Beetle damages on the roof's timber structure and fungal damage on the floorboards

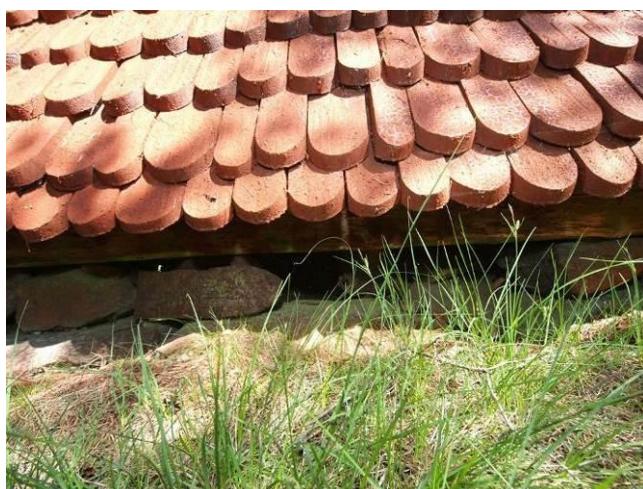
Fig. 2. The socket is piled without any mortar allowing water to flow inside.

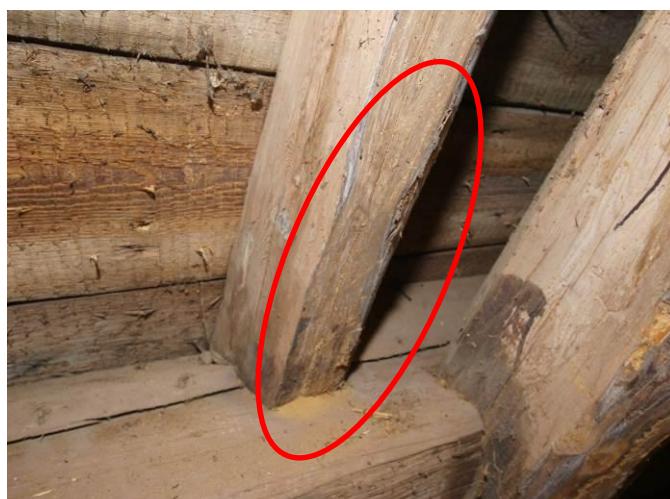
The northern and eastern parts of the interior walls were massively attacked by beetles. Mostly, were damaged boards and beams (Fig. 4 and 5). There was also some bore dust accumulated on the floor tiles under the structure. Unfortunately, we cannot be sure if this is still active damage.

Fig. 4. Bore dust and exit holes on the timber construction

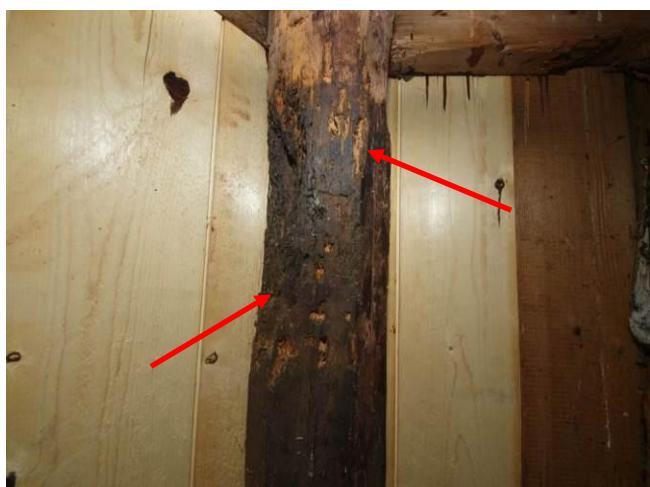
Two diagonal corner posts in the eastern side of the bellfry have mechanical damages (presumably committed by birds) (Fig. 6 and 7).

Fig. 6. Diagonal corner post with mechanical damages

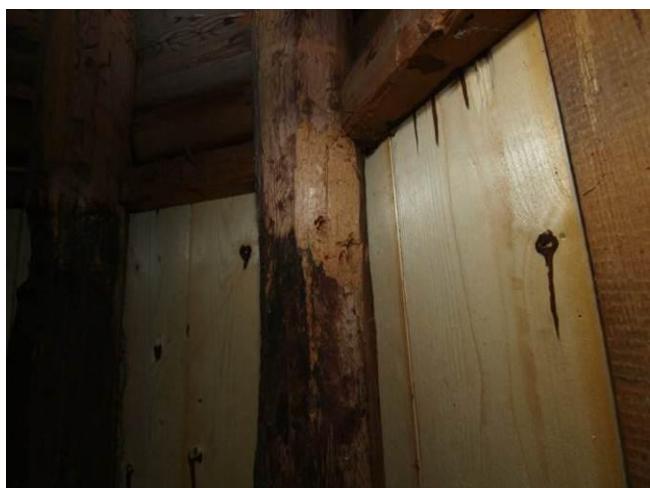
Fig. 7. Diagonal corner post with mechanical damages

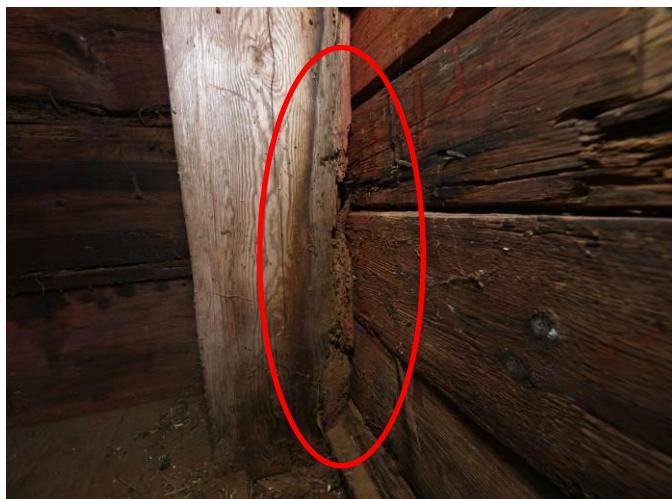
There were beams near the window and wall timber with severe beetle attack in the attic. Most of the timber was soft and friable (Fig. 8).

Fig. 8. Massive beetle attack on the beam

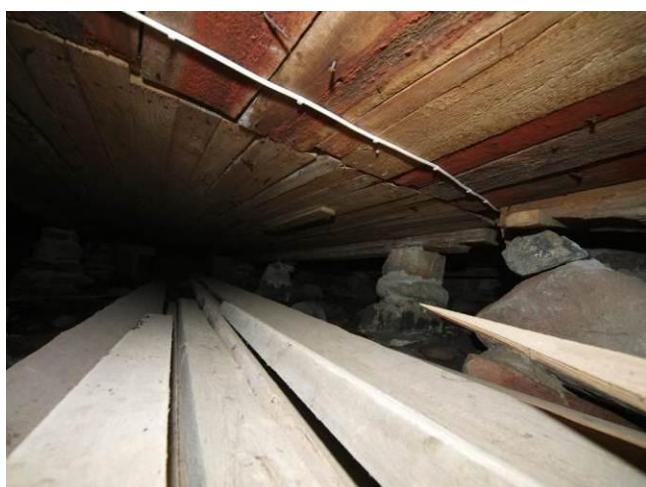
Fig. 6. Useless timber elements

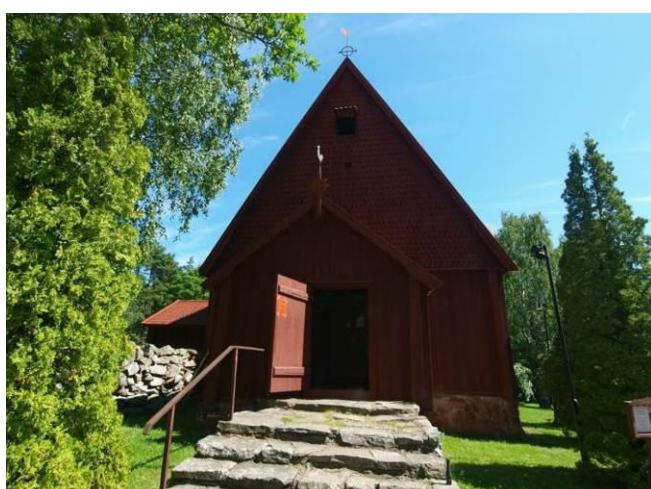
The surrounding greenery is too close to the building especially in the eastern side of the building (near the entrance) (Fig. 7). Leaves gather to the roof and this favours biodegradation in future.

Fig. 7. Birch tree is too close to the building.

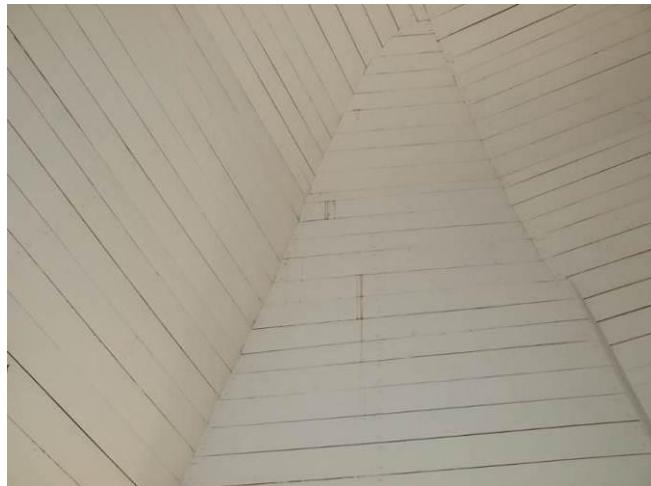
Fig. 8. Traces of water passage on the eastern part of the ceiling in the hall room

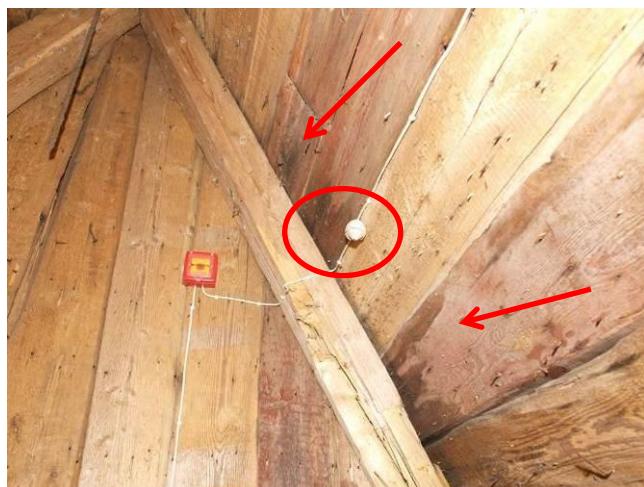
Fig. 9. Roof boarding has marks of water passages and wasp's nest

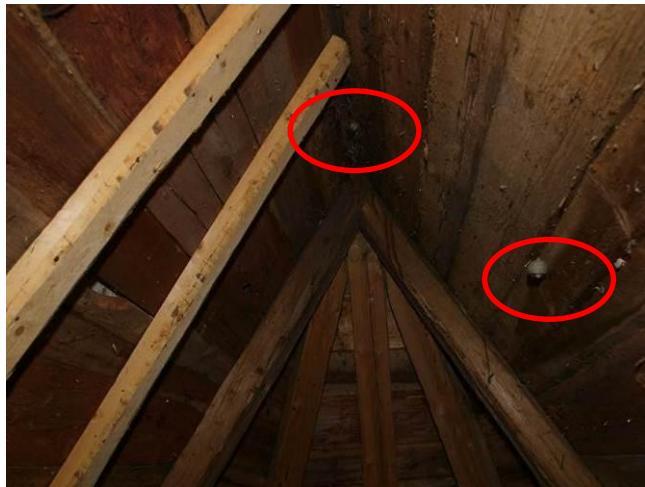
Fig. 10. Wasp's nests on the boarding

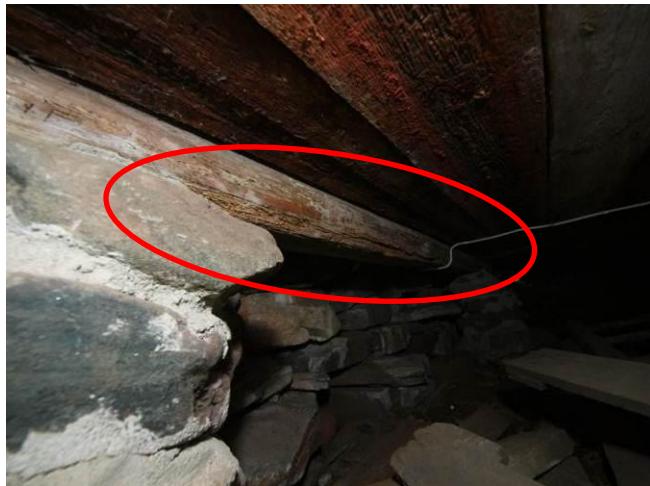
Longhorn beetles caused most of the beetle damages in this chapel church. Mostly were damaged hall room walls and bearing floor beams (Fig. 11 to 13).

Fig. 11. Bearing floor beam attacked by beetles

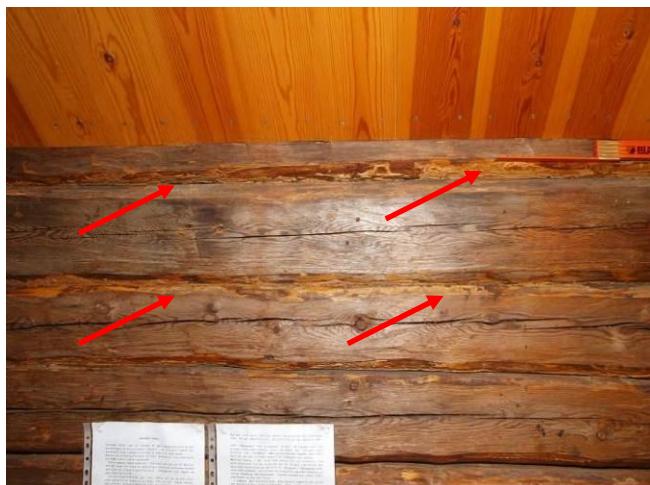
Fig. 12. Chapel church hall room wall, which has damages by bark and longhorn beetles

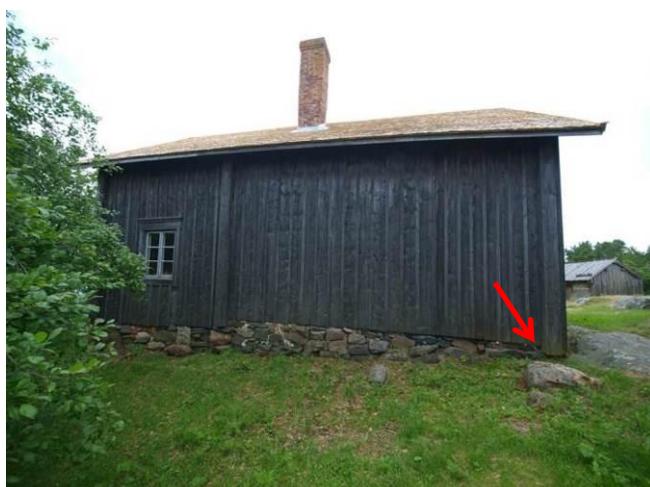
Fig. 2. Biodamages on the lower parts of the wall

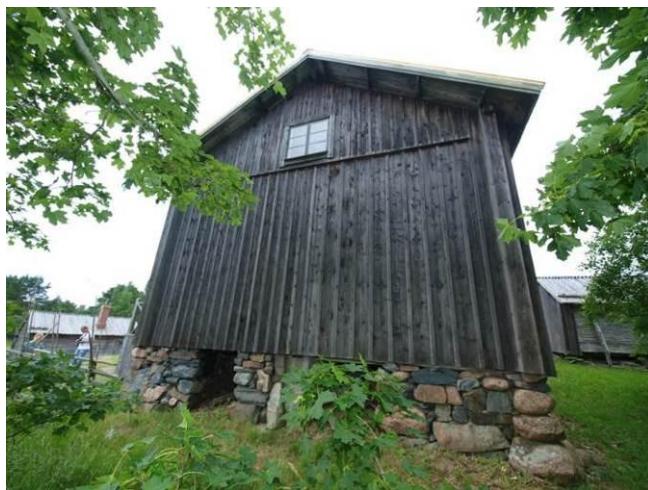
Fig. 3. The socket is piled mostly without any mortar

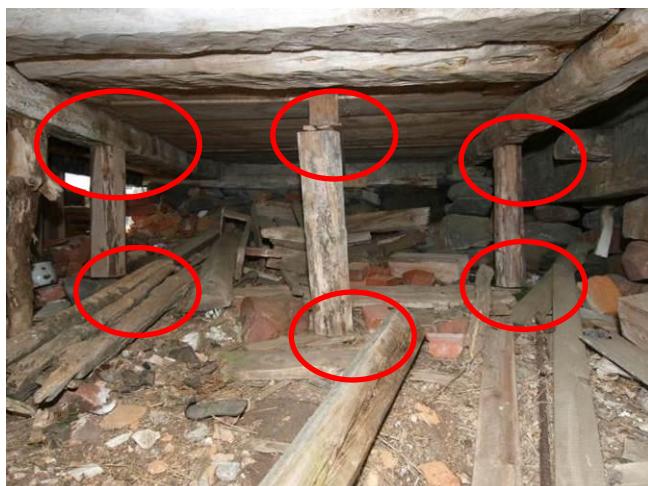
Fig. 4. The load-bearing posts are not firmly set to the ground and joined to the floorbeams, also direct moisture contact from the ground

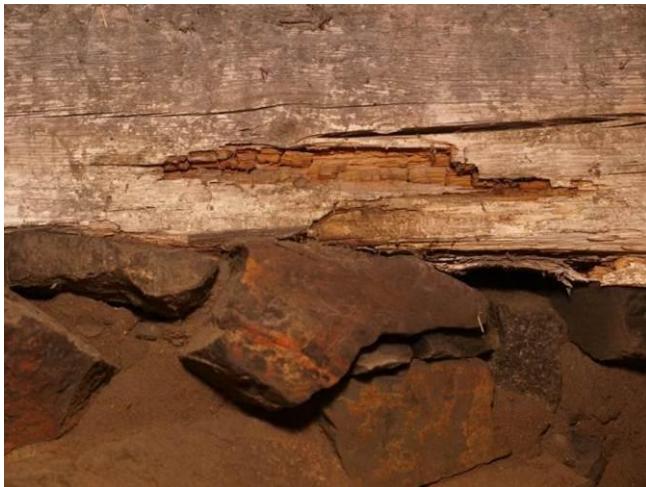
There is no hydro-insulation between the bearing floorbeams and stone foundation (Fig. 5 to 7). This causes constant damping to the bearing floorbeams and may result in their loss of strength. The water content of timber element was 25%. There is also salt and bio damages on the floorboardings and –beams (Fig. 8) near the entrance of the underground area.

Fig. 5. Missing hydro-insulation between the bearing floorbeams and stone foundation

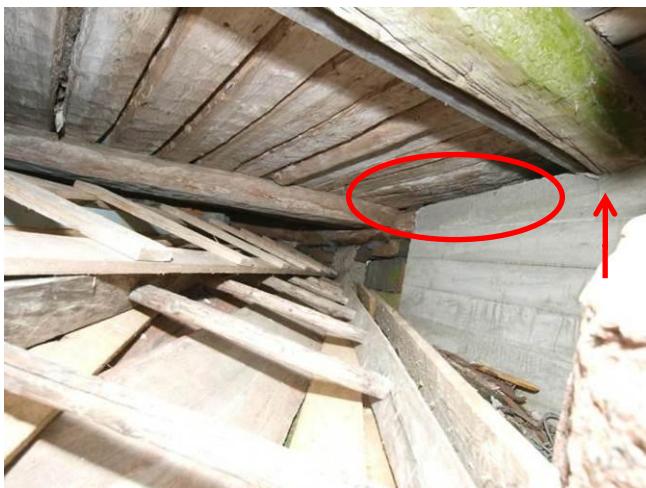
Fig. 6. Missing hydro-insulation between the bearing floorbeams and stone foundation

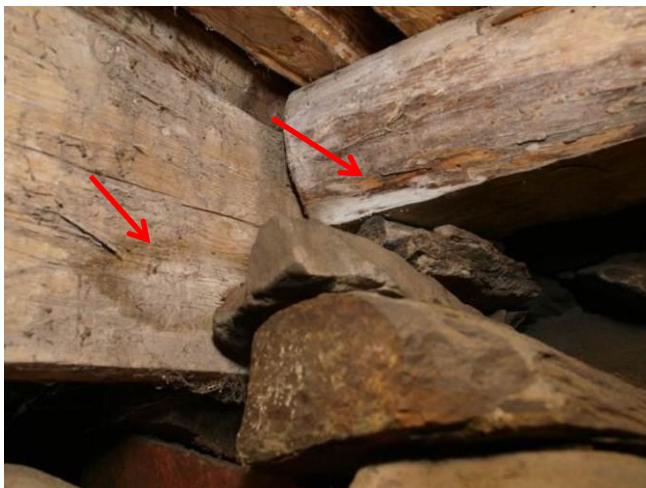
Fig. 7. Missing hydro-insulation and damped areas on floorbeams and foundation. Bio damages are on the floorbeam

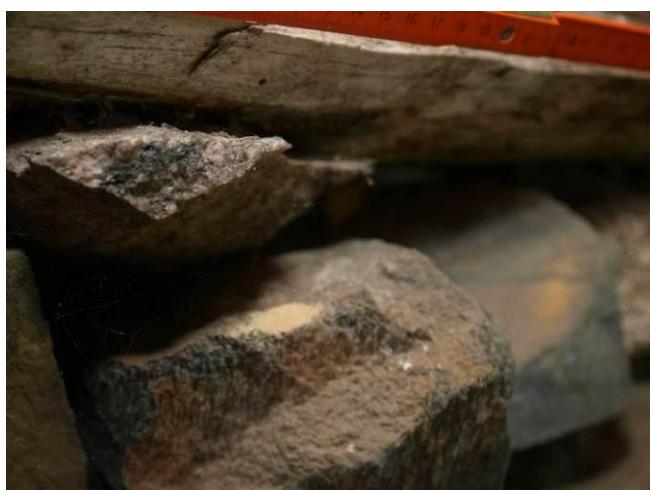
Fig. 11. Heaps of bore dust

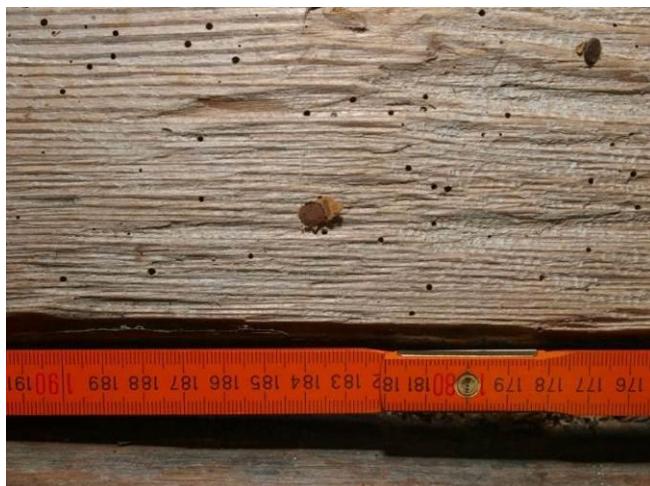
Inside the main building we found many old insect attacks in the rooms on the first floor. Several rooms had anobiid beetles (*Anobium punctatum* and *Xestobium rufovillosum*) attacks. First the hall ceiling, walls and the floor, secondly the Kammare room northern side of the ceiling and thirdly the kitchen walls. On the first floor and in the attic most of the furniture had attacks by anobiid beetles (Fig. 12). In the attic the walls and ceiling were covered with beetles' emergence holes and there was also lot of bore dust, which indicate to massive attack (Fig. 13 and 14). It should be monitored to make sure is it old or active damage.

Fig. 12. Exit holes of anobiid beetles

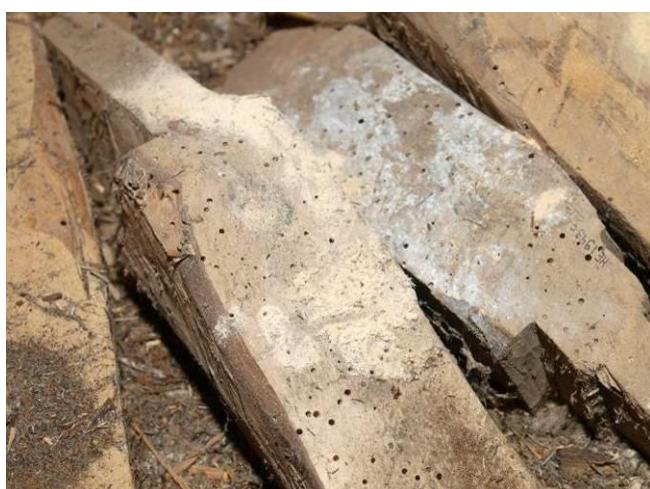
Fig. 14. Infested furniture in the attic

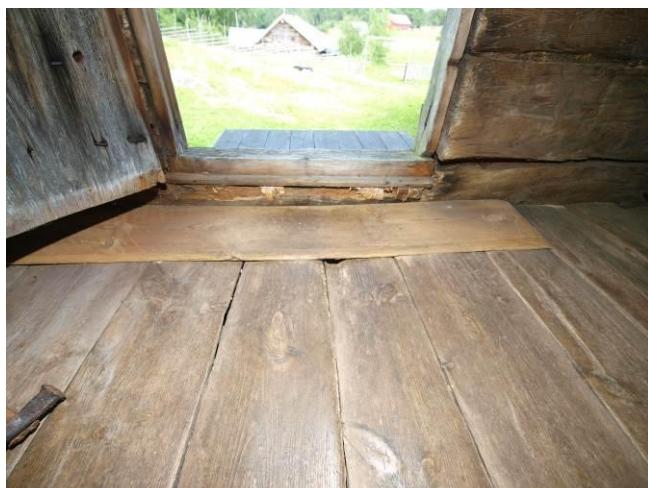
Fig. 4. Fixed floor near the entrance to room No. 3

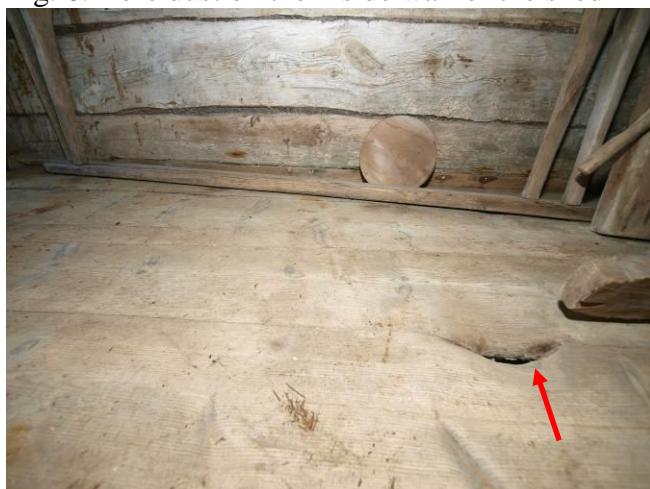
Fig. 7. Hole in the floor made by rodents

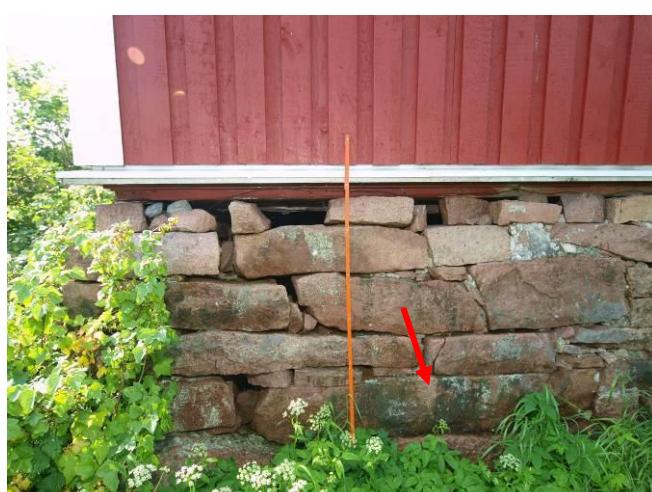
Fig.2. Piled socket partly without any mortar, biodamage on the socket

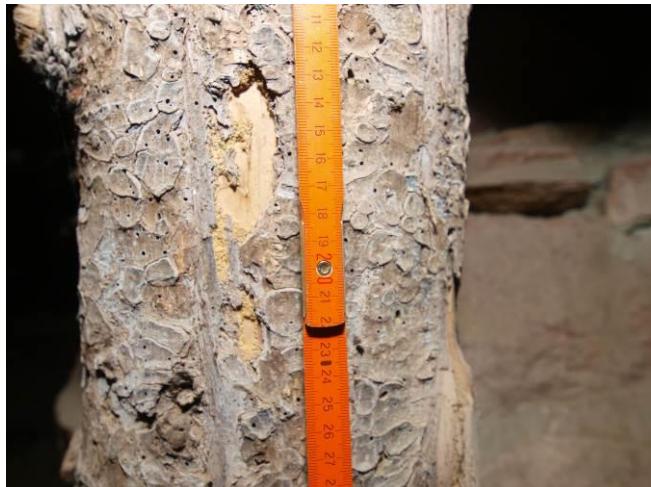
Fig.15. Bark beetle attacks in the cellar
