Inspections on Åland islands

Project Fungi and Beetles in Buildings on Islands of Baltic Sea (acronym FaB Bi)

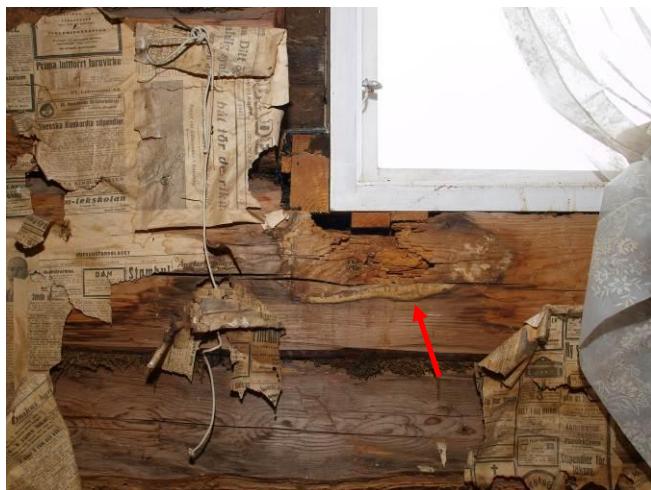
Fig. 17. Old fungal damages on the wall under window in the room No. 15

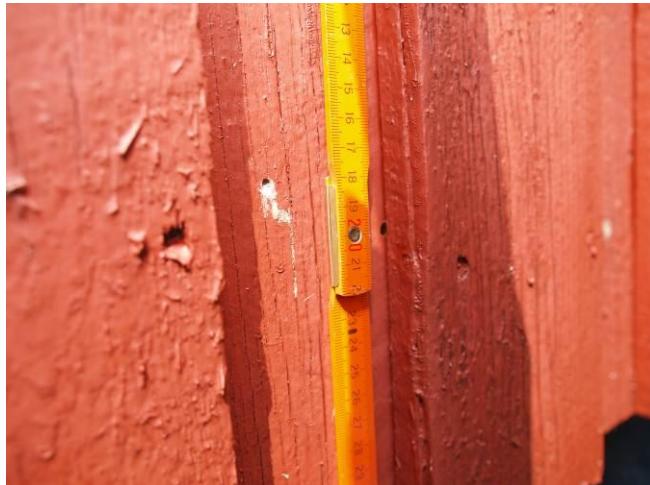
Fig. 9. Exit holes of the Old House Borer on the house exterior wall boarding

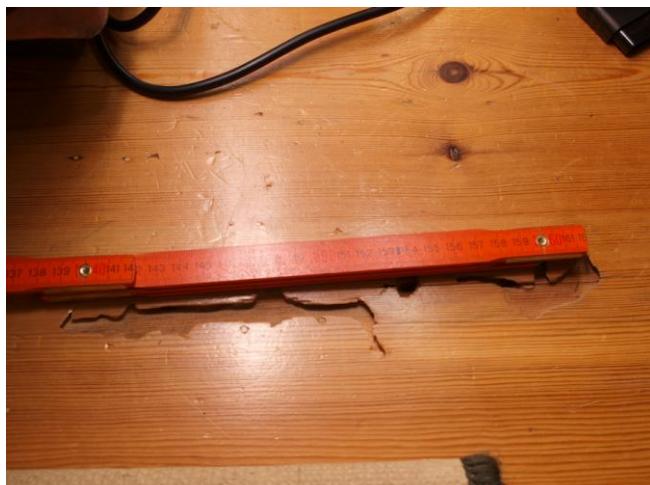
Fig. 11. Damages by the Old House Borer in the living room floor

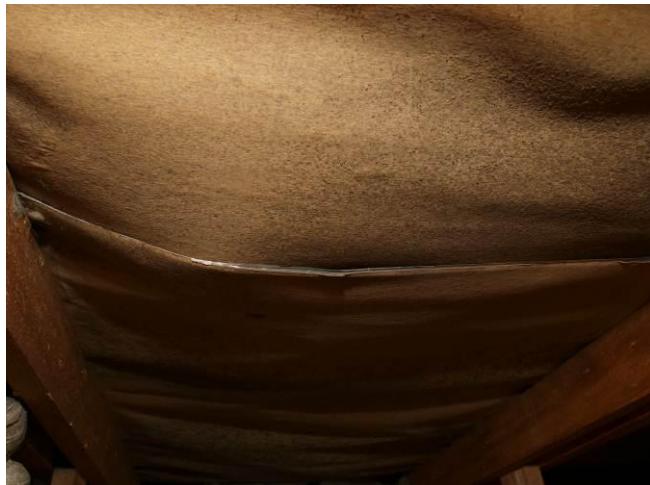
Fig. 12. Moulds on the the surface of the roof boarding
