THE FINAL RESEARCH REPORT

‘Sustainable Management of Historic Rural Churches
in the Baltic Sea Region (SMC)’

The final report of research of project 'Sustainable Management of Historic Rural Churches in the Baltic Sea Region (SMC)'

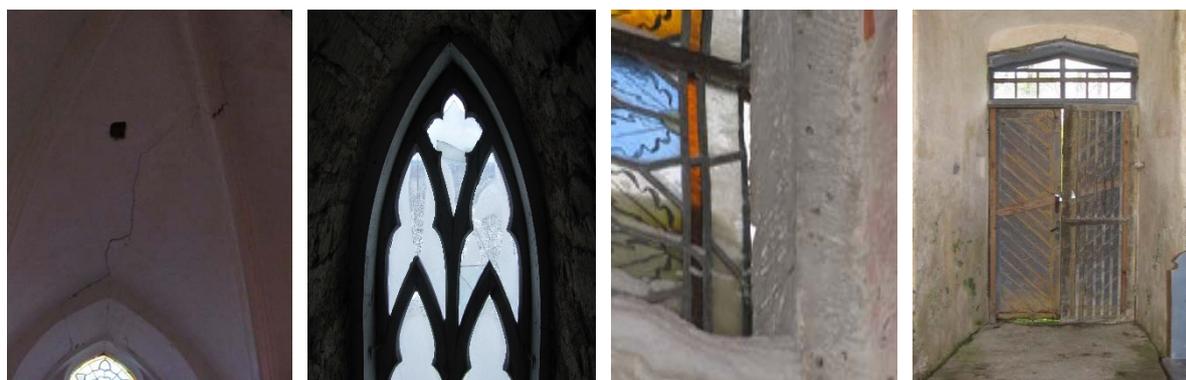
Figure 3.4 A: Ventilation holes in arches
 B: Broken window panes
 C: Cracks around windows
 D: Cracks around doors

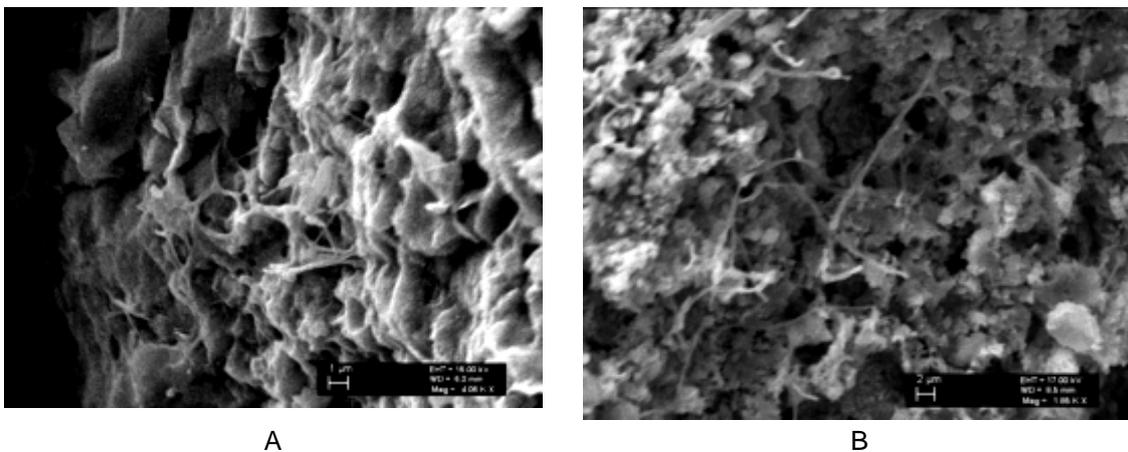
Figure 4.2 Contamination of the surface of plaster with fungal mycelium

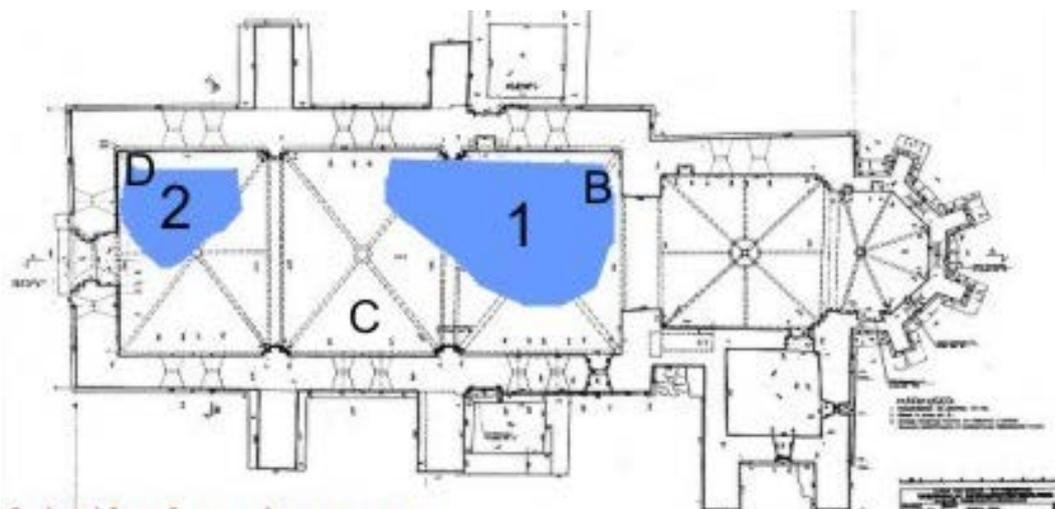
Figure 4.8 Distribution of the wood rot in the floor structures of St Martin's Church in Valjala

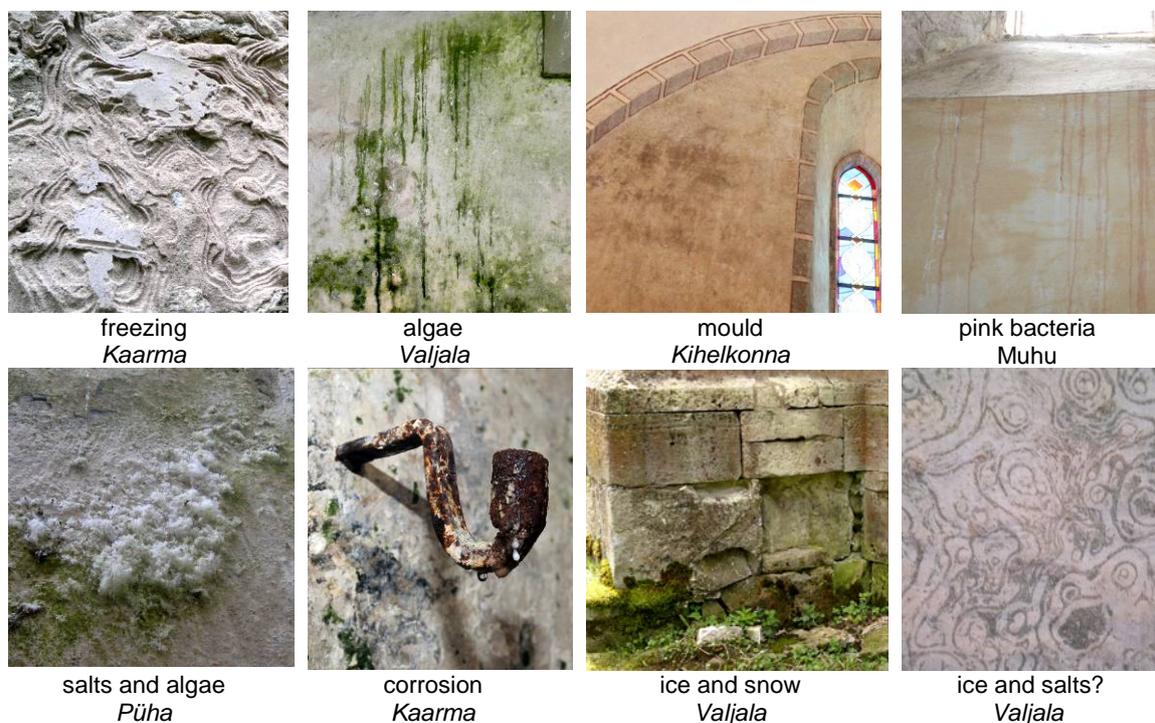
Figure 7.2 Typical damage caused by moisture

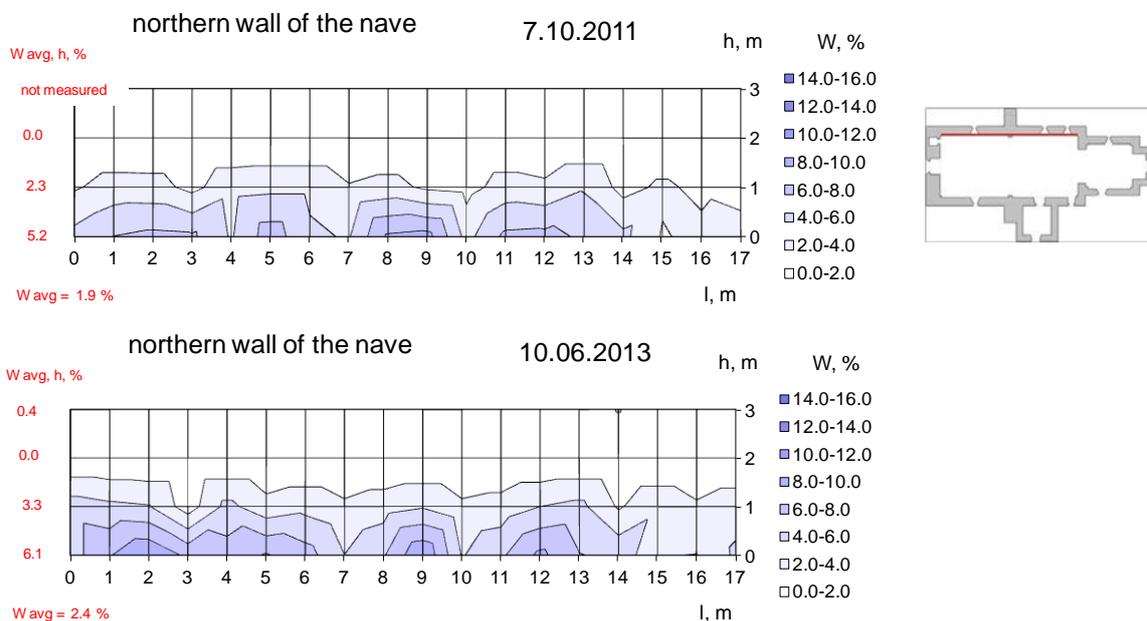
Figure 7.9 Typical picture of the upsoaring rising moisture in Muhu Church
