Inspections on Åland islands

Project Fungi and Beetles in Buildings on Islands of Baltic Sea (acronym FaB Bi)

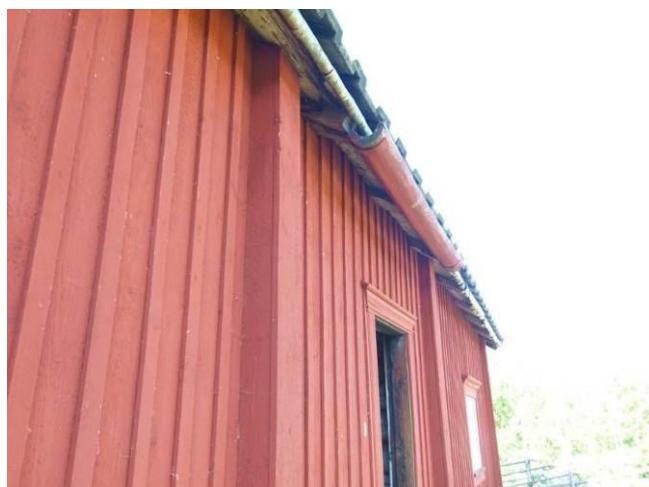
The building is situated on a hump. Rainwater is poorly conducted away from the building. Although the rainwater system is incomplete (Fig. 1.), the placing of the building favours the drainage of the rainwater. On the other hand, due to the height of the socket, timber walls experience a severe water load (rainwater is splashing up from the ground taking along organic matter) (Fig. 2.). The height of the socket is too low, varies from 10 to 30 cm.

Fig. 1. The rainwater system is incomplete

In order to reduce the rainwater load to the exterior part of the walls, it would be necessary (if possible concerning the historical value) to install complete rainwater system. As there were traces of water passages and the southern roofside undulates, the attic should be inspected thoroughly. Although there were no visual traces of damages to the timber floors in room No 2 and 3, there should be made additional incitement holes to the socket in the western part of the building in order to assure the ventilation beneath.

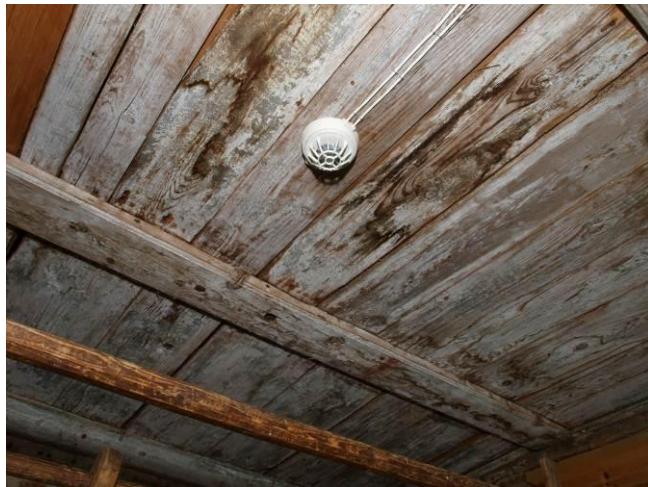
Fig. 5. Traces of water passages in room No. 4

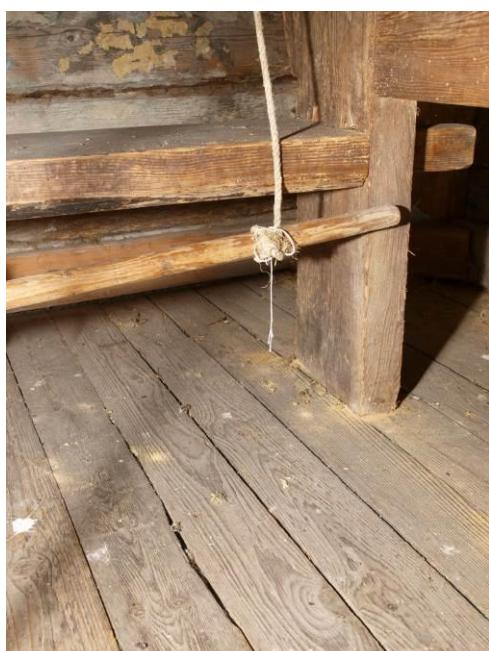
A few of the beetle damages were found outside, but most damages were inside the building. Precisely, all the wall constructions and handlooms in room No. 4. Walls and handlooms had massively attacked by the common furniture beetle (*Anobium punctatum*) (Fig. 6, 7, 8 and 9). Besides beetle exit holes we found holes on the floors, which were made by rodents.

Fig. 8. Handlooms attacked by furniture beetle

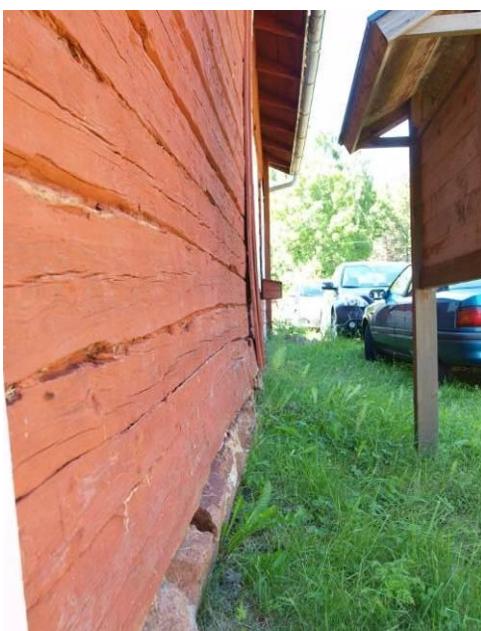
Some parts of walls have slanted out in the northern (Fig. 5) and southern (Fig. 6) sides of the building. There is also a severe UV-damage in the southern side of the building (Fig. 7).

Fig. 5. Wall slanted out

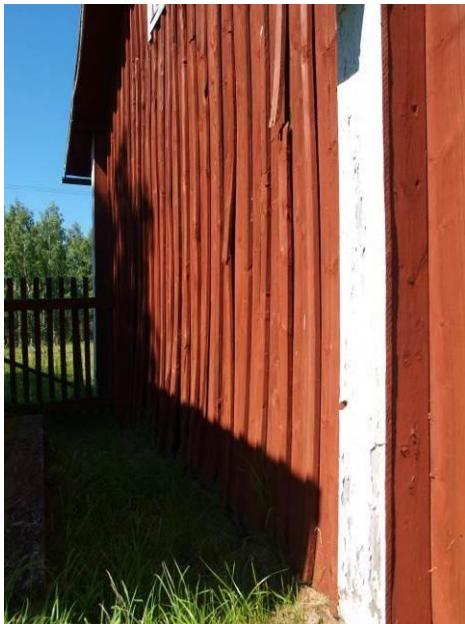
Fig. 6. Boarding and logs of wall have slanted out

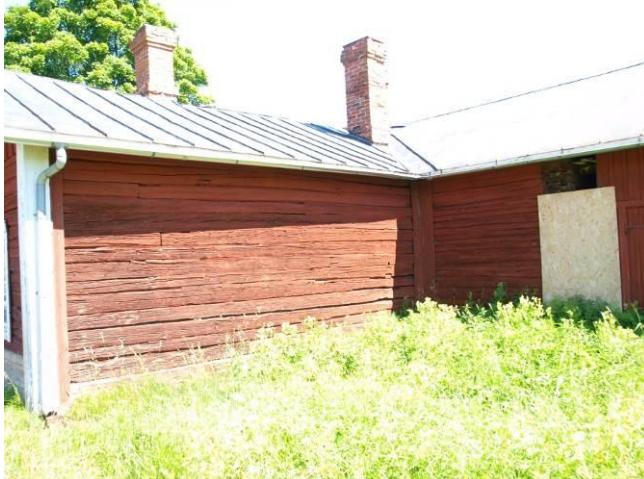
Fig. 7. The southern side of logwalls have severe UV-damaged

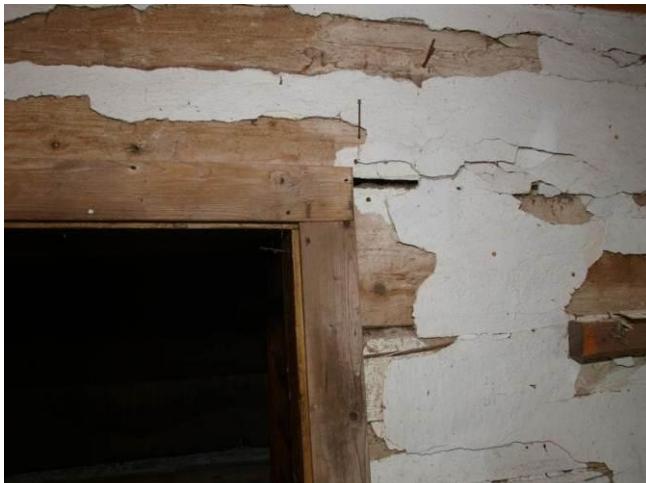
In room No. 6 the walls have loose and missing plaster, which indicates severe moisture damage (Fig. 8 and 9). In room No. 3 there has been already removed the lowest part of the damaged logged wall, but the problem consists in the absence of hydro-insulation – the socket is on a direct contact to the timber (quarrystones damps the timber element).

Fig. 8. Loose and missing plaster on the wall in room No. 6

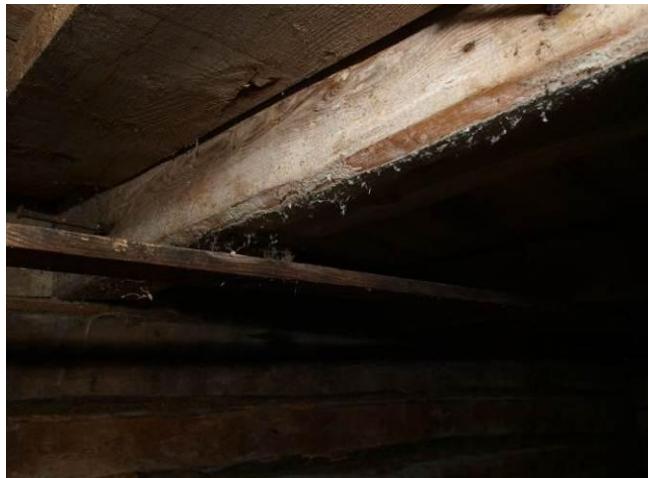
In room No. 8 the paint is peeling from the ceiling, which can indicate either to a water passage or a high humidity (Fig. 10). In room No. 2 there are some salt damages in the ceiling-beam (Fig. 11), this is due to the dairy, which was above the room.

Fig. 11. Salt damaged ceiling-beam in room No. 2

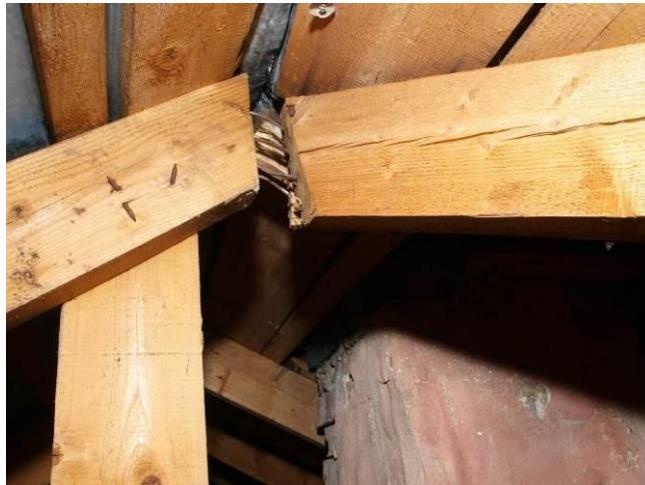
Near the chimney we identified ceiling-beam in bad condition (Fig. 13). The roof's timber structure has a loose connection (Fig. 14), which needs to be fixed immediately.

Fig. 14. A loose connection of the roof's timber structure

The plaster on the wall between rooms 3 and 4 should be removed, because the logged wall beneath is damaged. In the attic the timber structures must be fixed (Fig. 13 and 14). The metal plates must be removed in room No. 2.

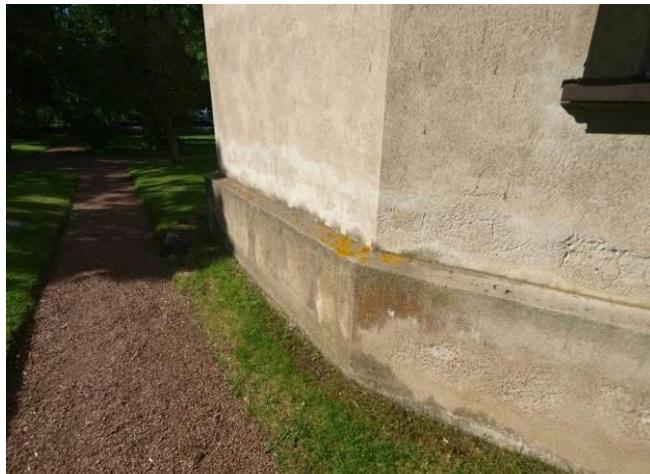
Fig. 3. The outreaching part of the wall is bio- and moisture damaged

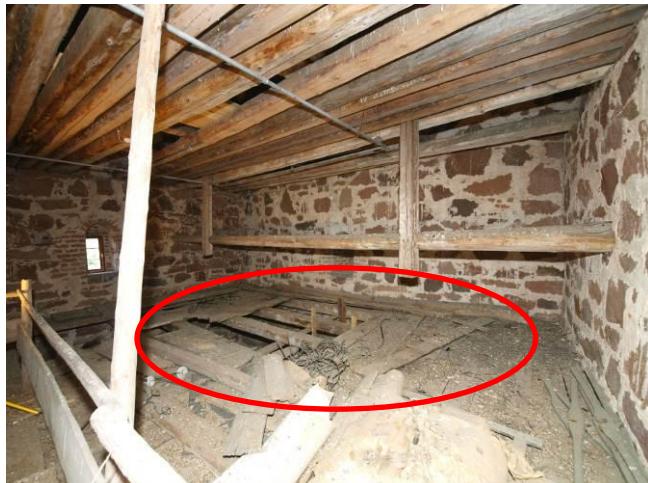
Fig. 5. The whole floor is covered with birds' excrements and some elements of the timber floor are damaged

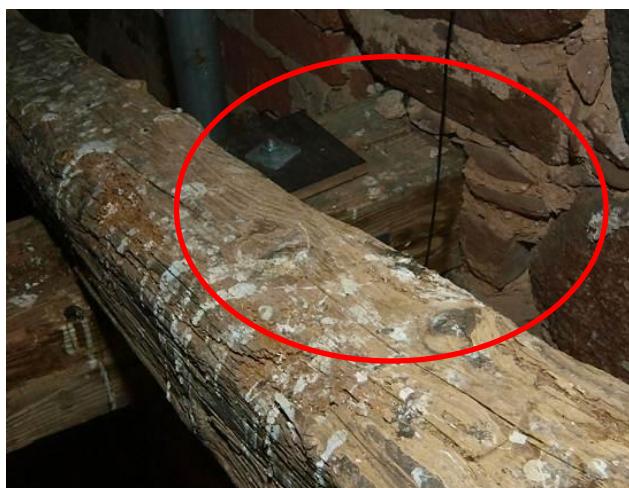
Fig. 7. Load-bearing timber element is unisolated with hydro-insulation - stonewall damps the timber, which may result in the reduction of shear strength

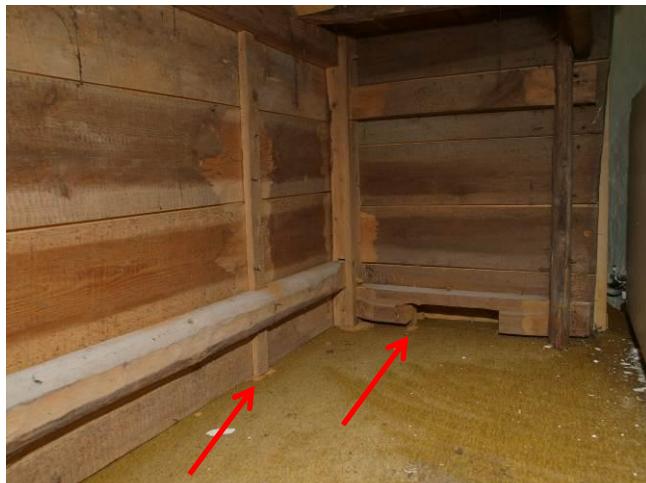
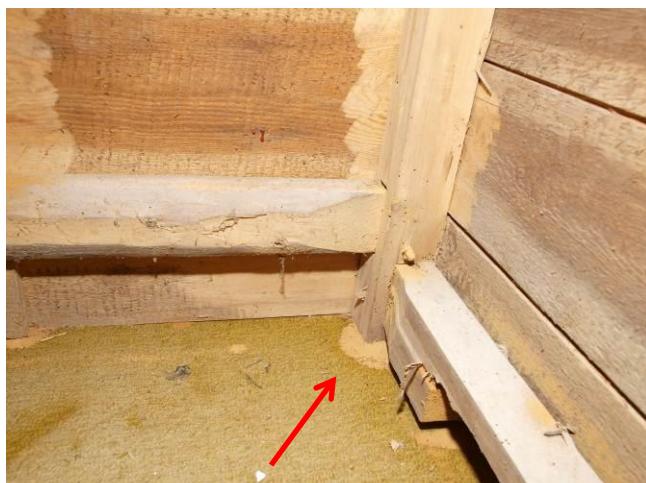
The altar in this church had active insect damages. We identified bore dust inside the altar, mainly in the corners (Fig. 8 and 9). In the attic few timber elements had old insect damages caused by bark beetles (Fig. 10).

Fig. 8. Bore dust inside the altar

Fig. 9. Closer view to the bore dust inside the altar

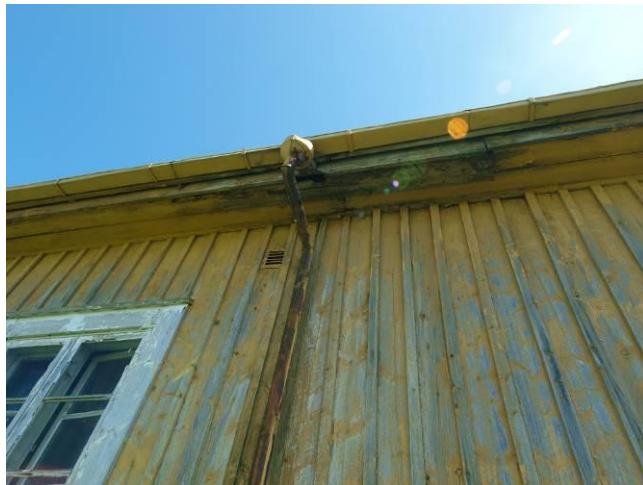
Fig. 3. Corroded and malfunctioning rainwater pipe

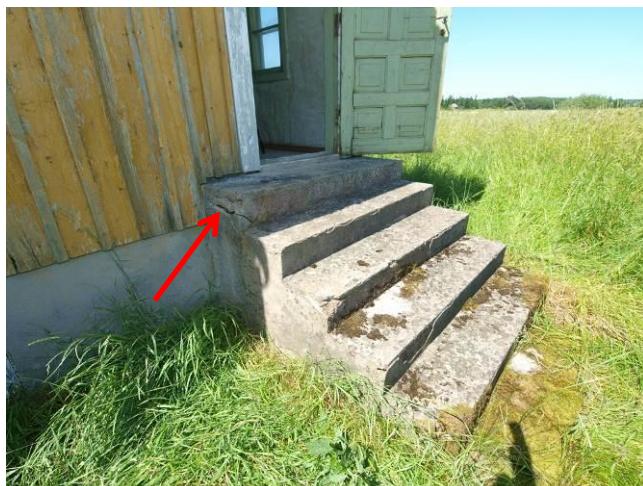
Fig. 4. Cracked and biodamaged staircase

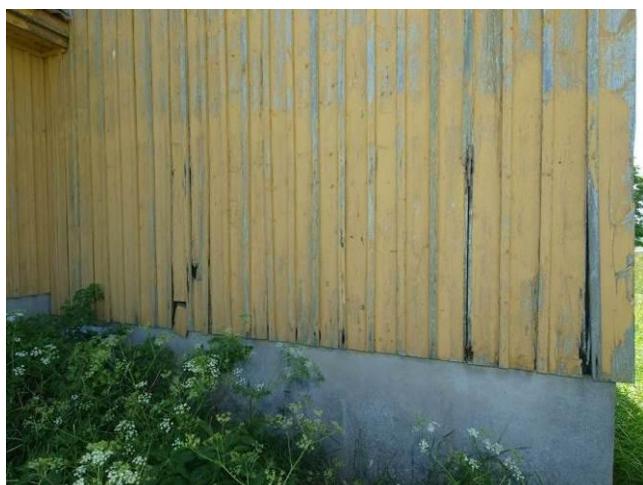
The paint of exterior walls has flaked off and the wall boarding has partially degraded (Fig. 5), eave-boardings are missing on the southern side (Fig. 6). The roof has some tiles missing, indicating to a severe water passages (Fig. 7 and 8). The basement stairs have no hatch, causing severe water load down to the basement (Fig. 9).

Fig. 5. The wall boarding has partially degraded and paint has flaked off

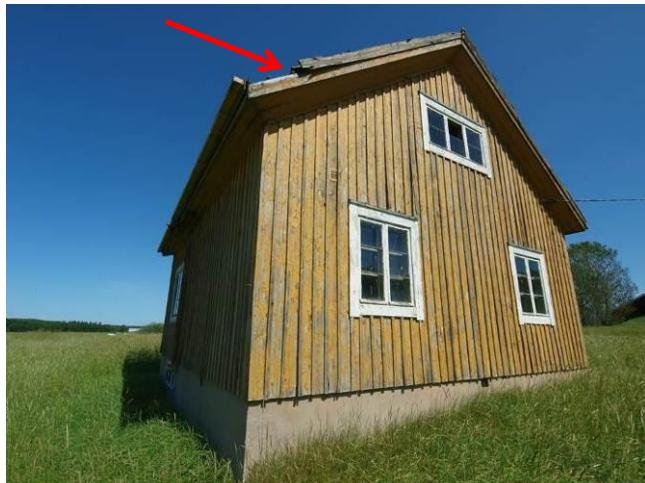
Fig. 6. Missing eave-boardings, paint has flaked off

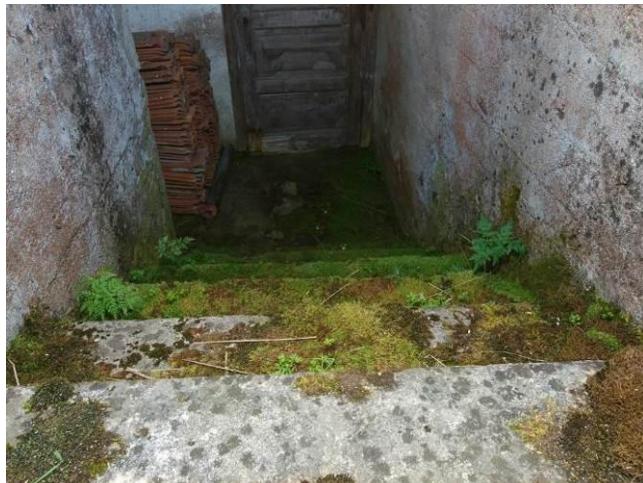
Fig. 9. The cellar's stairway has no hatch, causing severe water load down to the basement. The stair steps and floor are covered mostly with mosses

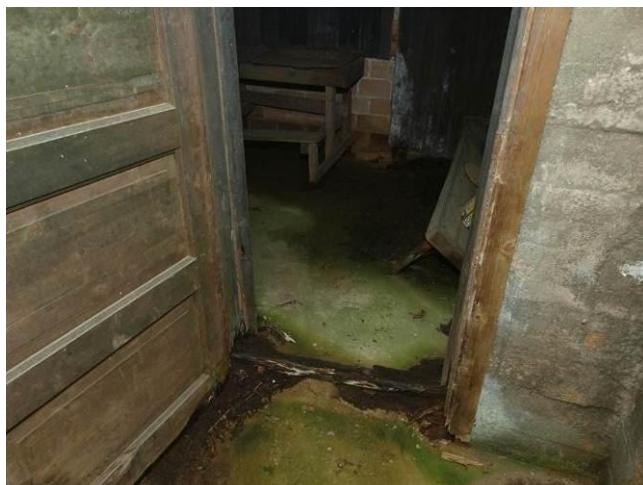
Due to the missing hatch of the basement, water load has caused severe bio and salt damage to the walls and ceiling and degradation of timber elements in the rooms (Fig. 10 to 14). There are also moisture and frost damages causing plaster to flake off (Fig. 15).

Fig. 10. The basement's floor is covered with algae and the timber elements are degraded

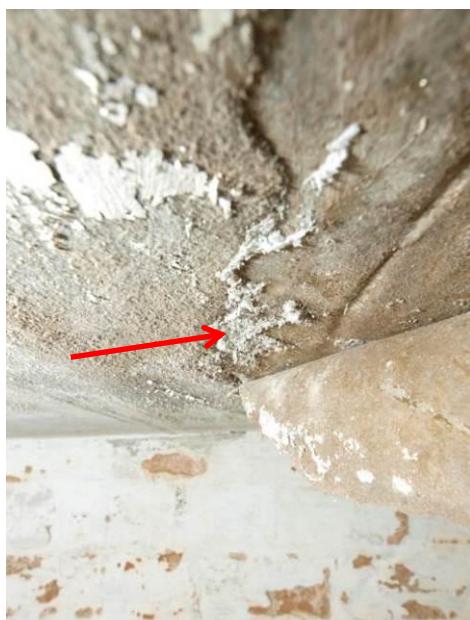
Fig. 12. Salt damages in the ceiling

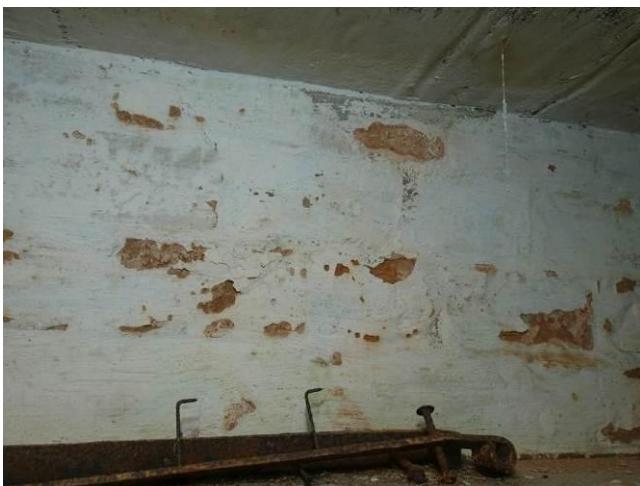
Fig. 15. Moisture- and frost damage causing plaster to flake off

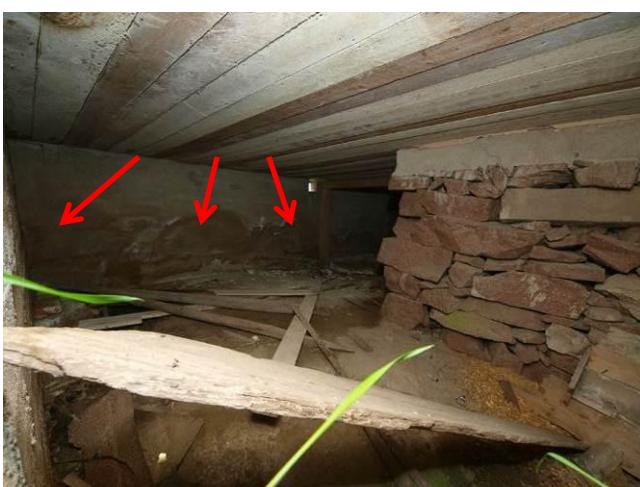
The southern side of the basement's walls are with moisture and salt damage (Fig. 16). There are also a lot of old timber boards, should be removed.

Fig. 16. Moisture and salt damages on the walls of the southern part of the basement

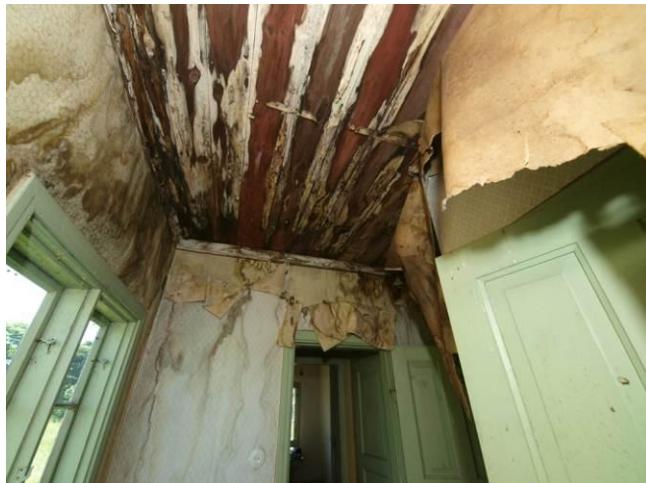
The building has several water passages that have caused severe damages to the walls, ceilings and floors (Fig. 17 to 24). Water content of timber elements of kitchen floor was 53.6% and 18.6%.

Fig. 17. Severe water damages in the hall room

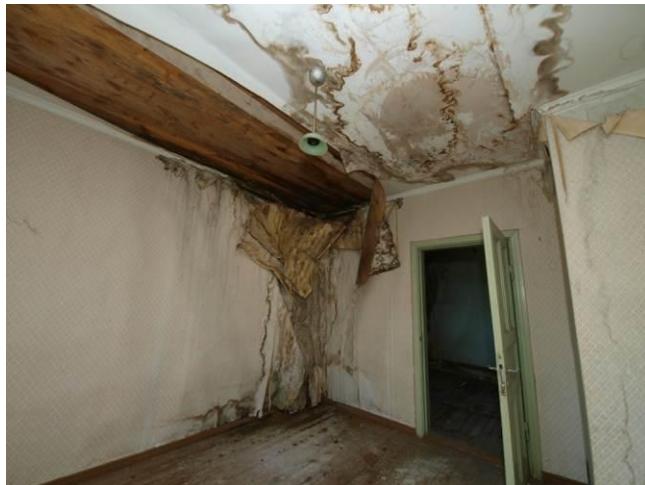
Fig. 22. Severe water damages in the livingroom

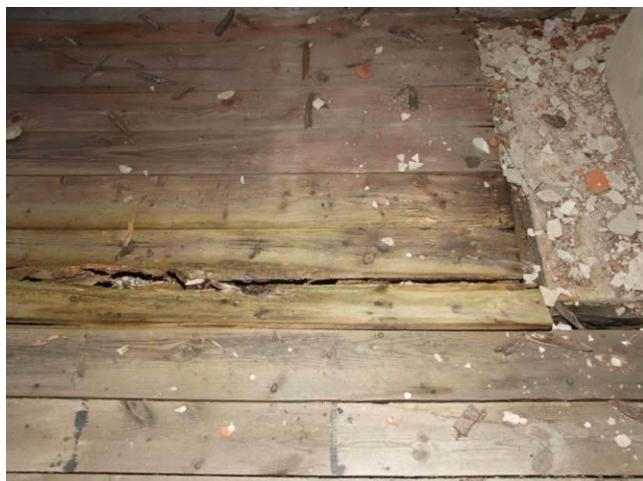
Fig. 28. Severe water damages in the attic's floor

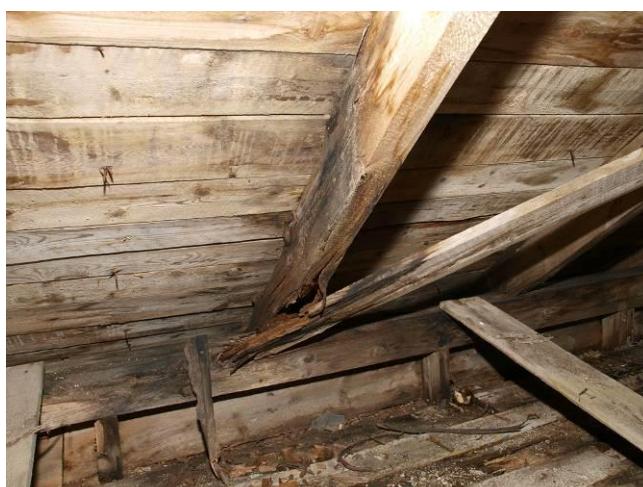
Fig. 29. Due to the water leakage, the rafter and the wind beam has degraded and lost its strength

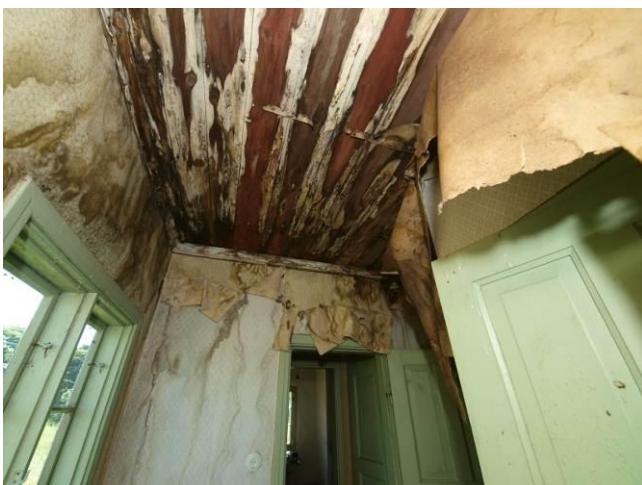
were severe fungal attacks on the floors, walls and on the ceilings on the first floor. All these damages are caused by the roof leakages. Mainly we found mycelium and fruitbodies of *Antrodia* species and also some mould fungi on the wallpapers (Fig. 32 to 34).

Fig.32. Fungal attack on the hall ceiling

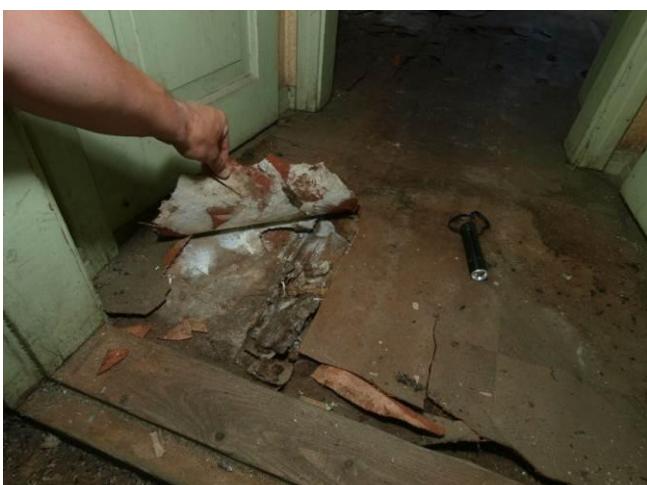
Fig.33. Mycelium of *Antrodia* on the floor material in the hall

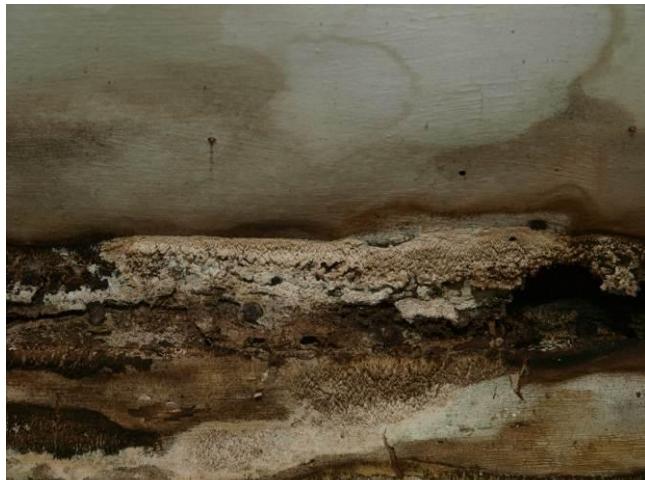
Fig. 34. Fruitbody of *Antrodia* species on the floorbeam

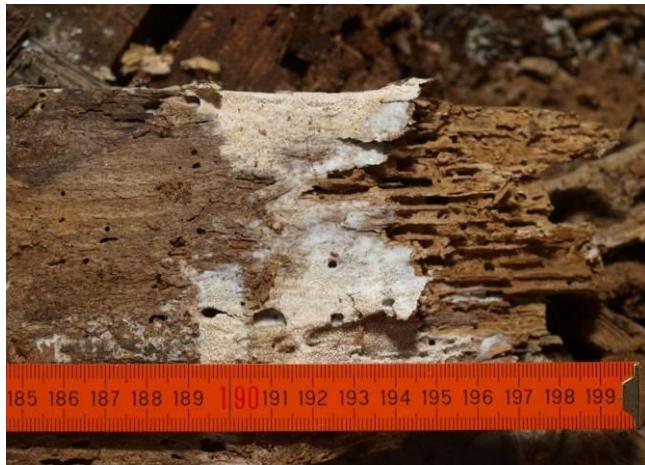
In the attic we found several beetle and fungal damages. Firstly, longhorn beetle (*Callidium violaceum*) had attacked the attic's roof timber (Fig 35). Also the upper part of the roof was damaged by Corticiaceae fungal species (Fig. 36). The floor beams had both the fungal and insect damages. Fungal damages were made by *Antrodia* species and Myxomycetes fungus and insect damages by anobiid beetle (Fig. 37 to 39).

Fig.37. Fungal and beetle damages on the floorboards

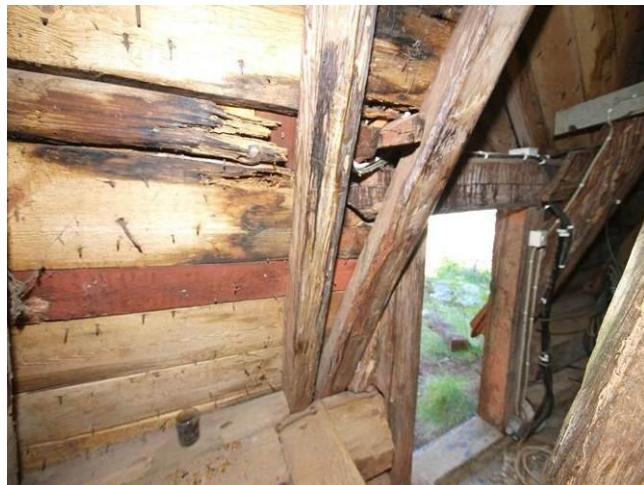
Timber structures by the entrance are severely degraded; diagonal posts and roof's timberboarding are rotten (brown rot damage) (Fig. 3).

Fig. 3. Degraded diagonal posts and roof's timber boarding near the entrance

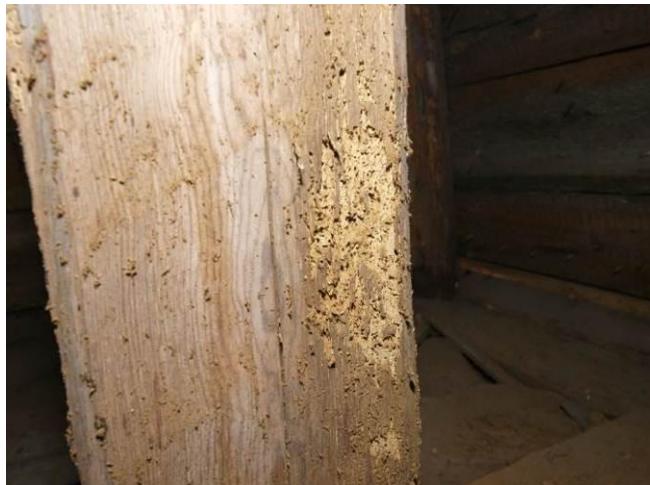
Fig. 5. Beetle attack on the beam

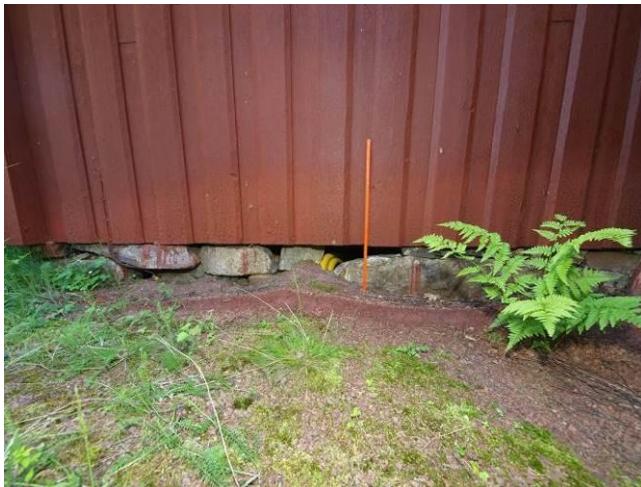
The building is situated on a hump. Therefore, water loads to the northern side of the foundation. There is not any rainwater system and rainwater is not conducted away from the building. The northern part of the socket is piled without any mortar (Fig. 2) and there were some loose and missing plaster on the southern part of the socket (Fig. 3) (Appendix G).

Fig. 2. The socket is too low and mortar between quarrystones is missing

In order to reduce the rainwater load to the northern part of the foundation and underground area, it would be necessary to install complete rainwater system. As there were some traces of water passages on the eastern part of the ceiling in the hall room, ceiling's boarding should be detached and inspected. Although there were no severe visual traces of damages to the timber floors, there should be made additional incitement holes to the socket in the southern, eastern and western parts of the building in order to assure the ventilation beneath. Because the building is situated on a hump, it causes a severe water load to the northern side of the foundation when raining. Hence the water must be conducted away.

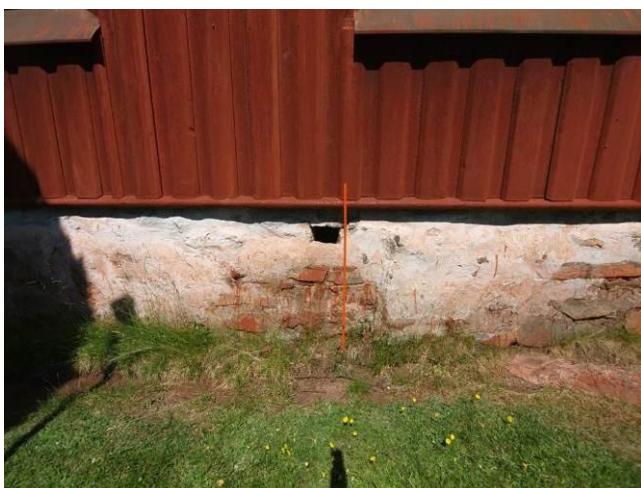
Fig. 3. There is some loose and missing plaster on the socket

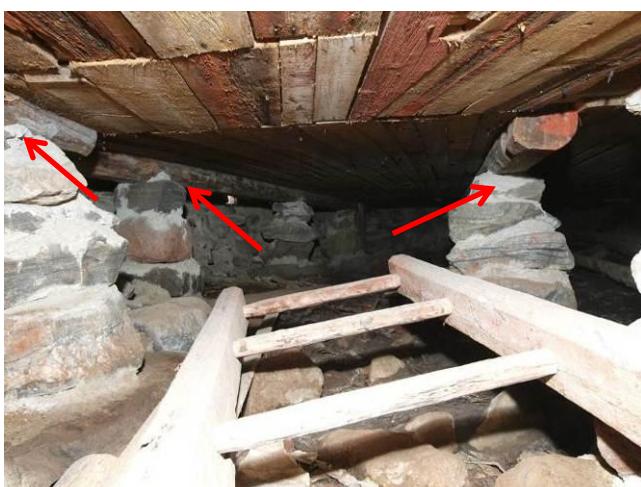
There is no hydro-insulation between the bearing floorbeams and stone foundation (Fig. 4). This causes constant damping to the bearing floorbeams and may result in their loss of strength. The water content of those timber elements were 25% and 40%. There were also useless timber elements (Fig. 5 to 6), which should be removed to prevent degradation.

Fig. 4. Missing hydro-insulation between the bearing floorbeams and stone foundation

Between the bearing floorbeams and stone foundation a layer of hydro-insulation should be set. For this kind of repairment one should use lifting jacks to raise the floorbeams in order to set a tar layer between.

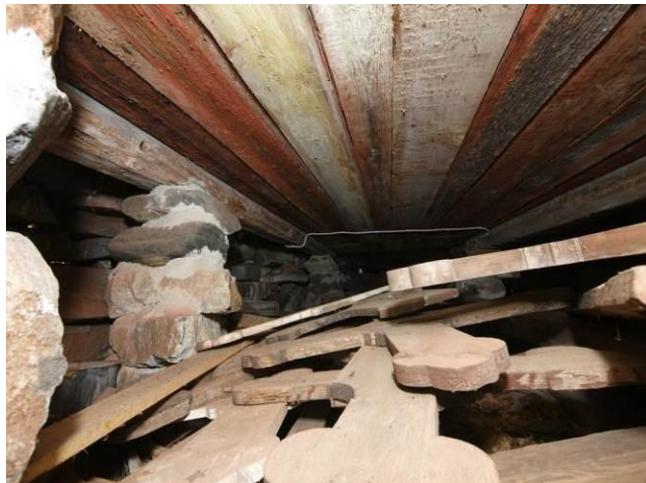
Fig. 5. Useless timber elements

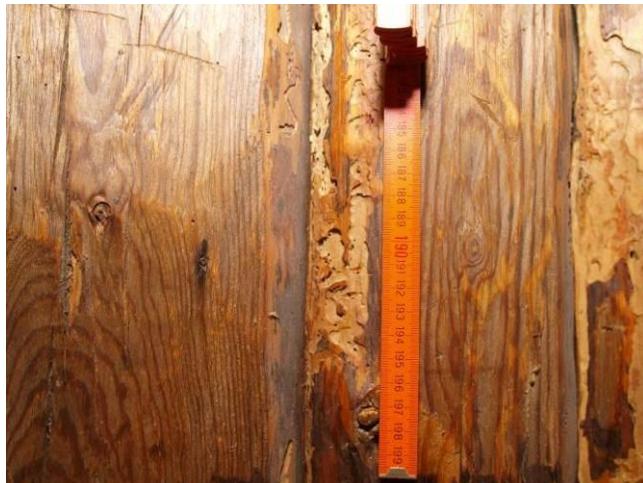
Longhorn beetles caused most of the beetle damages in this chapel church. Mostly were damaged hall room walls and bearing floor beams (Fig. 11 to 13).

Fig. 13. Larvae tunnels on the surface of timber made by bark beetles

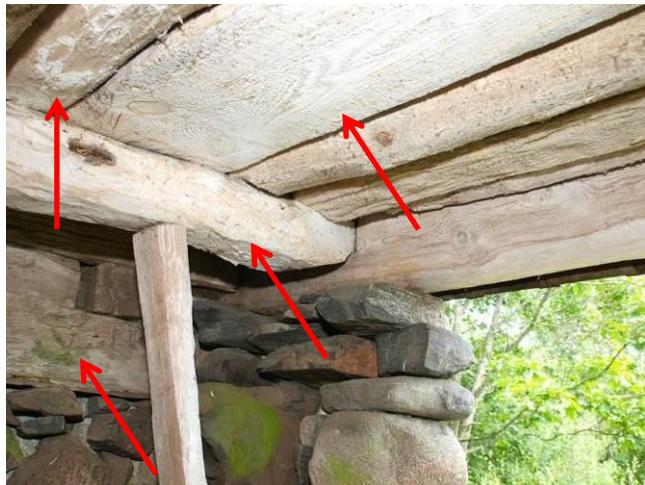
There is no hydro-insulation between the bearing floorbeams and stone foundation (Fig. 5 to 7). This causes constant damping to the bearing floorbeams and may result in their loss of strength. The water content of timber element was 25%. There is also salt and bio damages on the floorboardings and –beams (Fig. 8) near the entrance of the underground area.

Fig. 8. Salt and biodamages on the floorboards and –beams

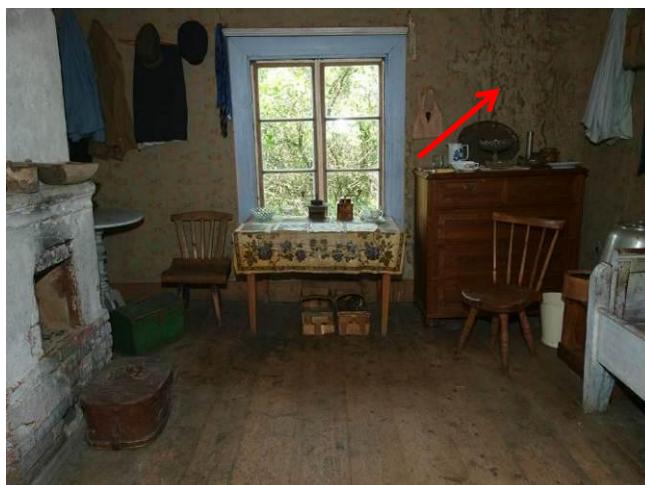
The building has timber floors, which are partially ventilated (rooms No. 1 and 2). Northern side of room No. 1 (wall and ceiling) has traces of water passage (Fig. 9). Due to the wallpaper the extent of damage to the bearing wall parts is unspecified. The underground area of room No. 3 is poorly ventilated; water content of timber flooring was 22% and 24%.

Fig. 9. Traces of water passage on the wall in the room No. 1

As there were some traces of water passages in the room No. 1, wall's wallpaper should be removed and inspected. Although there were no severe visual traces of damages to the timber floors, there should be made additional incitement holes to the socket in the eastern part of the building (below the room No. 3), in order to assure the ventilation beneath.

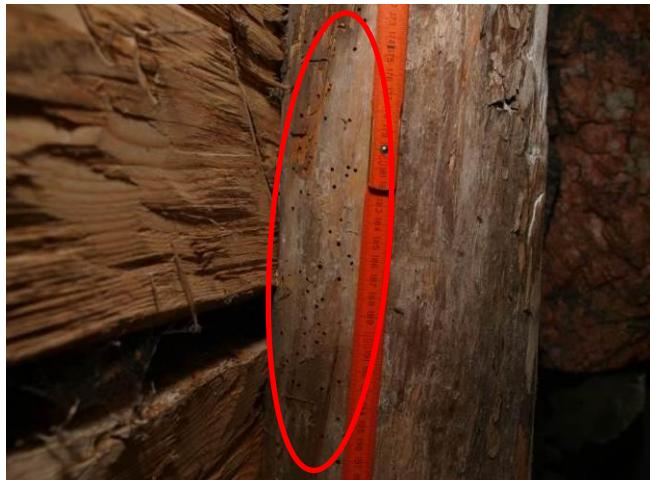
There were insect damages inside and outside the main building. First, the underground area floorbeams had attacks by the Deathwatch beetle (*Xestobium rufovillosum*) (Fig. 10). There were some bore dust heaps, which indicates to active damage (Fig. 11). Also some floorbeams were found with old brown rot damages (Fig. 5).

Fig. 10. Damaged underground floorbeam

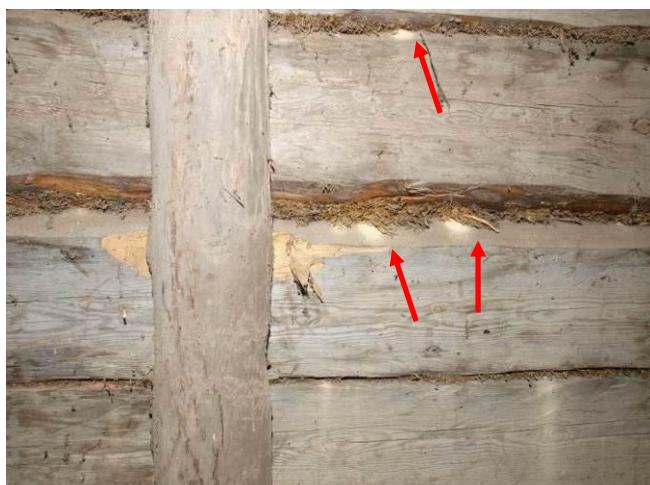
Inside the main building we found many old insect attacks in the rooms on the first floor. Several rooms had anobiid beetles (*Anobium punctatum* and *Xestobium rufovillosum*) attacks. First the hall ceiling, walls and the floor, secondly the Kammare room northern side of the ceiling and thirdly the kitchen walls. On the first floor and in the attic most of the furniture had attacks by anobiid beetles (Fig. 12). In the attic the walls and ceiling were covered with beetles' emergence holes and there was also lot of bore dust, which indicate to massive attack (Fig. 13 and 14). It should be monitored to make sure is it old or active damage.

Fig. 13. Bore dust in the attic wall

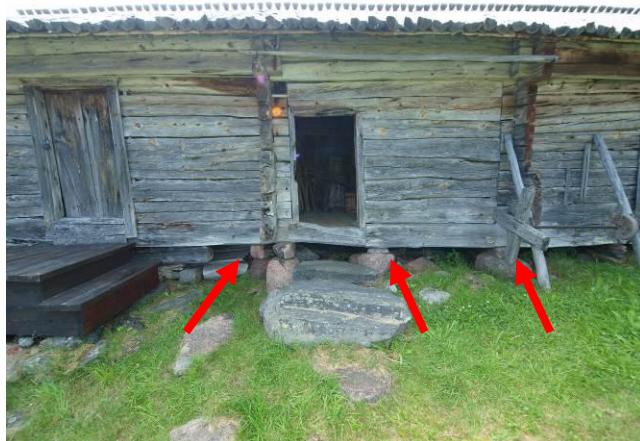
There is no hydro-insulation between the bearing logs and quarystone (Fig. 1 and 2). This causes constant damping to the bearing logs. The logs of the walls have been hogged (Fig. 1 and 2).

Fig. 1. Missing hydro-insulation, hogged logs of the wall

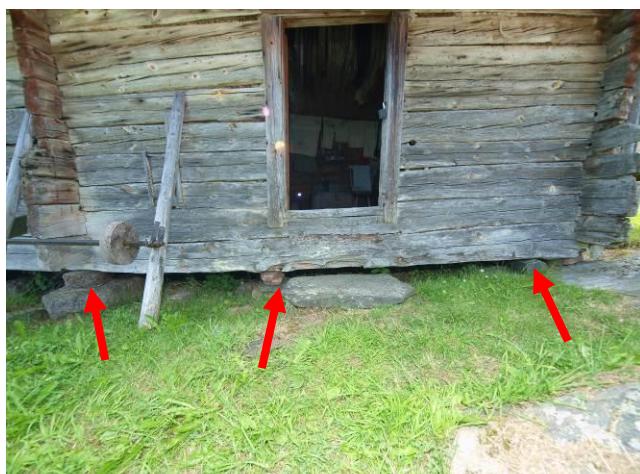
Fig. 2. Missing hydro-insulation, hogged logs of the wall

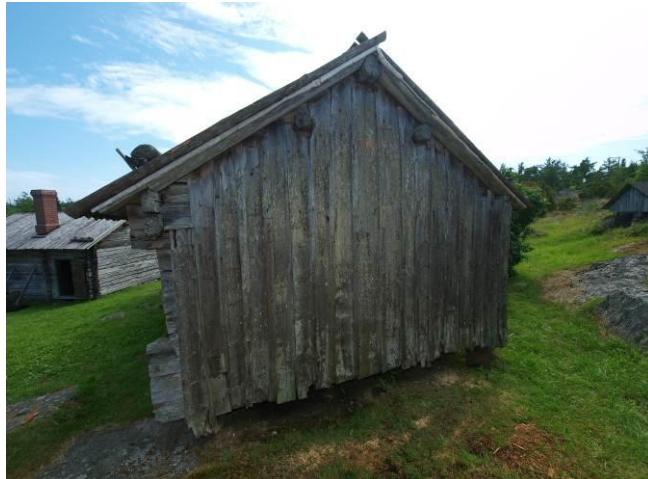
Lichens covered the northern side of the shed exterior wall panelling (Fig. 3). Also on the eastern side of the shed there were lichens growing.

Fig. 3. Lichens have covered the shed exterior wall panelling

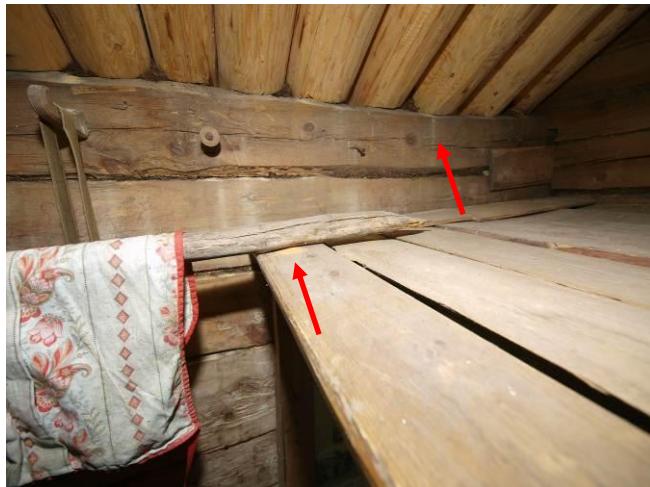
Fig. 5. Bore dust under the timber bar and on the upper part of the walls

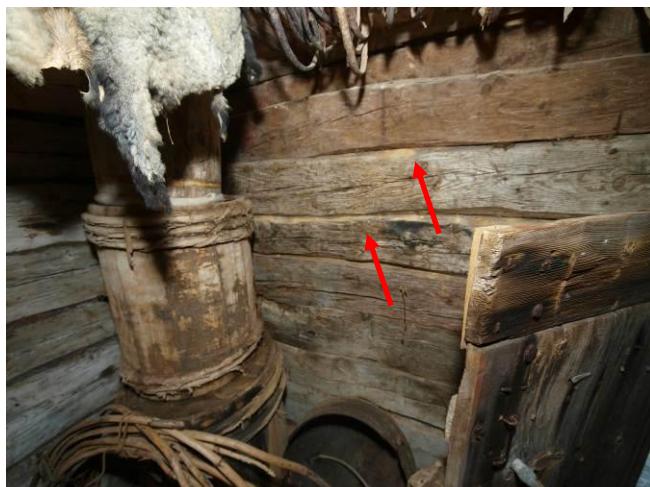
Fig. 6. Bore dust on the inside wall of the shed

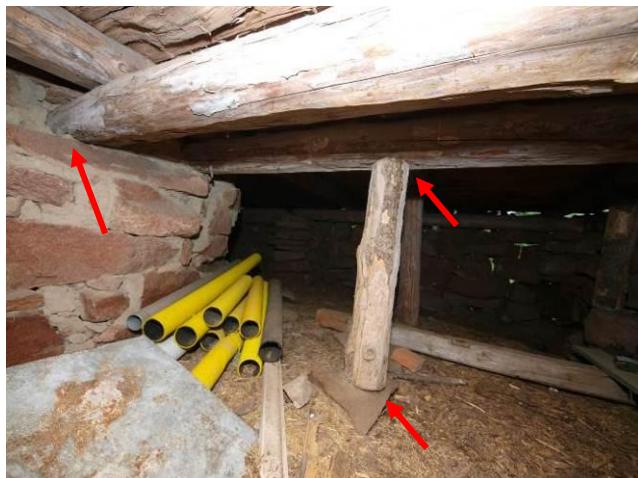
There is no hydro-insulation between the bearing floorbeams and stone foundation (Fig. 3 and 4). This causes constant damping to the bearing floorbeams and may result in their loss of strength.

Fig. 3. Missing hydro-insulation, unstable timber joints

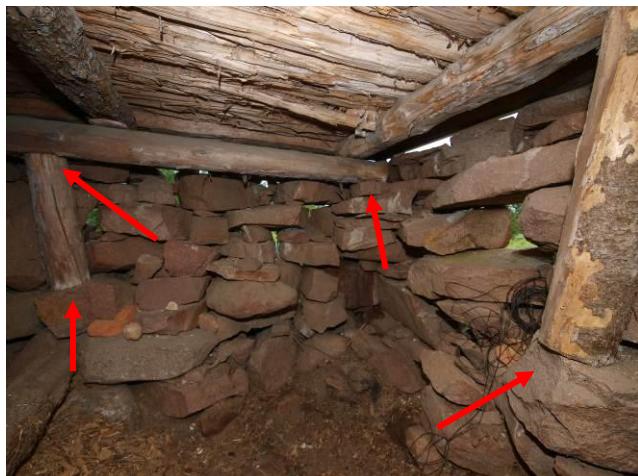
Fig. 4. Missing hydro-insulation, unstable timber joints

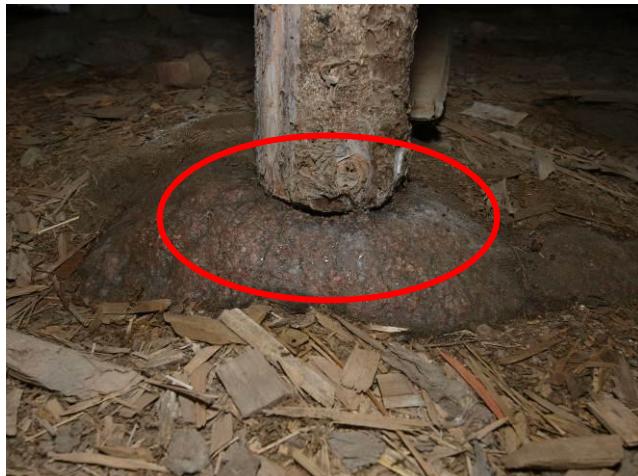
The socket is piled partly without any mortar (Fig. 2) and there are three ventilation holes, thus the underground area is ventilated, keeping it less dampy. The load-bearing posts are not firmly set to the ground and joined to the floorbeams and there is a direct moisture connection from the ground (Fig. 3 to 5). The water content of timber elements were measured 24% and 32%. There are also useless timber elements and drebis, which should be removed from there.

Fig. 5. Missing hydro-insulation

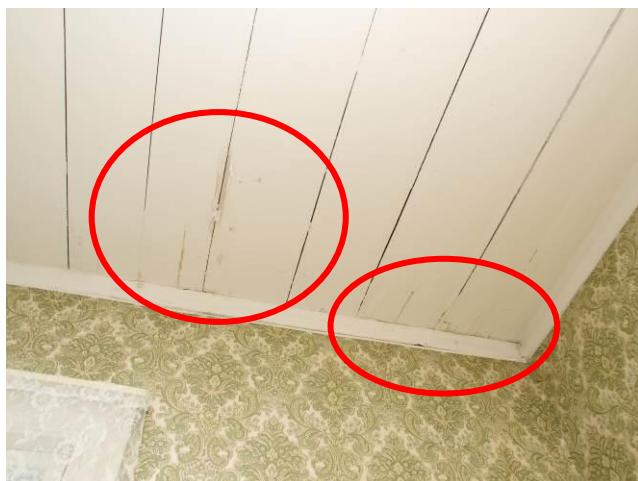
The building has timber floors, which are completely ventilated. Room's No. 1 ceiling has traces of water passage (Fig. 6).

Fig. 6. Traces of water passages

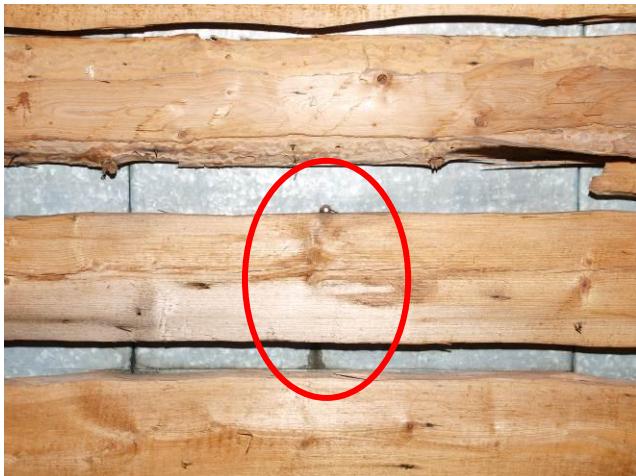
The roof's timber structure and attic's timber floor have some water damages; some of the timber balks and posts have degraded (Fig. 7 and 9). It is caused by the nails that have been striked through the metal sheet roofing. Some of the balks are spliced between the rafters (Fig.

Fig. 7. Water passage in the metal roofing

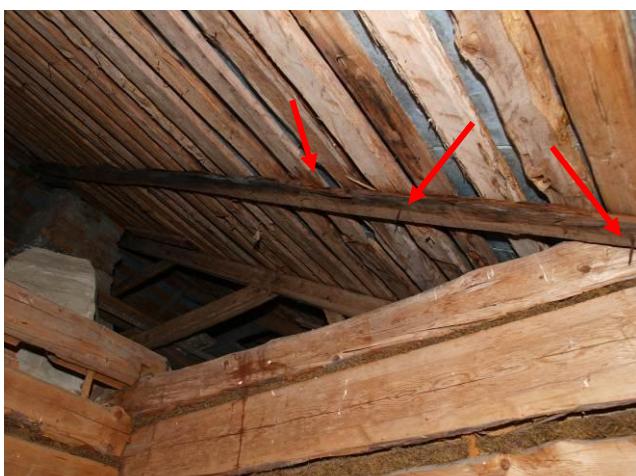
Fig. 8. Traces of water passages, caused by the nails, that are striked through the metal sheet roofings

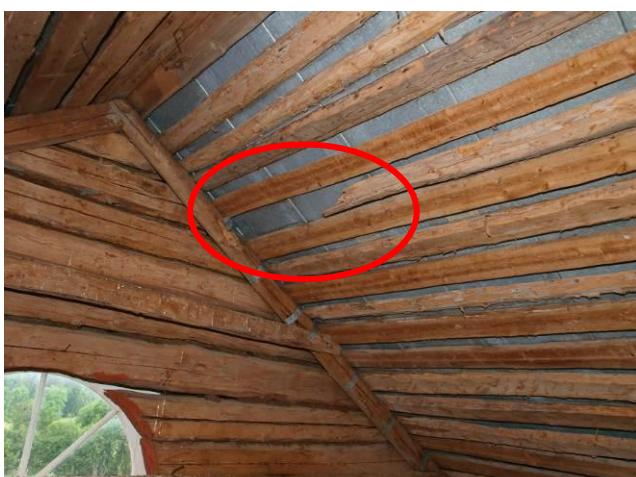
Fig. 9. Broken balk

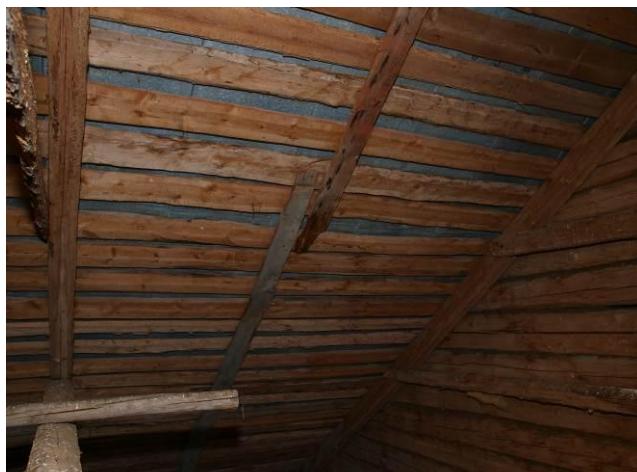
10). One supporting post is detached from the wall and the wall structure is unstable (Fig. 11 and 12). There is also missing underlay covering that catches condensated water.

Fig. 10. The gap between the rafters is too big, a risk of hogging of balks

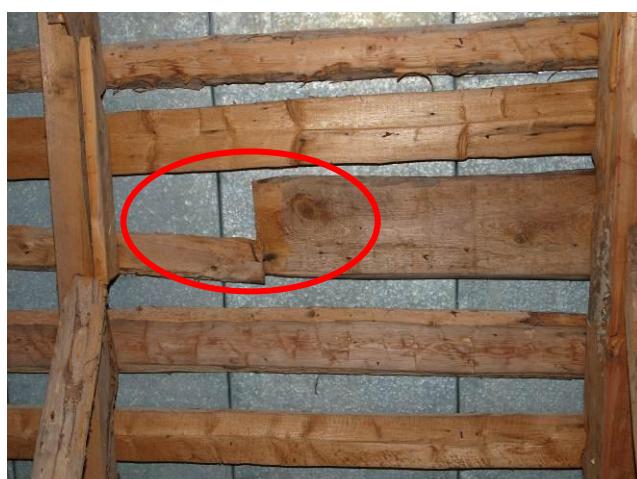
Fig. 11. Balks are spliced between the rafters

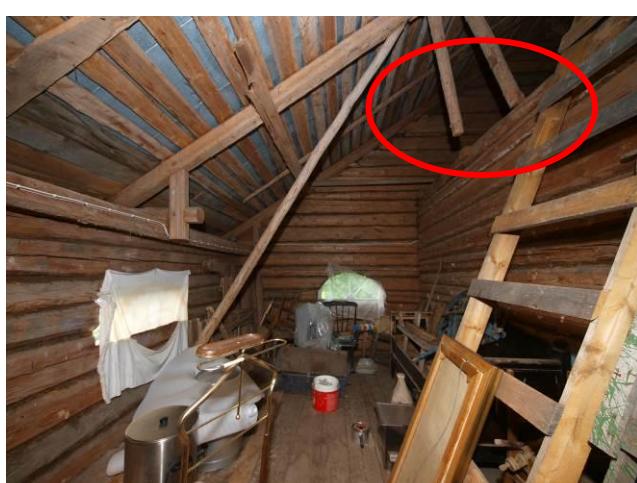
Fig. 12. Detached timber element

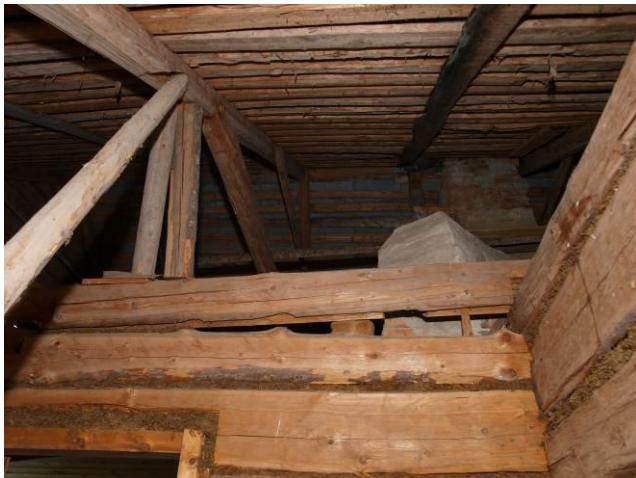
Fig. 13. Unstable timber structure

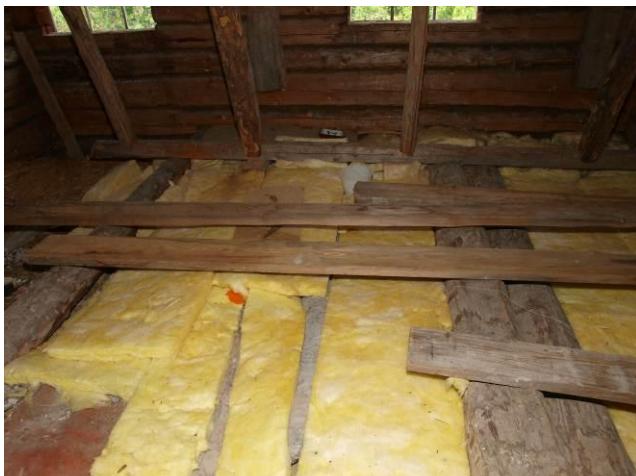
The attic's floor is inefficiently insulated with glass wool (Fig. 14). Due to the water passages in the roofing, the insulation gets wet and its thermal function decreases. Another issue is that the wool slabs must be placed tightly next to each other and covered with wind-barrier layer.

Fig. 14. Inefficient thermal insulation

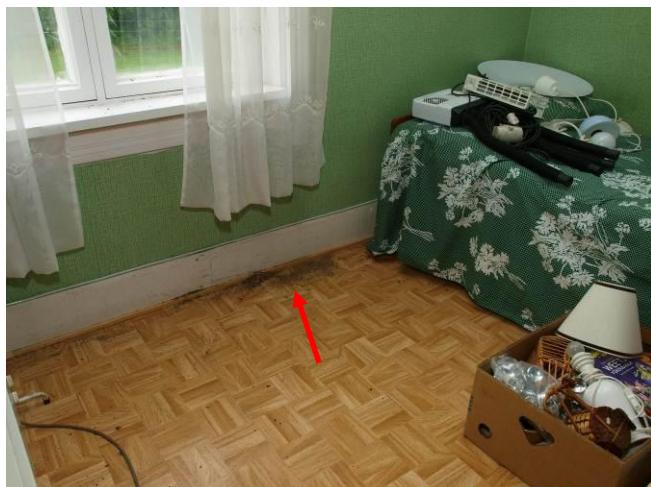
We found few bark beetle attacks (Fig. 15), because of the use of unpeeled timber, in the cellar. Inside the house we found ants in room No. 3 (Fig. 16). It seems that walls in the southern side of this forementioned room are damages by ants. In the attic we found fungal and insect damages. Mainly, fungal damaged were walls under windows, due to leakage from these areas (Fig. 17). All the fungal damages were old. Besides rotten walls, we found lichens growth on the windowframe in the southeastern side (Fig. 18). In several walls in the attic we found insect attacks. The main damage are longhorn beetles from family Cerambycidae (Fig. 19) and Anobiidae beetles (Fig. 20). We also found bark beetle attacks in the attic's timber structure.

Fig.16. Ants on the floor of the room No. 3

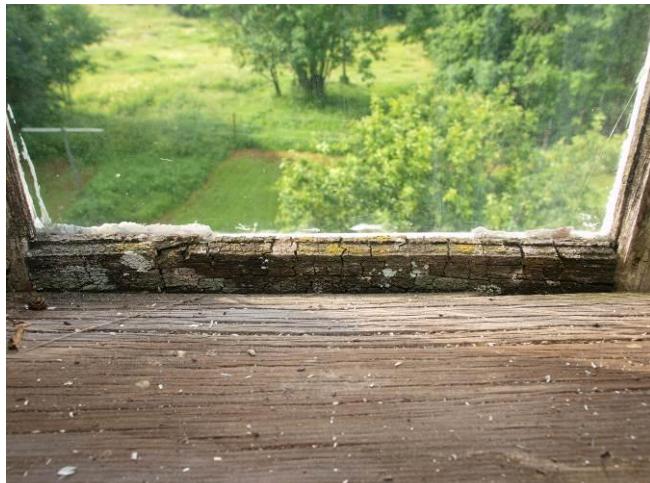
Fig.18. Lichens growth on the windowframe
