Inspections on Åland islands

Project Fungi and Beetles in Buildings on Islands of Baltic Sea (acronym FaB Bi)

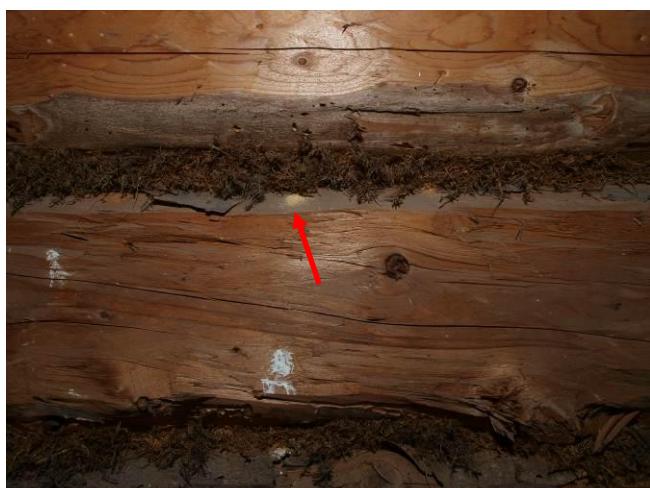
We found few bark beetle attacks (Fig. 15), because of the use of unpeeled timber, in the cellar. Inside the house we found ants in room No. 3 (Fig. 16). It seems that walls in the southern side of this forementioned room are damages by ants. In the attic we found fungal and insect damages. Mainly, fungal damaged were walls under windows, due to leakage from these areas (Fig. 17). All the fungal damages were old. Besides rotten walls, we found lichens growth on the windowframe in the southeastern side (Fig. 18). In several walls in the attic we found insect attacks. The main damage are longhorn beetles from family Cerambycidae (Fig. 19) and Anobiidae beetles (Fig. 20). We also found bark beetle attacks in the attic's timber structure.

Fig. 19. Exit holes and bore dust on the wall in the attic

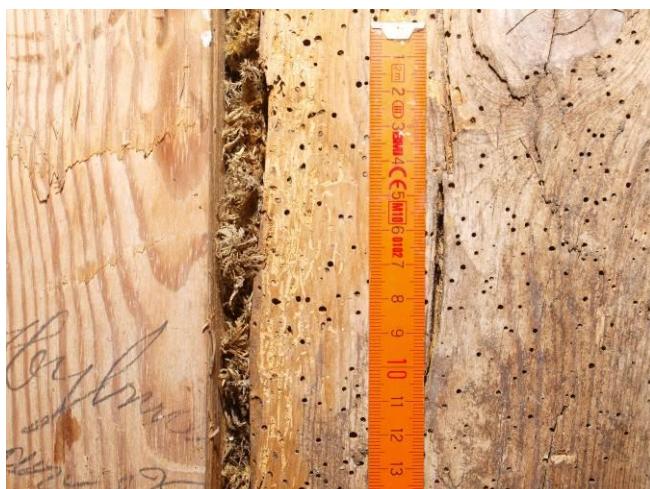
Fig. 20. Exit holes on the wall in the attic

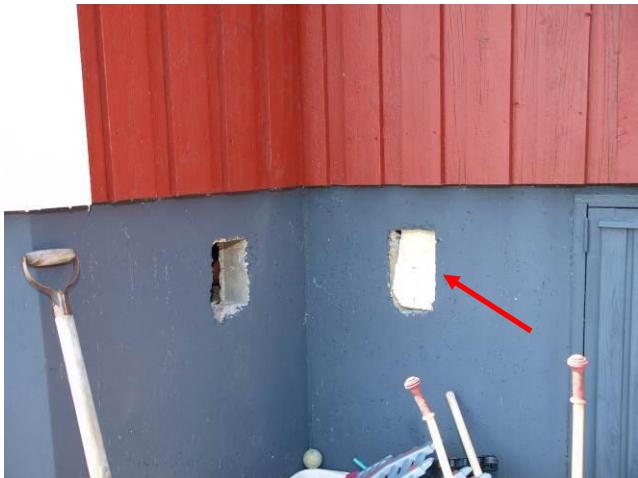
Fig. 2. Closed ventilation hole

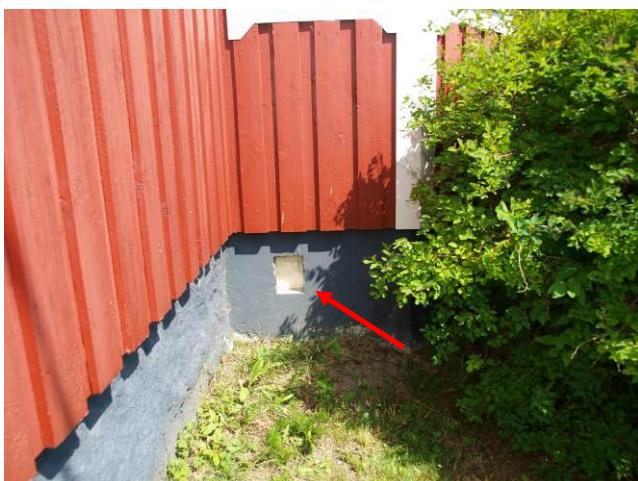
Fig. 3. Closed ventilation hole

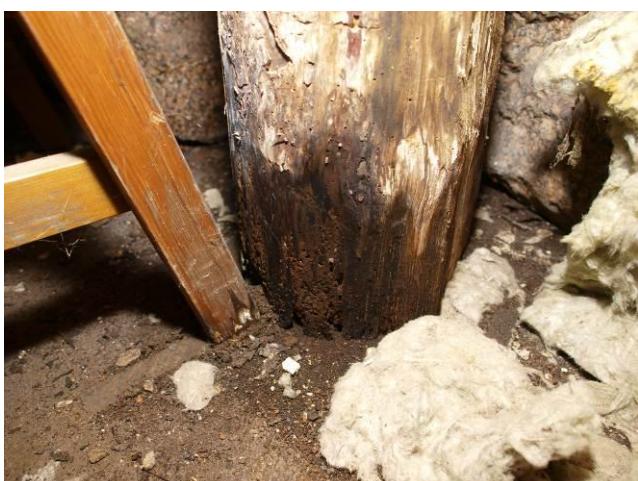
Fig. 4. Missing hydro-insulation, anobiidae beetles damage (in the basement)

Southern side of the house exterior wall boarding was attacked by the Old House Borer (House Longhorn beetle; *Hylotrupes bajulus*) (Fig. 9). In the cellar, ceiling beam and load-bearing posts had Anobiidae beetles damages (Fig. 4). On the first floor, we found Old House Borer attacks in the living room window frame and in the floor (Fig. 10 and 11). Also some Old House Borer exit holes in the balcony's doorframe. All the attacks inside the building were in the southern side.

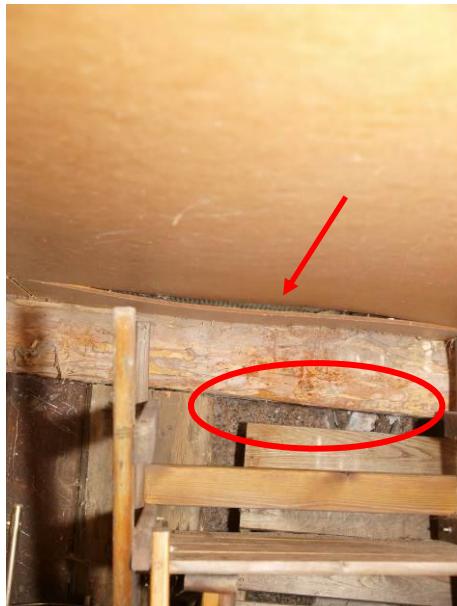
There is also missing hydro-insulation between the bearing floorbeams and stone foundation in some areas (Fig. 5). This causes constant damping to the bearing floorbeams and may result in their loss of strength.

The basement's ceiling is partly inefficiently covered with wind and moisture barrier, which allows moisture absorption from the air (Fig. 5 and 6). The wool's thermal function decreases.

Fig. 5. Missing hydro-insulation and there are gaps in the ceiling's covering layers (in the basement)

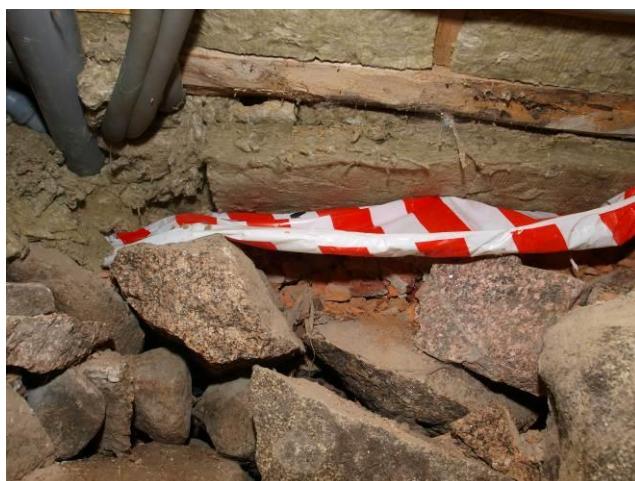
Fig. 6. Uncovered thermal insulation (in the basement)

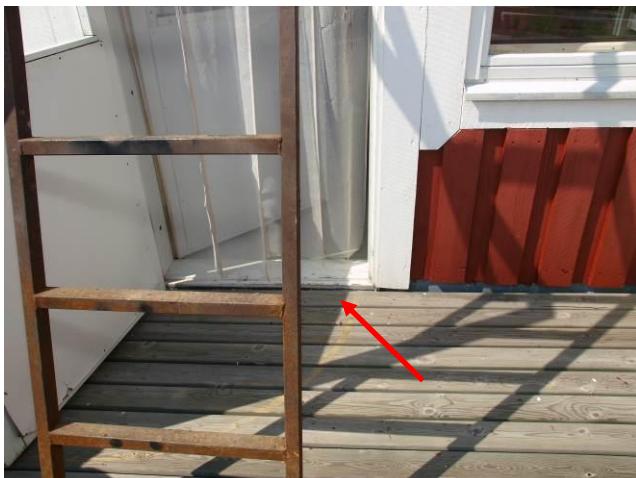
The balcony's door doesn't work properly (Fig. 7). The balcony's floor should be lower (approx. 10...15 cm) than the building's floor. This also helps to keep away severe moisture load to the timber boards and door during winter time.

Fig. 7. The balcony's floor should be lower than the floor inside the building

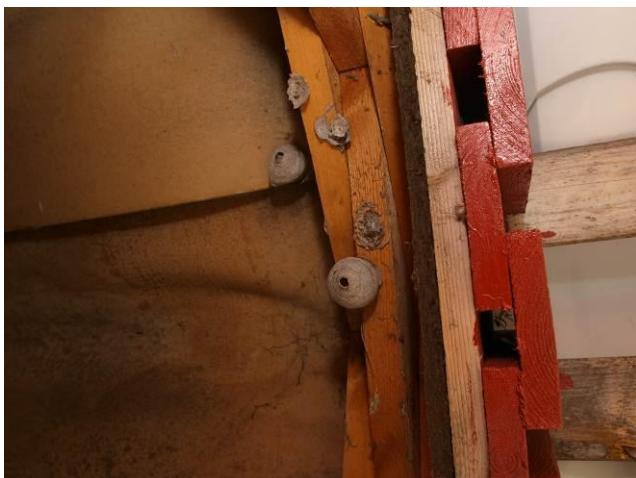
We found some wasp's nests on the roof ceiling (Fig. 8).

Fig. 8. Wasp's nests in the attic

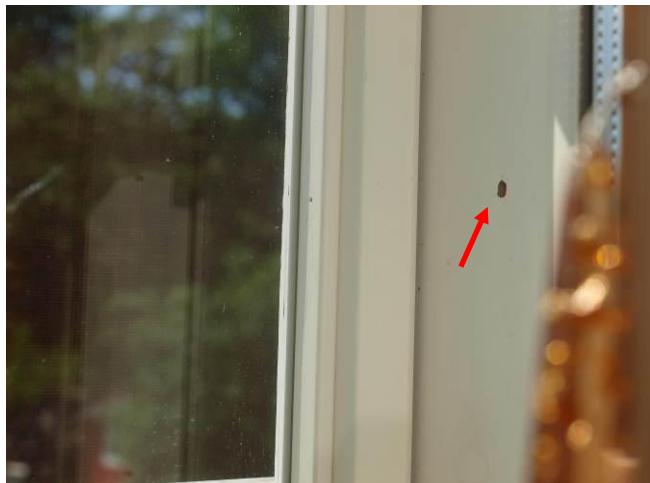
Fig. 10. Exit hole of the Old House Borer in the window frame
