THE FINAL RESEARCH REPORT

‘Sustainable Management of Historic Rural Churches
in the Baltic Sea Region (SMC)’

The final report of research of project 'Sustainable Management of Historic Rural Churches in the Baltic Sea Region (SMC)'

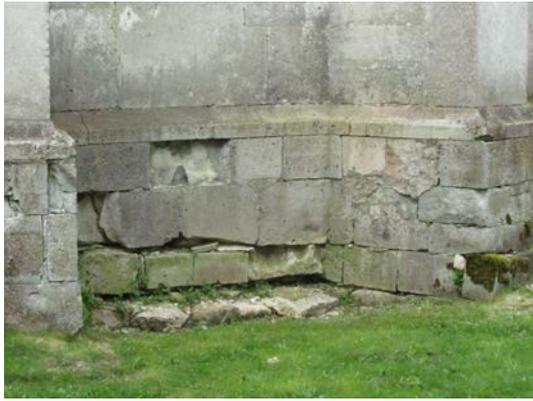
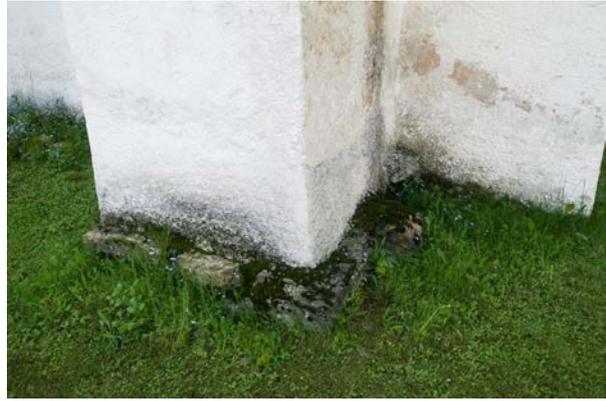
Hoone rajamisega võrreldes on pinnasekõrgus hoone ümber tõusnud (vt. Joonis 1.2 paremal). Nii huumusetekkest, kirikuaeda matmistest kui ka räästast langeva vee erodeeriva mõju tõttu on pinnase kalded hoone ümber aja jooksul kadunud või muutunud rohkem hoone poole kaldu (Joonis 1.2 vasakul). Hüdroisolatsiooni puudumine, niiskesse pinnasesse ulatuv krohv, vuugimört ja poorsed müüriksid võimaldavad kapillaartõusu, mille tõttu liigub vesi konstruktsioonis ka veega otseses kontaktis olevast pinnast kõrgemale. Kõrgem pinnasetase ja hoone poole olevad kalded tähendavad suuremat soklitele ning seintele mõjuvat niiskuskooormust (vt. Joonis 1.1) – tagajärjeks kiirendatud lagunemine ning probleemid vetikate, soolade ja hallitusega (vt. ka jaotused 1.3.3.2 ja 1.3.3.3). Lahenduseks on hüdroisolatsiooni rajamine, hooneümbruse kallete korrastamine, sademevee korraldatud ärajuhtimine (vt. ka Joonis 1.3) ning vajadusel drenaažisüsteemi rajamine.

Joonis 1.2 Vasakul: hooneümbruse pinnase kalle on kiriku poole ja juhib täiendavat vett välisseina äärde.
Paremal: pinnase kõrgus hoone ümber on aja jooksul tõusnud, millega kaasneb ka tõenäoline niiskukoormuse kasv seinatarindile.

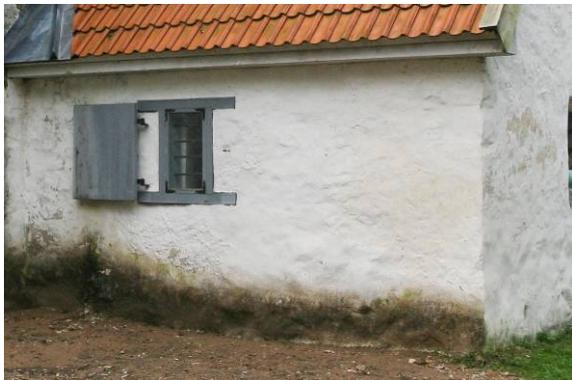
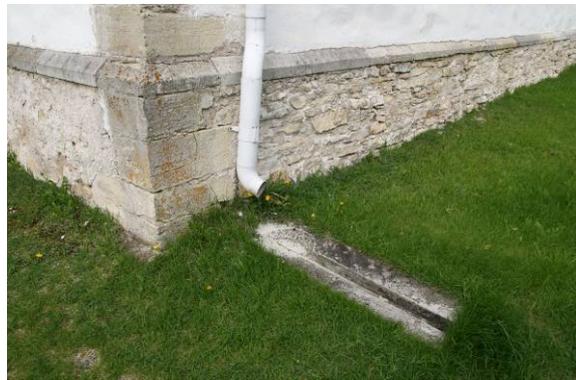
Joonis 1.3 Vasakul: vihmaveerennita räästast langev vesi märgab soklit, pinnaselt seinale pritsiv märg huumusekiht aitab kaasa määrdumisele, vetikate kasvule ja külmakindluse langemisele.
Paremal: vihmavee ohutu hoonest eemale juhtimine on sokli eluea ja niiskuskahjustuste vältimise osas kriitiline, abiks on nii sobivad pinnasekalded kui spetsiaalsed rennid.

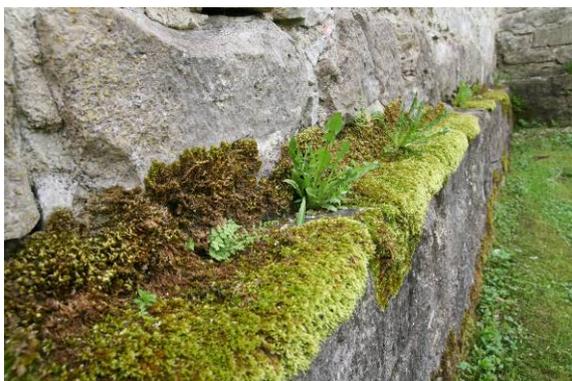
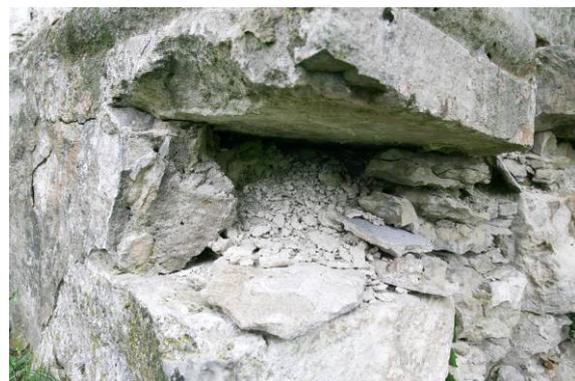
Joonis 1.4 Vasakul: etteastega soklil peab vee ärajuhtimiseks olema piisav kalle ning karniis; pildil olev sokkel on olnud sambla ja taimekasvuks piisavalt niiske, kiirendades seeläbi konstruktsiooni lagunemist ja niiskusest tingitud probleeme veelgi.
Paremal: müüritise, kus keskmine täidiskiit pole sideainega seotud, võib ühe väliskihi lagunemine viia varisemisohlikku seisule.

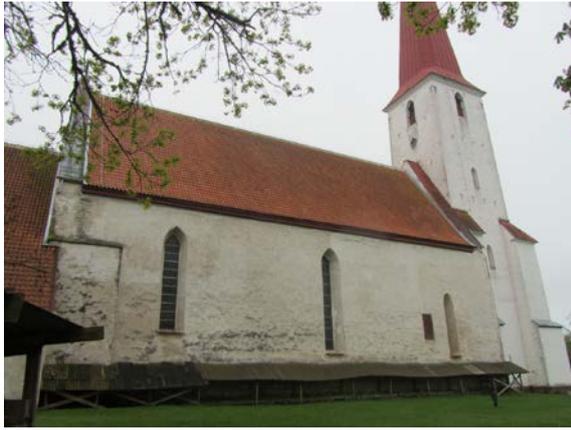
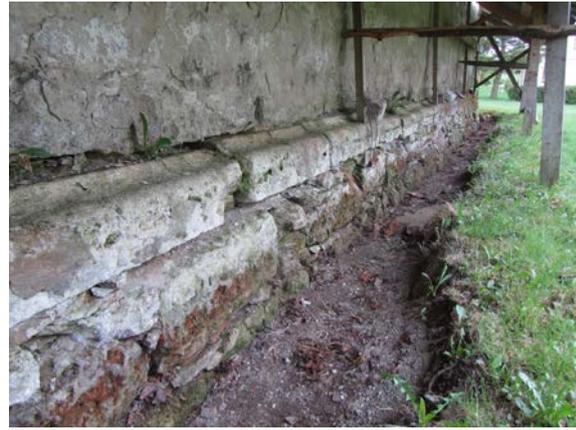
Joonis 1.5 Sokli ja vundamendi kaitseks ehitatud kaitsekatus. Töid pole lõpuni viidud: süvendist ja hoone ümbrusest vee eelmalejuhtimine on lahendamata.

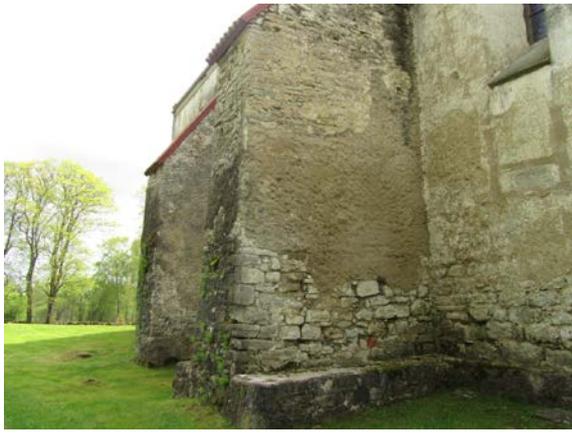
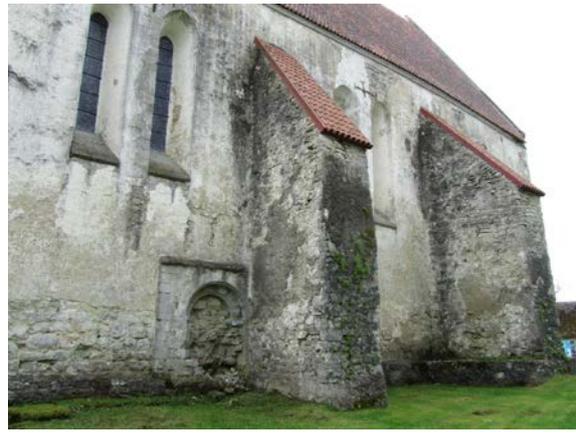
Joonis 1.6 Kontraforssidel on küll katus peal, aga liiga lühikese ülekattega seinale, mistõttu sealt langeb vesi otse seinale. Sein on märg, millele viitab samba intensiivseim kasv selles osas, mis on räästa üleulatusest väljaspool.

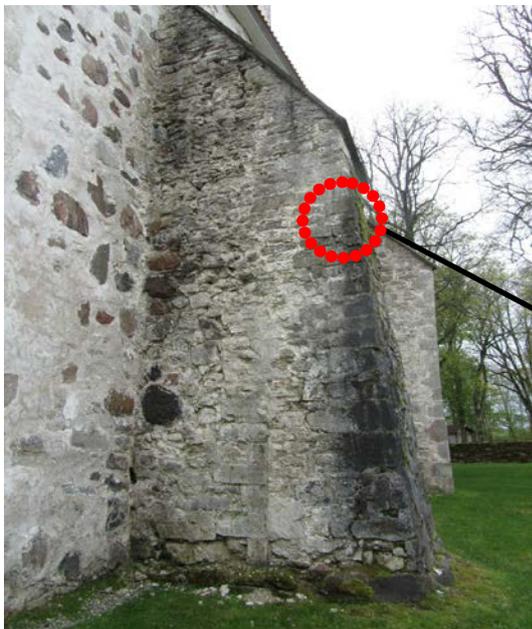
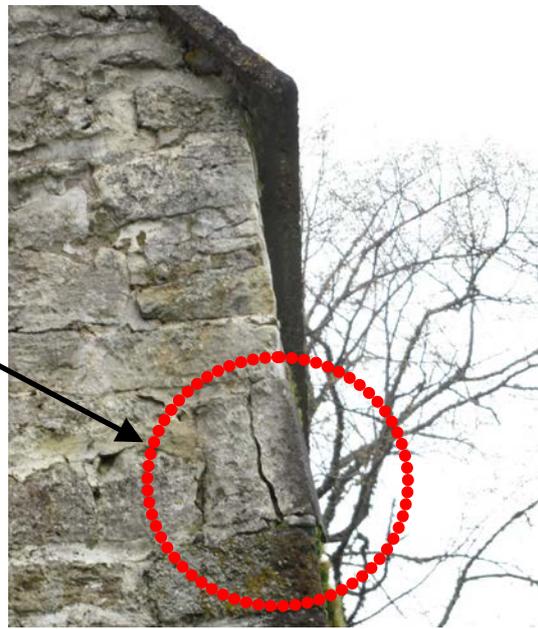
Joonis 1.7 Kontraforssi valgunud vesi on külmudes lõhestanud kivi.

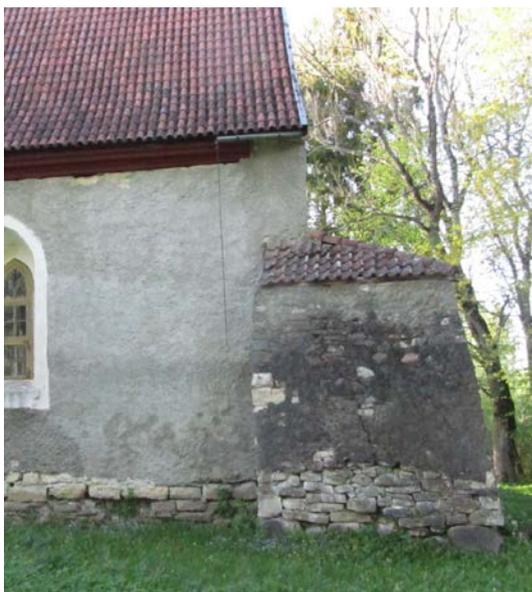
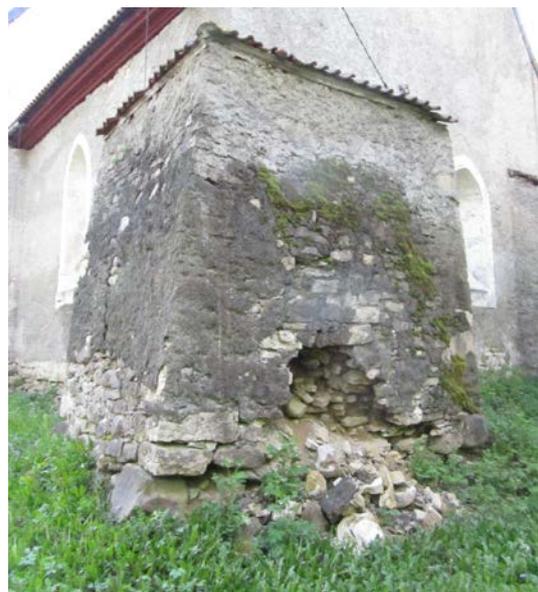
Joonis 1.8 Kontraforssidesse valgunud vesi on viinud müüritise lagunemiseni.

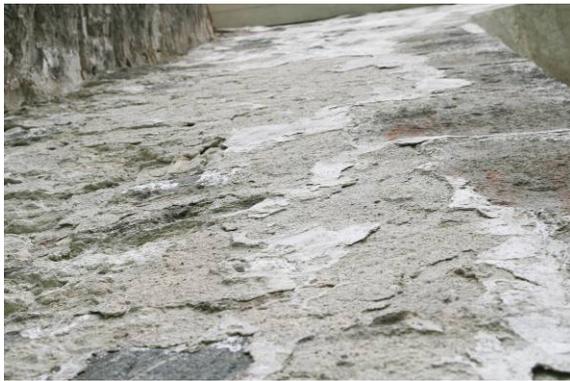
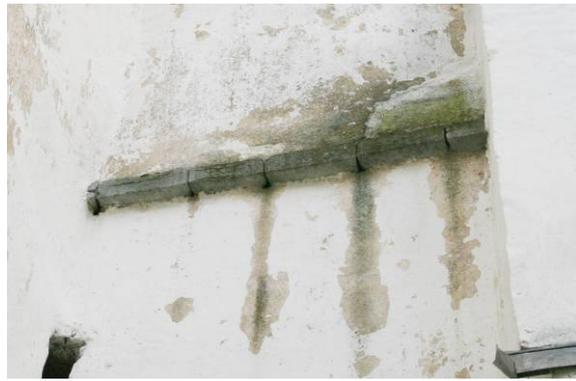
Joonis 1.9 Vasakul: krohvi eluea ammendumist kiirendavad näiteks liigne veekoormus. Paremäl: raidkivikarniisi liitekohad on hüdroisoleerimata ning vesi jõuab fassaadile.

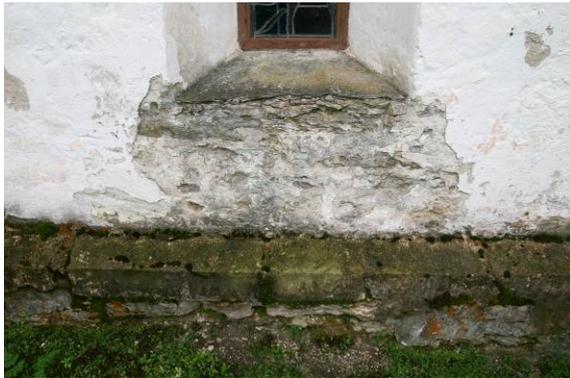
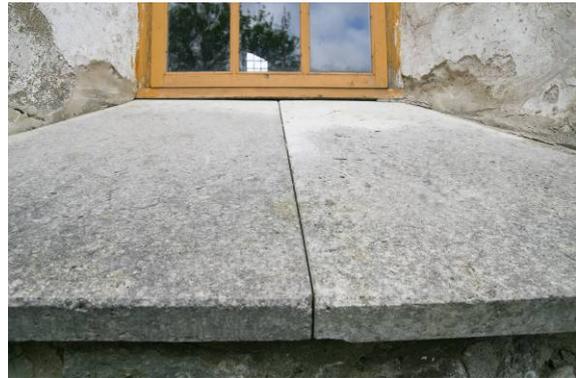
Joonis 1.10 Vasakul: mördist aknaplaat pole sadevett fassaadist ohutult eemale juhtinud. Paremäl: raidkivist aknaplaadid ulatuvad küll fassaadist üle, kuid plaatide liitekoht võimaldab veel müüritiseni jõuda, samuti on probleemsed servad.

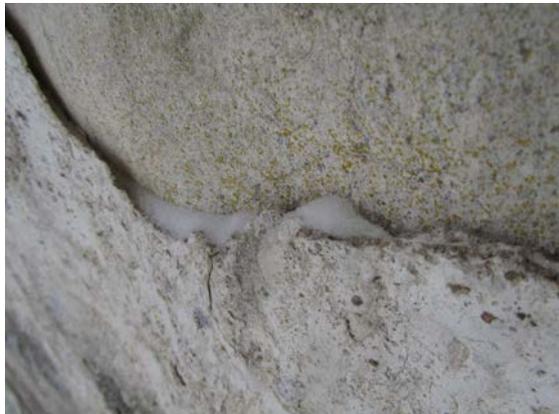
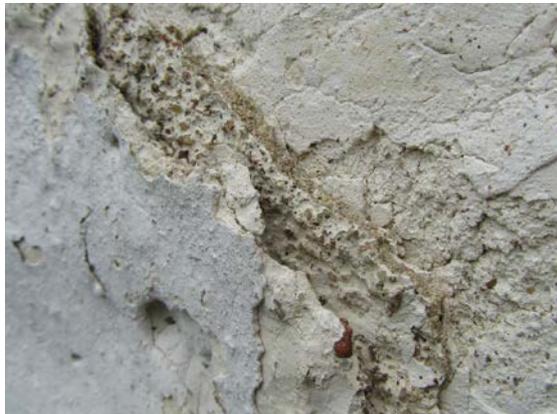
Joonis 1.11 Krohvi kahjustuste kaudu konstruktsiooni tungiv vihm ja lumi põhjustavad külmudes seina lagunemise.

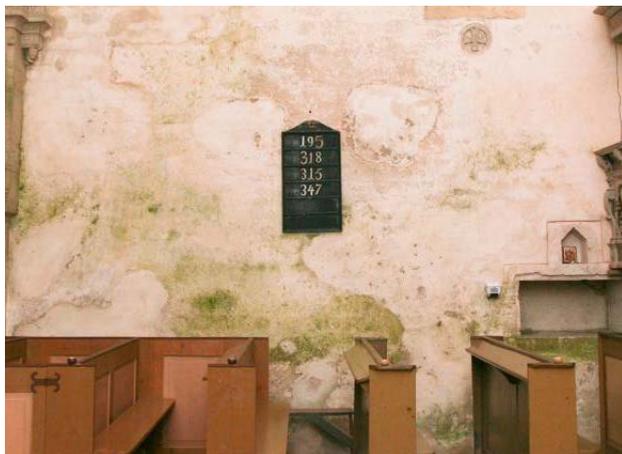
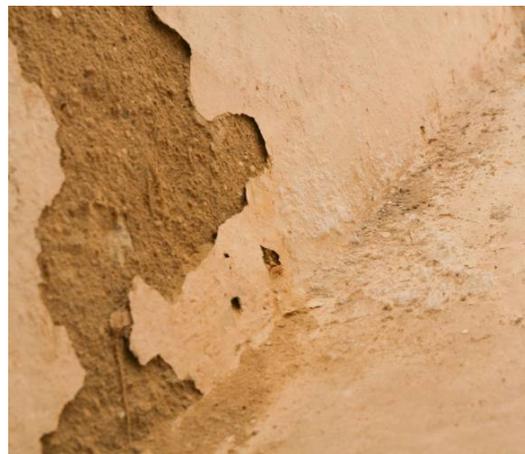
Joonis 1.12 Vasakul: vetikakasv on viiteks seina pinna kõrgele niiskussisaldusele. Paremal: Soolad võivad kristalliseeruda nii krohvi/värvikihi all kui selle pinnal.

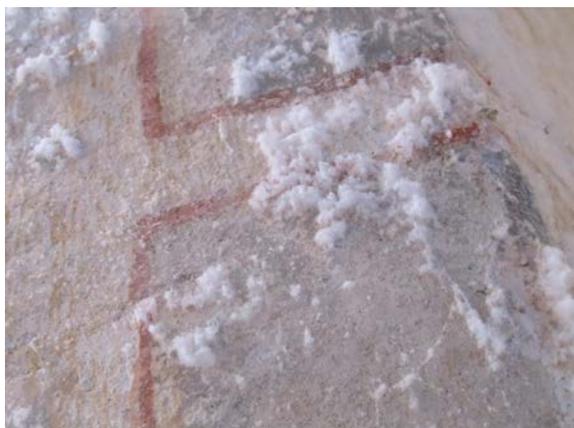
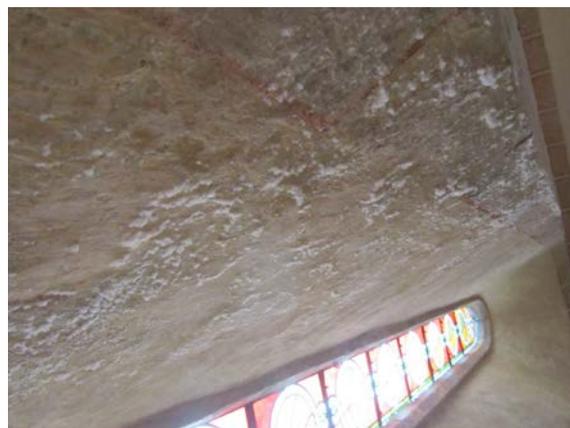
Joonis 1.13 Soolkahjustused välisseina sisepinnal.

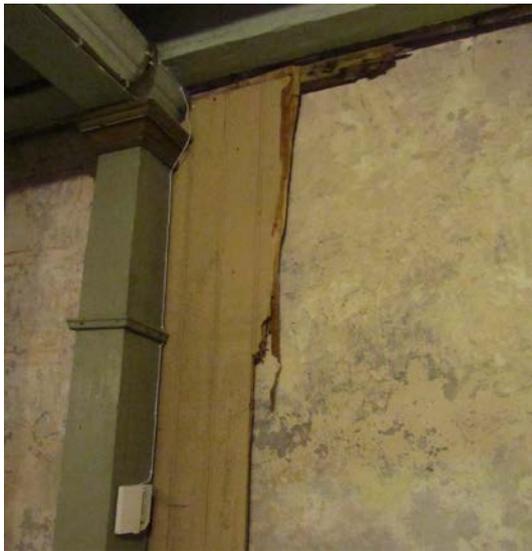
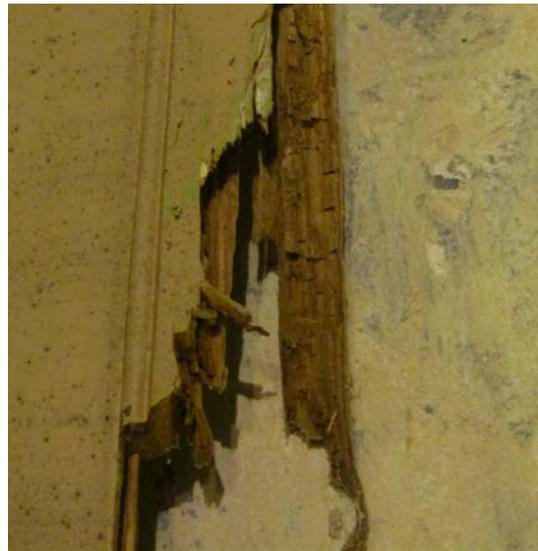
Esines kirikuid, kus esteetilistel kaalutlustel oli seinte sisepinnale lisatud täiendav laudisekiht. Niiske seina ette puitlaudise paigaldamine tõstab müüritise ja laudisevahelise õhu niiskusetaseme kõrgeks ning tekib hallituse- ja mädanikuoht (vt. Joonis 1.14). Lisaks laudise enese lagunemisele on ebasoodsas seisus ka laudisega kokkupuutuvad vahelae- või rõdotalad (vt. Joonis 1.15 vasakul) – ohtu satuvad ka kandekonstruktsioonid.

Joonis 1.14 Hävinud laudis seina sisepinnal: niiske kivisein on olnud seest poolt kaetud puitlaudisega, seina ja laudise vahel tekivad sel juhul sobivad tingimused hallitus- ja mädanikseente kasvuks.

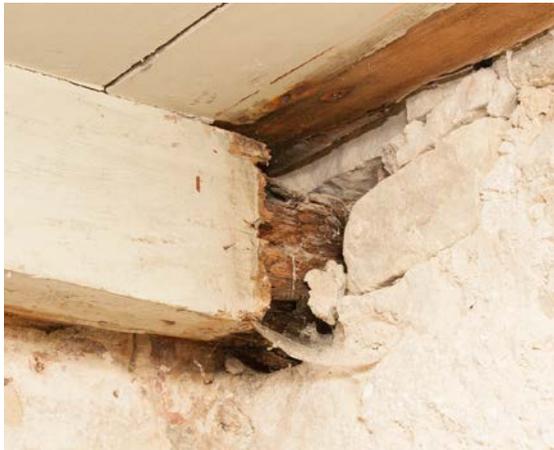
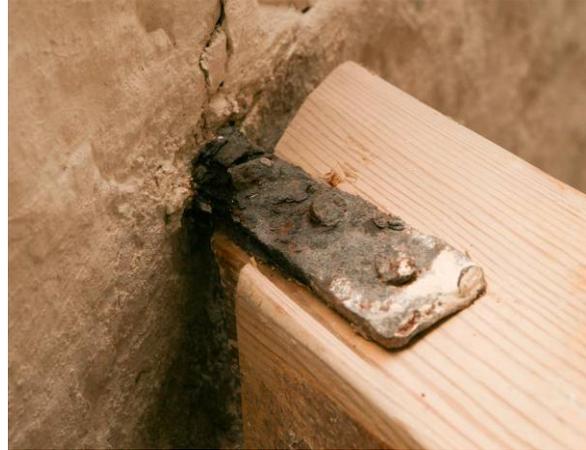
Niisked seinad on ohuks ka neile toetuvatele puidust taladele (vt. Joonis 1.15 vasakul) ja arhitektuursetele elementidele (vt. Joonis 1.17) ning roostetavast terasest detailidele (vt. Joonis 1.15 paremal). Puittalade seinaga kokkupuutuvad pinnad peaksid olema kaetud hüdroisolatsiooniga. Roostetava terase puhul tuleb kasutada kaitsekihti või projekteerida keskkonda sobiva korrosioonikindlusega.

Joonis 1.15 Vasakul: Seinale toetuv rõdutala on niiske seina tõttu muutunud soodsaks kasvukohaks mädanikseentele, protsessi on kiirendanud ka seinte sisepinda katnud laudis. Paremal: Kaitsmata roostetava terase või raua puhul esineb kontaktis niiske seinaga korrosioon.

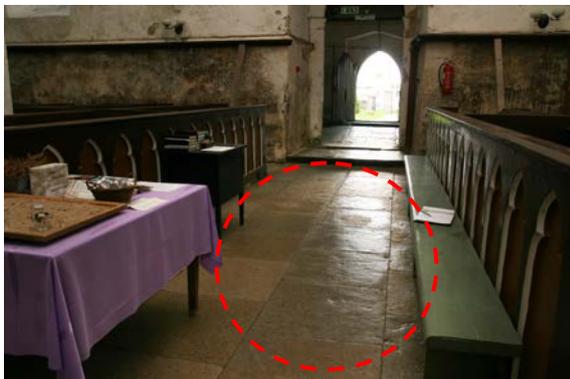
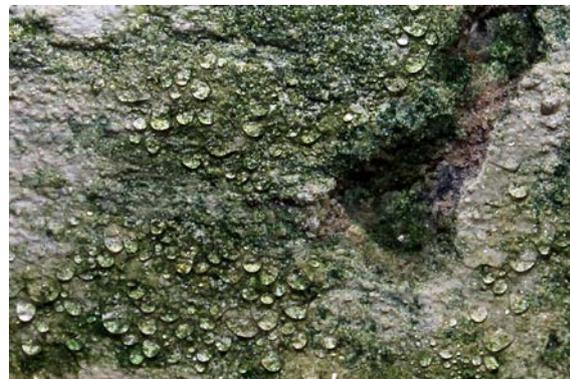
Joonis 1.16 Madala temperatuuriga pindadele kondenseeruv veeaur on oluline tegur tarindite märgumisel (eelkõige kevad-suvisel perioodil ülessoojenemata kirikute ventileerimise tõttu). Vasakul: punase ringiga tähistatud kondensaad avatud kirikuukse ees. Paremal: kondensaadipiisad vetikaga kaetud seinapinnal.

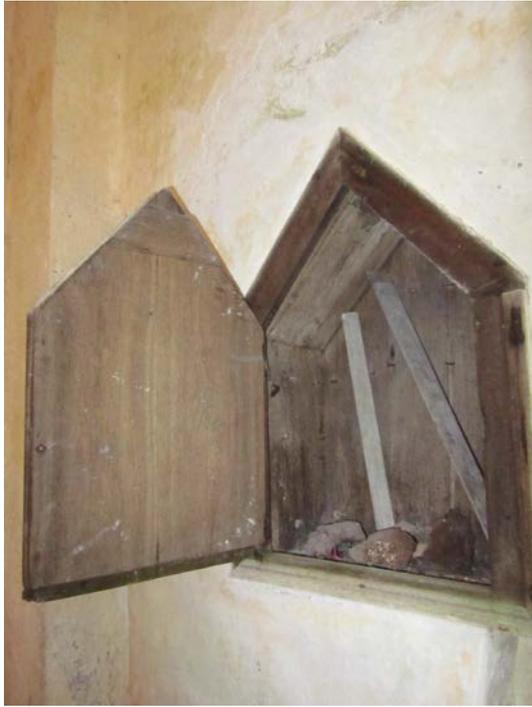
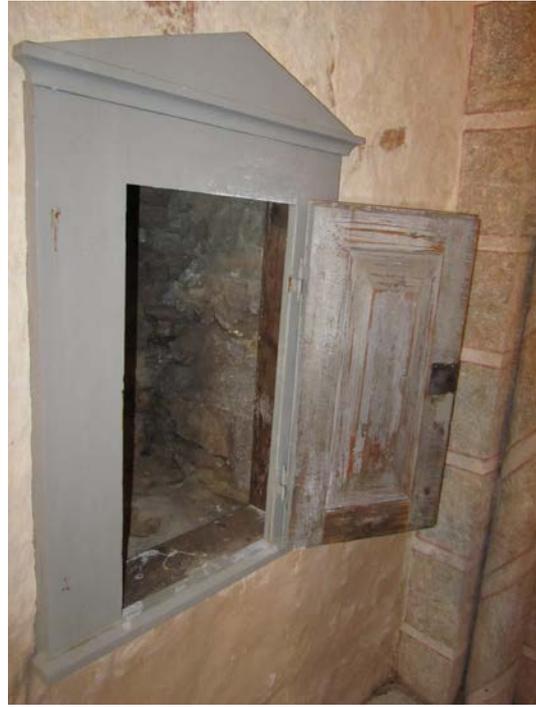
Joonis 1.17 Niiskes kiviseinas olev puitkapp on potentsiaalne koht hallituse tekkeks. Halvimal juhul hakkab arenema puitu lagundav mädanikseen.

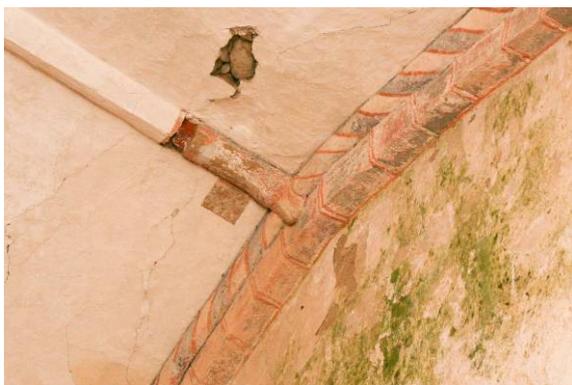
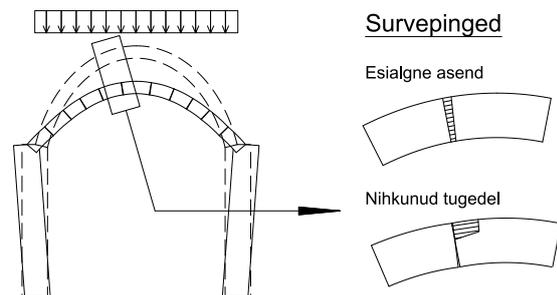
Joonis 1.18 Vasakul: võlvitesse on tekkinud praod, kukkuv krohv ja kivid on ohuks allviibijatele, deformatsioonide edasi arenedes võib variseda ka terve lagi. Paremal: võlvi tööskem - kui võlvi toed on esialgsest asendist (kriipsjoon) nihkunud, väheneb kivide kokkupuutepind (survetsoon) ning sama koormuse vastuvõtmiseks kasvavad survepinged ja tugedele mõjuv horisontaalkoormus. Materjali purunedes arenevad deformatsioonid edasi kuni konstruktsiooni varisemiseni.

Igal juhul on pragude ja võlvide kujupüsivuse osas tähtis pikaajaline jälgimine (nt. kipsmajakate ja reeperitega) ning vajadusel otsustav sekkumine.

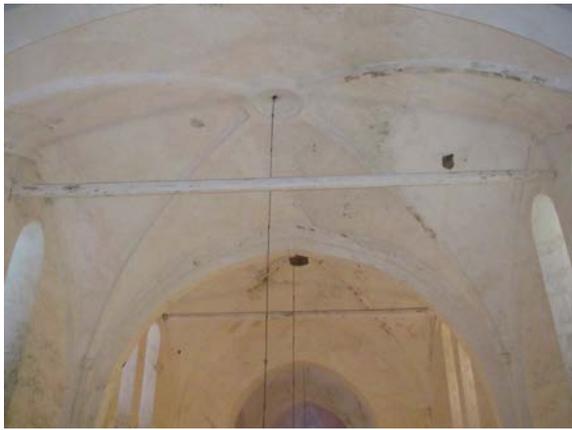
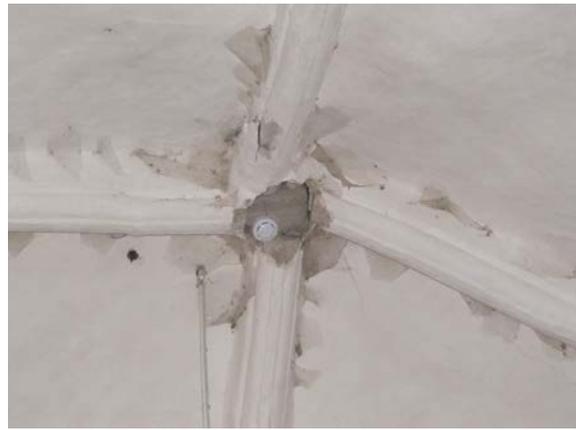
Joonis 1.19 Vasakul: Vasakul: võlvlagede konstruktsiooni on täiendavate deformatsioonide vähendamiseks tugevdatud tõmbidega.
Paremal: Võlvikiirdis võlviroiete ebasümmeetriline ühendumine

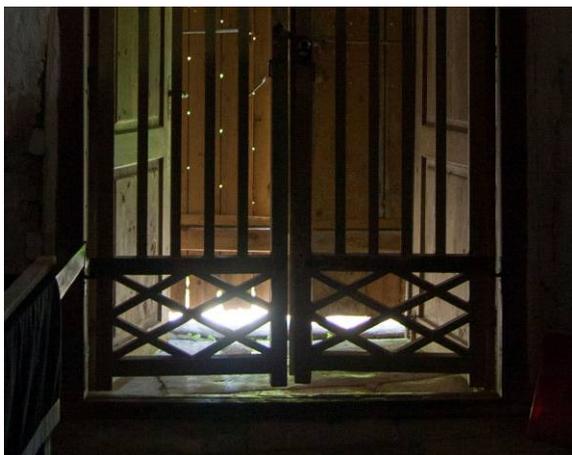
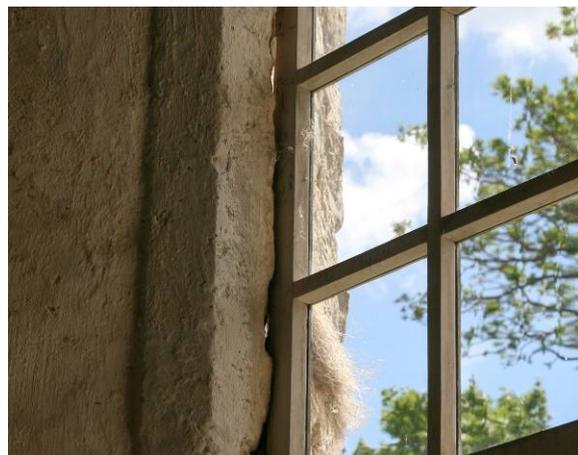
Joonis 1.20 Avatäidete õhutihedus on silmaga nähtavalt madal.

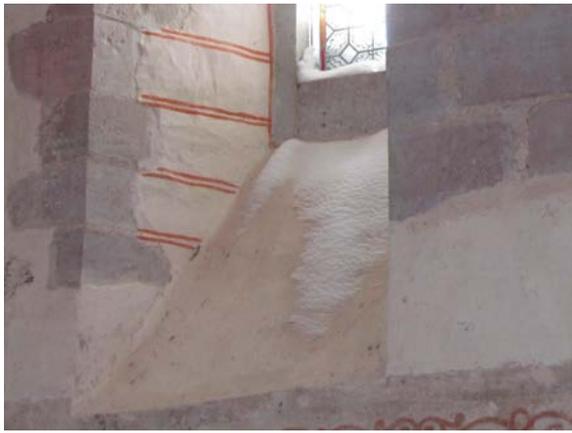
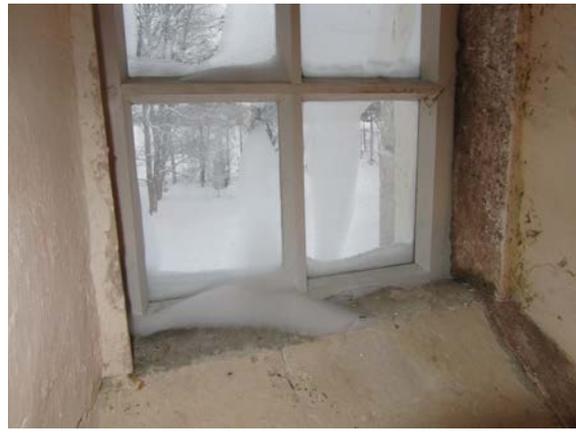
Joonis 1.21 Lume tungimine siseruumidesse madala õhutiheduse tõttu. Lume sulades konstruktsioon märgub.

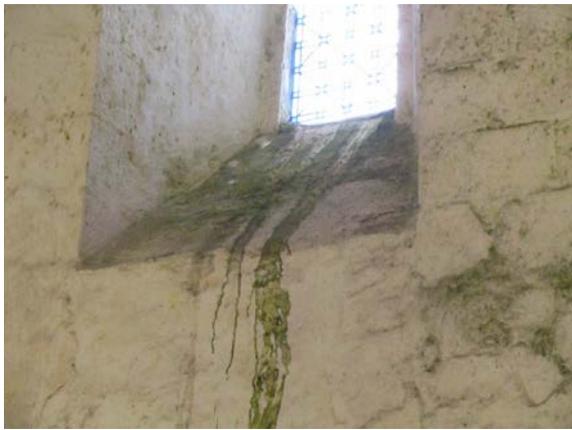
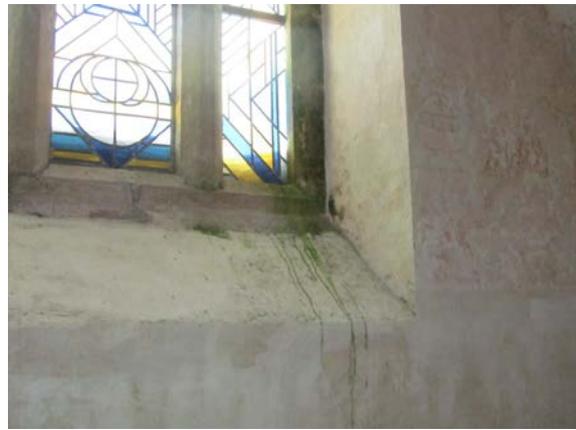
Akende madalast soojapidavusest tingituna toimub õhus oleva veeauru kondenseerumine madala sisepinna temperatuuriga raamidele ja klaasidele. Niiske keskkond on sobiv kasvukeskkond vetikatele ja põhjustab kuivades ka soolade väljakristalliseerumist – vt. Joonis 1.22.

Joonis 1.22 Akna läbijooksu ja pinnakondensaadi tagajärg välisseina sisepinnal.

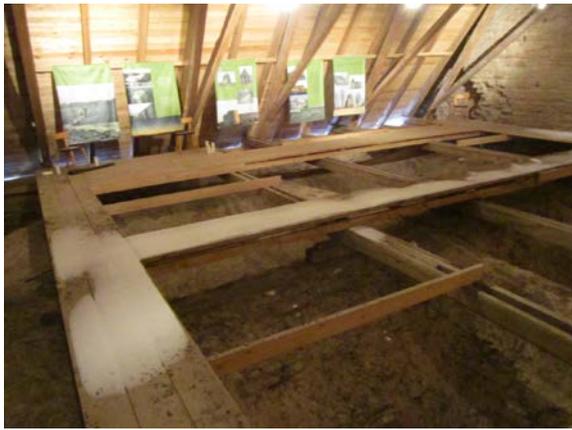
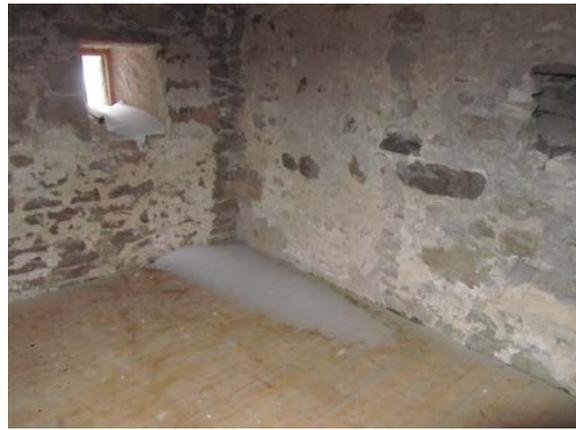
Joonis 1.24 Katusevõlvide peale tuisanud lumi, mis sulades valgub laevõlvidesse (vasakul). Aknast puitpõrandale tuisanud lumi (paremal).

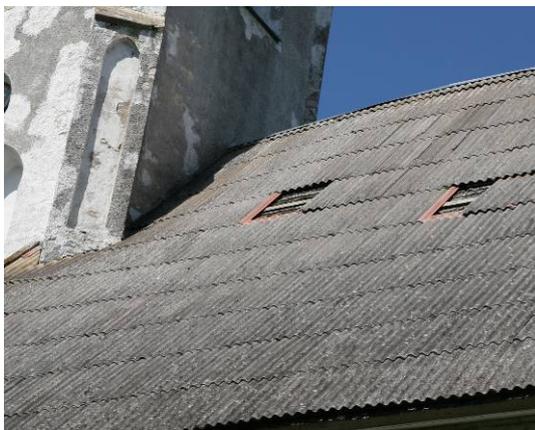
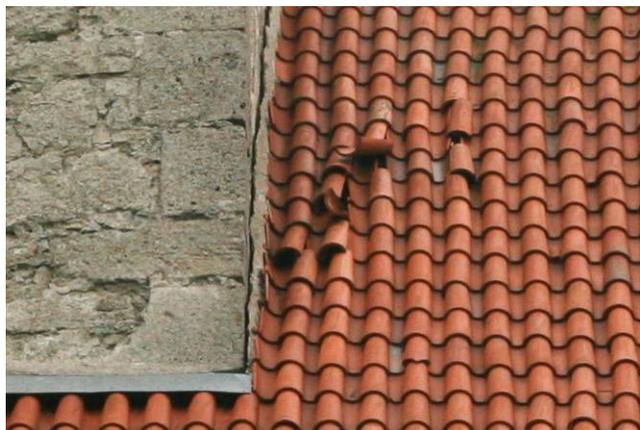
Joonis 1.25 Vasakul: juba ühe tahvli purunemine on tsementkiudplaatkatustel tõsine probleem – korraga hakkab lekkima suhteliselt suur pind katust. Paremal: oma kohalt nihkunud munk-nunn katusekive pole võimalik seest korrastada, katus võib jääda pikaks ajaks lekkima.

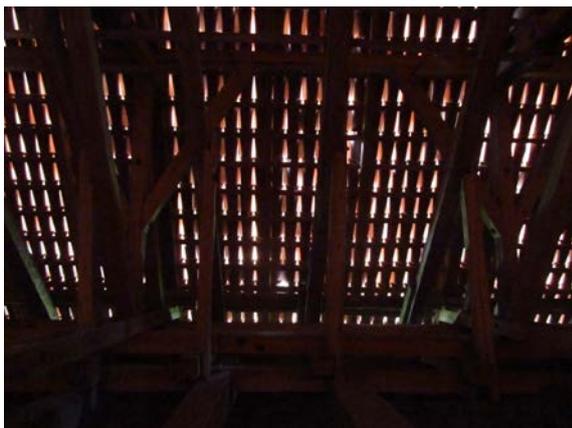
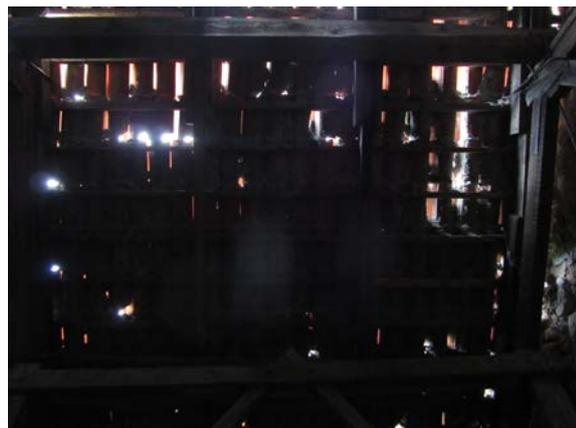
Joonis 1.26 Kivikatus vajab aluskatust – läbituiskav lumi ja vihm põhjustavad täiendava niiskuskooormuse, samuti on aluskate abiks kivide võimaliku purunemise/kao puhul.

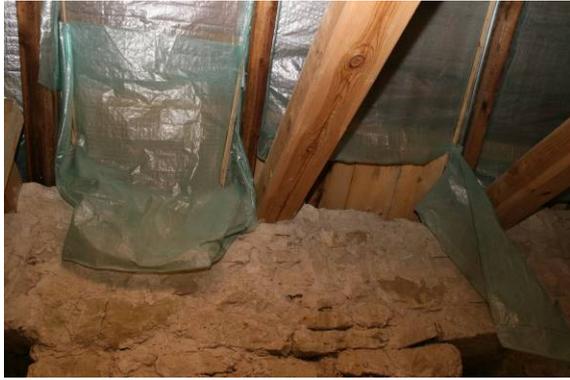
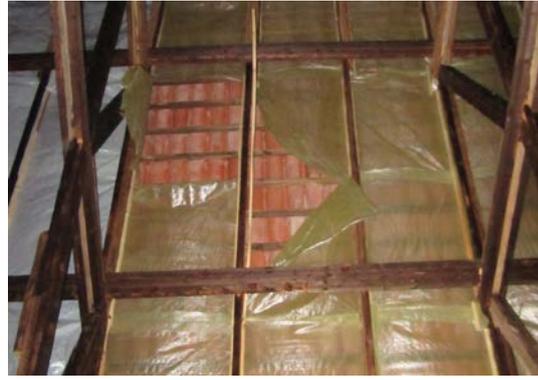
Joonis 1.27 Hiljem lisatud aluskatte töökindlus on väiksem, samuti ei pruugi aluskate olla korrektsest väliskeskkonda viidud, vaid juhib sademed konstruktsioonidesse.

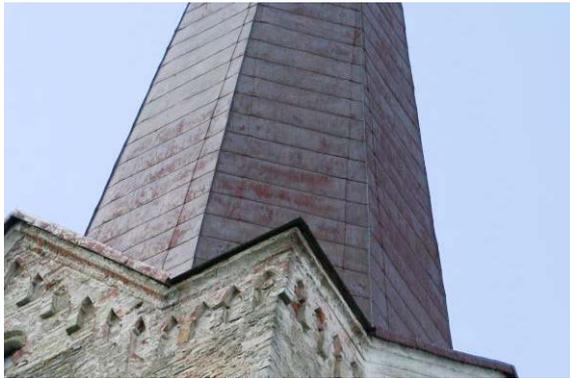
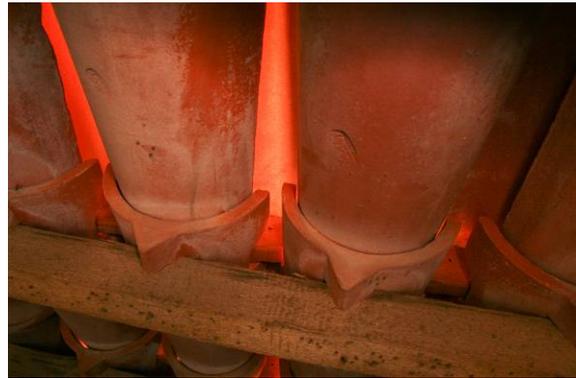
Plekki on peamiselt kasutatud tornikiivritel. Plekist katuste seisund erineb pea amortiseerunud katustest (Joonis 1.28) kuni täiesti uuteni. Kahjustunud või ammendunud tsinkkattega, kuid seni veel veetihedatel katustel, on võimalik eluiga pikendada kasutades spetsiaalset värvi. Värv peatab terase korrosiooni, mis kaitsekatteta areneb väga kiirelt. Seda meetet tuleks rakendada vastavalt hooldusvälbale kuni uue katusekatte paigalduseni.

Joonis 1.28. Vasakul: valtsplekist katusekate. Paremal: Kivikatus vajab aluskatet ja kivide kinnitamist katuseroovide külge.

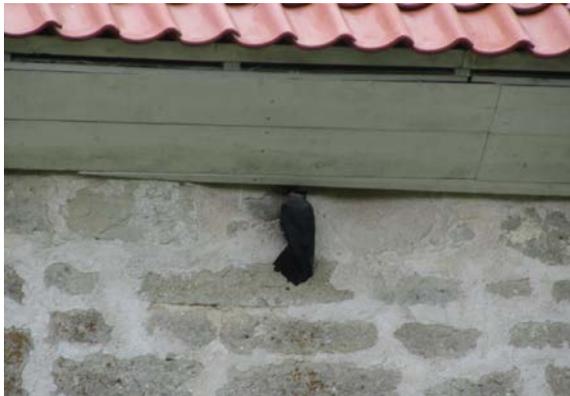
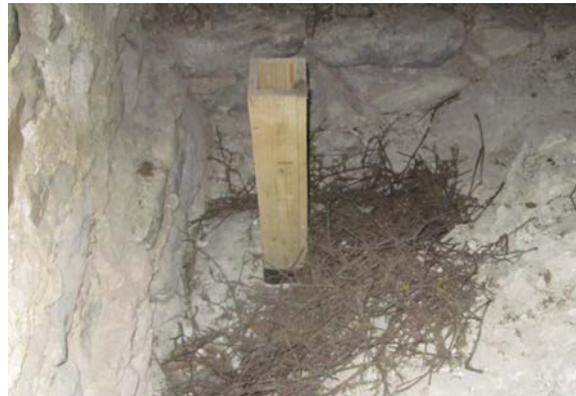
Joonis 1.29 Lind on alustamas kirikuvõlvidele pesamaterjali tagasitoomist.

Vaatamata osalistele pingutustele probleemi lahendamiseks, olid mitmetes kirikutes siiski põõningul ja kirikutornis linnupesad. Lindude ekskrement on ebasanitaarne ning rikub konstruktsioone visuaalselt, kuid võib omada ka lagundavat mõju. Lisaks lindude minematõrjumisele ja pesade kõrvaldamisele tuleks vältida ka nende naasmist (vt. Joonis 1.29). Tuulutus- ja muud avad (ka räästas) tuleks lahendada nõnda, et linnud sealt läbi ei pääseks, nt metallvõrguga kattes. Linnutõkked vajavad perioodilist kontrolli ja hooldust.

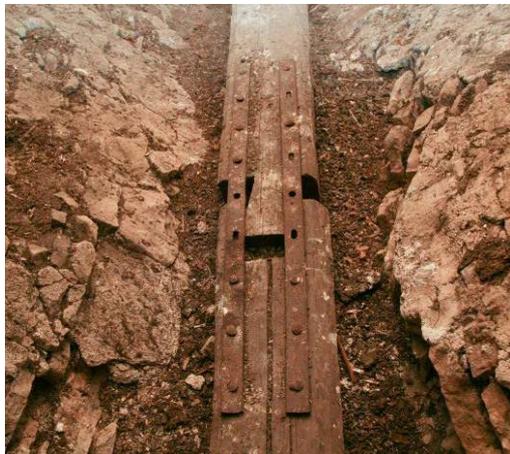
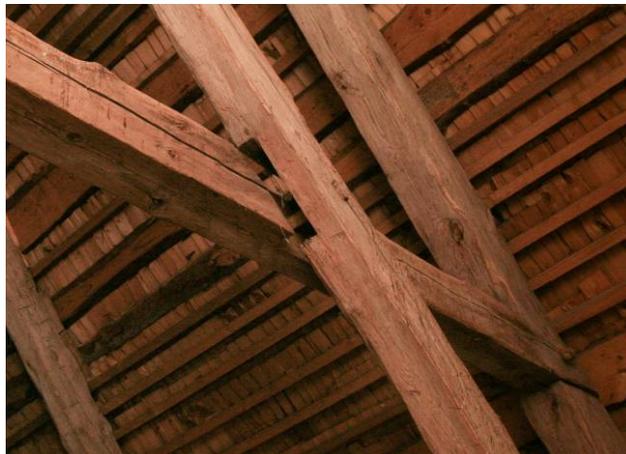
Joonis 1.30. Vasakul: deformeerunud tõmbeliide põhjustab katusesõrestiku geomeetria muutust ning potentsiaalselt ka täiendava horisontaalkoormuse müüritisele. Paremal: puitnaagliga liide on deformeerunud ja vajab kiiret sekkumist.

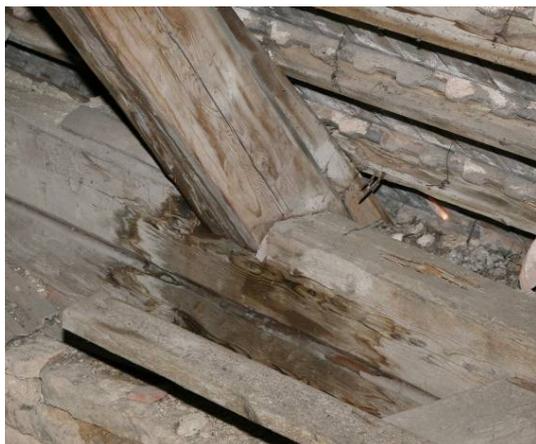
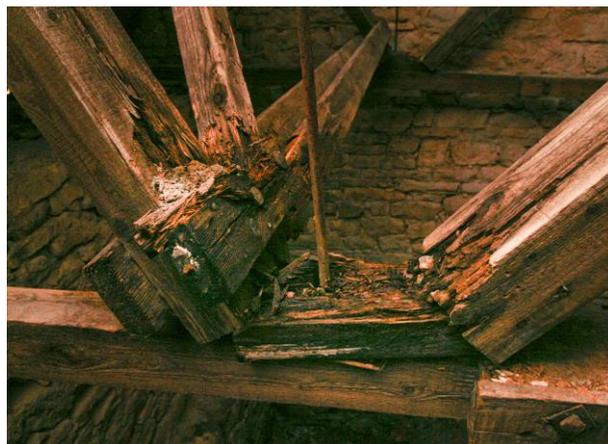
Joonis 1.31. Vasakul: lekete ja niiske müüritise tõttu märgunud puitkonstruktsioon on kasvukoht mädanikseentele. Paremal: hävinud katusesõrestiku liide vajab kiiret sekkumist.

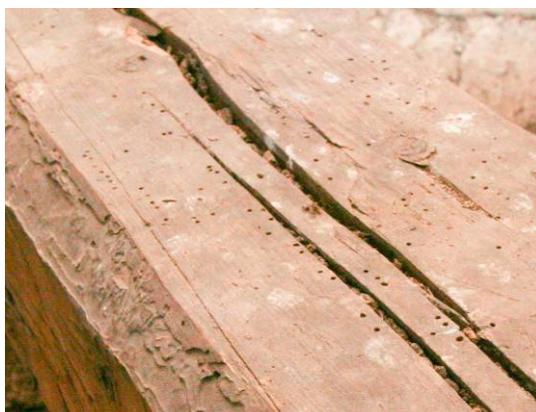
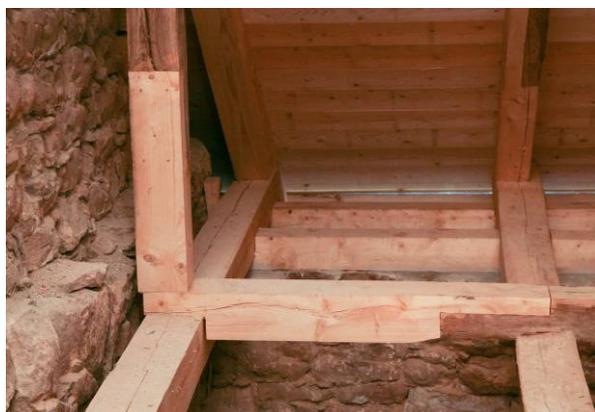
Ülevaatus käigus avastati mitmel juhul vanematel puitdetailidel putukate lennuavasid. Kuigi need olid märgid varasemast kahjurirünnakust ja käesoleva uuringu käigus värskeid jälgi ei leitud, tuleb konstruktsioone sellegipoolest perioodiliselt kontrollida. Vanemad terasdetailid olid korrosiooni eest pinnakatetega kaitsmata ning ka vihma eest kaitstud osadel oli õhuniiskusest tingitud aeglane korrosioon märgatav.

Joonis 1.32. Vasakul: kuigi avastatud lennuavad olid vanad, tuleks puitkonstruktsioone perioodiliselt jälgida ning vajadusel abinõud tarvitusele võtta. Paremal: viimastel aastakümnetel on terve katusekonstruktsiooni väljavahetamise asemel esialgset vajaduspõhiselt korrastatud.

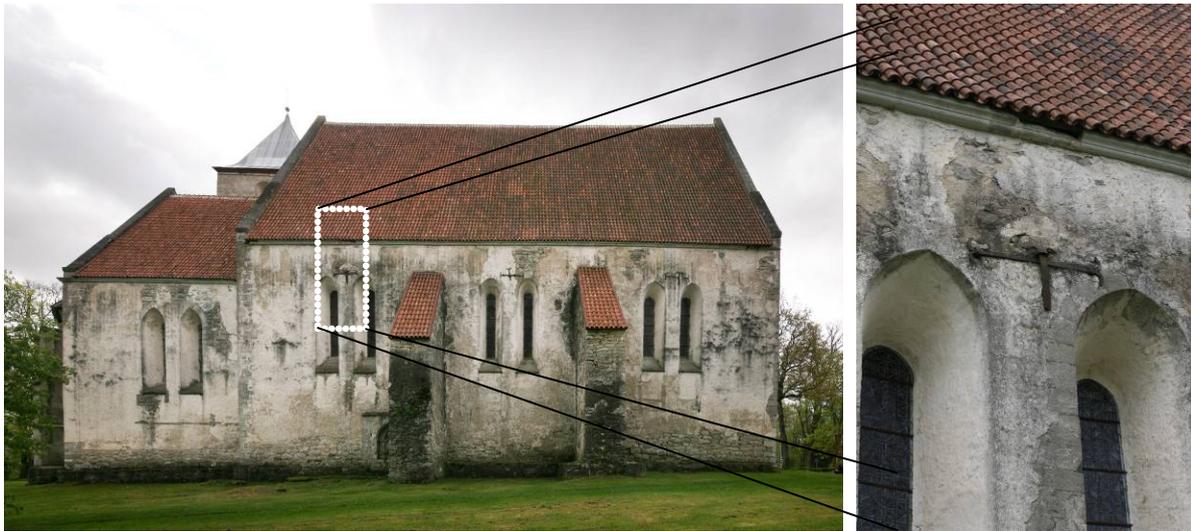
Joonis 1.34 Kitsas rennide ja vihmaveetorudeta räästas ei kaitse fassaadi vihma eest ning on teguriks nii fassaadi määrdumisel ja lagunemisel, aga ka kahjustuste tekkel seinte sisepinnale.

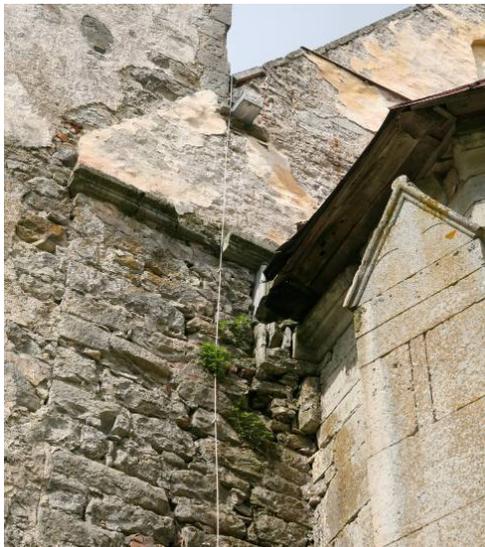
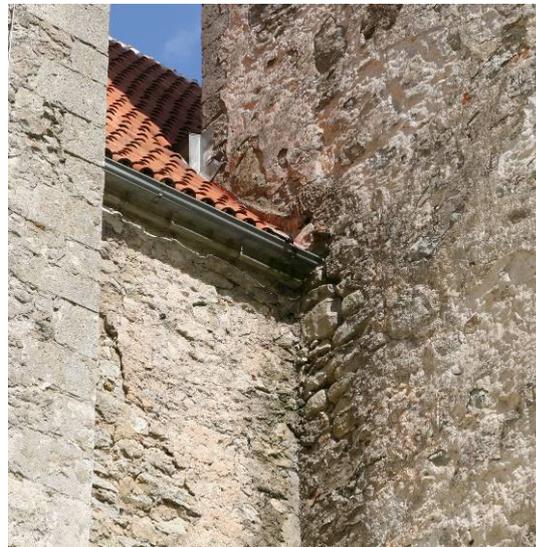
Joonis 1.35 Korreksete vihmaveesüsteemide varasem puudumine on põhjustanud fassaadi tõsist kahjustumist.

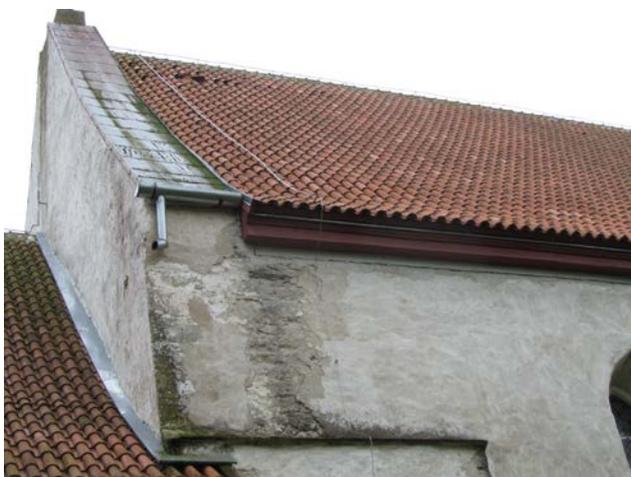
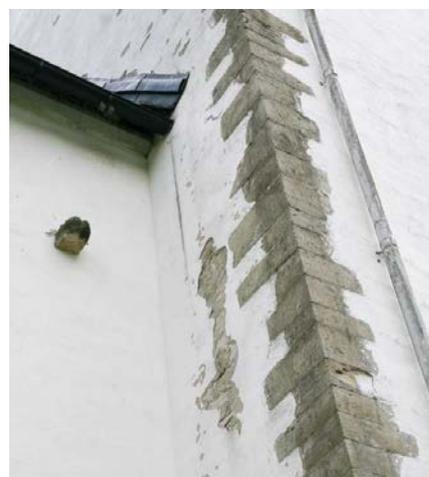
Joonis 1.36 Vasakul: töö on jäänud poolikuks: vihmaveetorust valgub vesi seinale. Paremal: katuse küljepilekk ulatub üle renni, fassaadil on külmakahjustused.

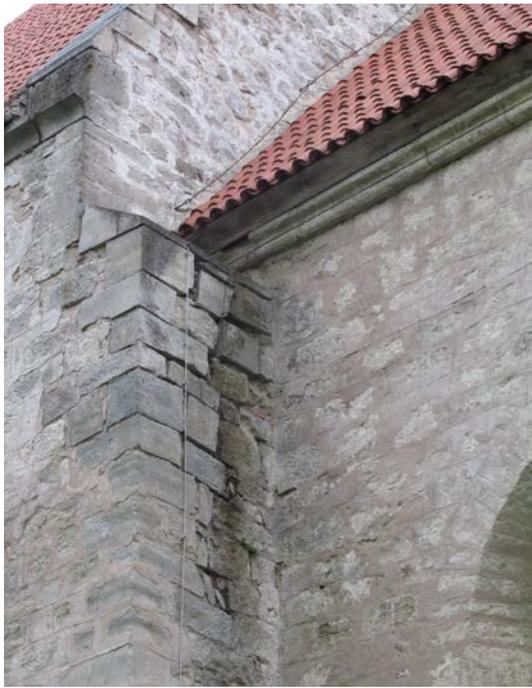
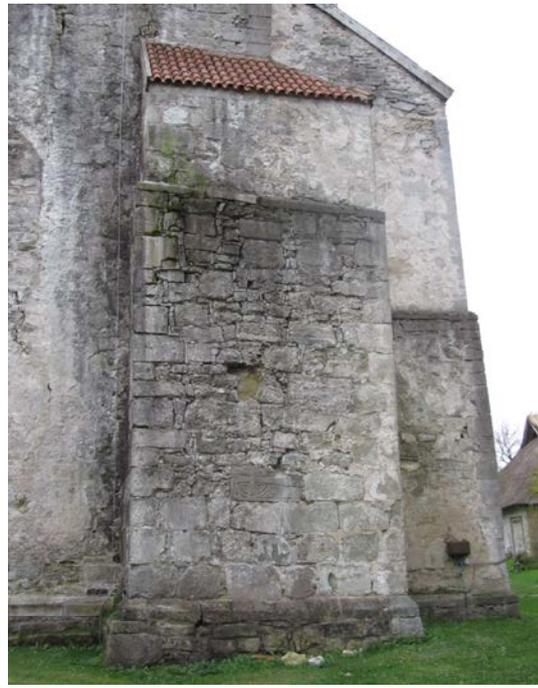
Joonis 1.37 Katuseräästad on liiga lühikesed ja ilma vihmaveerennideta. Katuselt allalangev vesi kahjustab välisseinu: mört on kivide vahelt välja uhutud, samuti on nähtavad külmakahjustused.

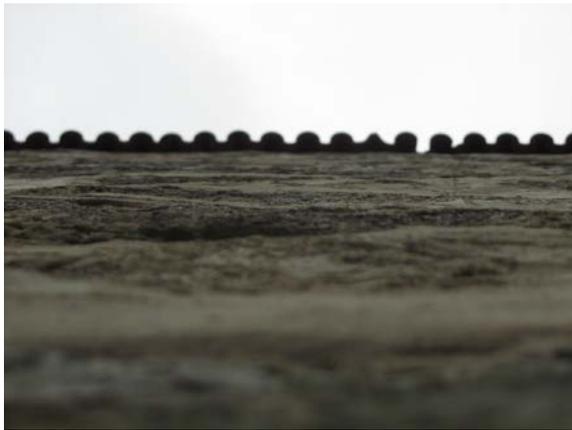
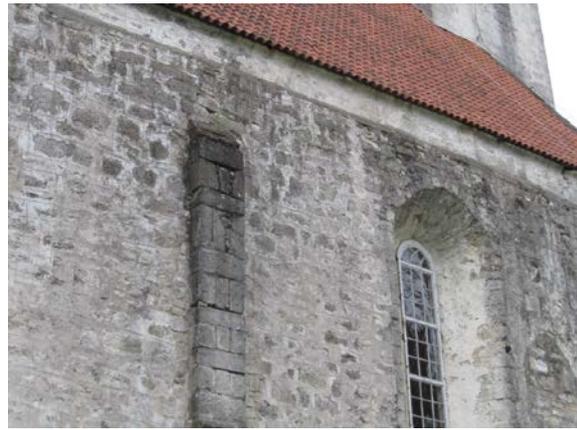
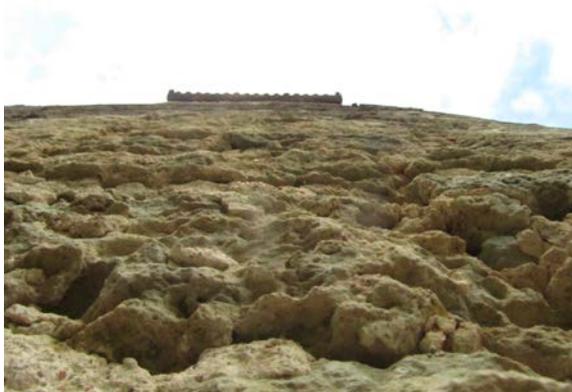
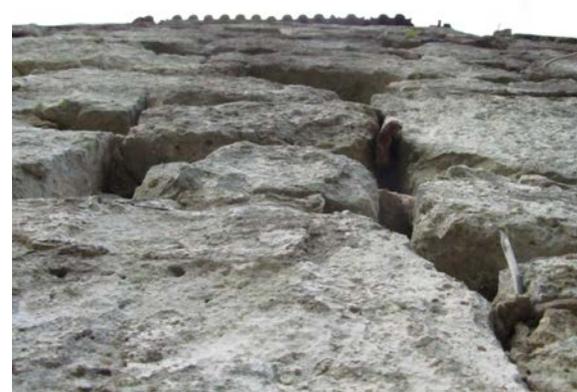
Joonis 1.38 Katuselt valgub vihmavesi otse välisseinale. Tulemuseks on kahjustunud välisseinad ja seinamaalingud.

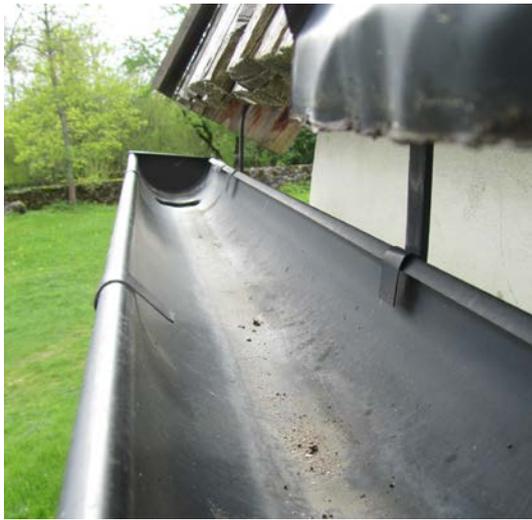
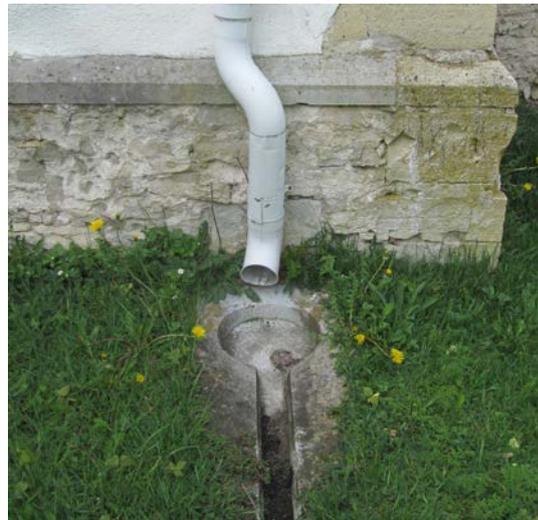
Joonis 1.39 Puhas vihmaveerenn (vasakul) ja hoonest eemale juhitud vihmavesi (paremal).

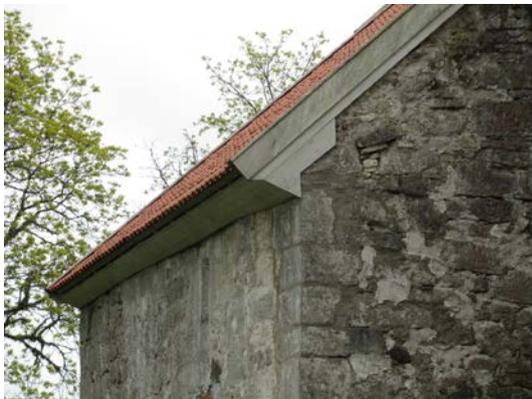
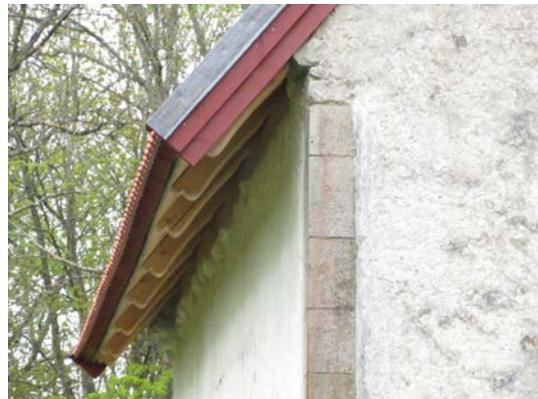
Joonis 1.40 Laiendatud räästas. Puudu on veel vihmavee äravoolusüsteem.

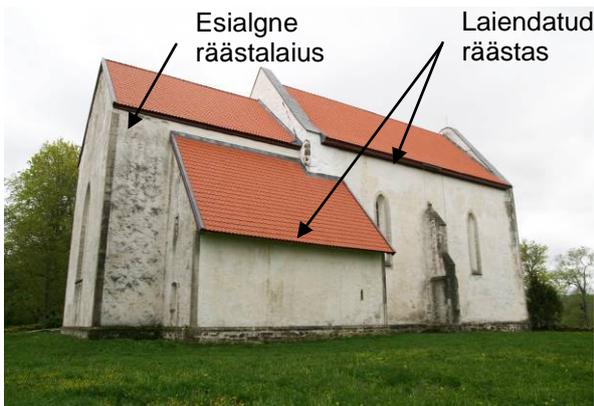
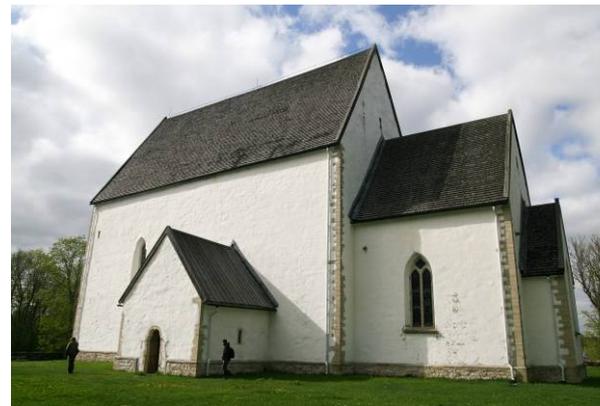
Joonis 1.41 Vasakul: Karja kirik osaliselt esialgse ja osaliselt laiendatud räästaga, puuduvad vihmaveerennid ja -torud. Kitsa räästaga seinosaal on suurem veekoormus ilmne. Paremal: Muhu kirik esialgse räästalaiuse ja vihmaveerennide ning -torudega.
