THE FINAL RESEARCH REPORT

‘Sustainable Management of Historic Rural Churches
in the Baltic Sea Region (SMC)’

The final report of research of project 'Sustainable Management of Historic Rural Churches in the Baltic Sea Region (SMC)'

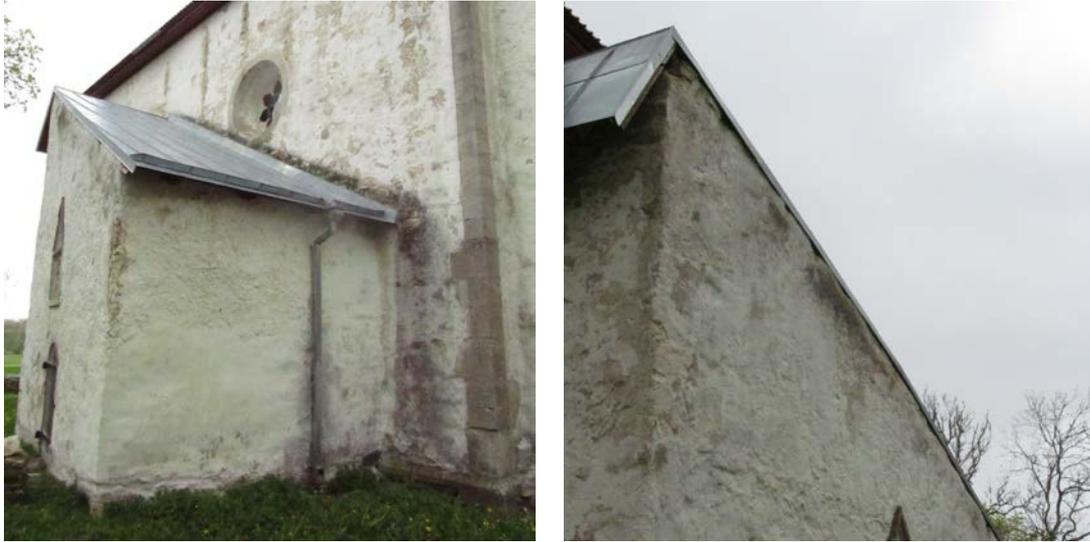
Joonis 1.42 Käärkambri katuselt on vihmavee äravool korraldatud korralikult. Katusepleki ülepööre seinale on jäänud 15...20cm liiga madalaks (vasakul). Otsaseina juures on katuse üleulatus seinast lubamatult väike (paremal).

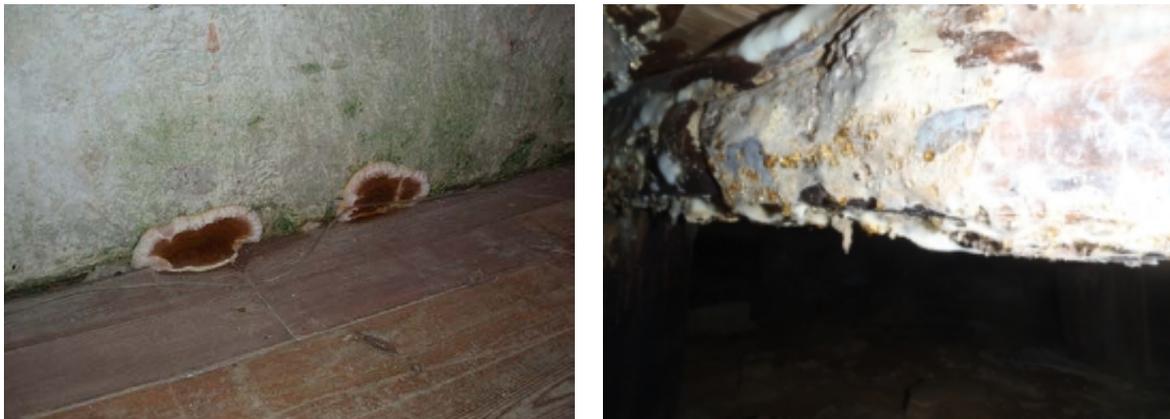
Seoses hüdroisolatsiooni ja drenaaži puudumisega on põrandate all nii pinnase niiskussisaldus kui õhu veeaurusisaldus kõrge. Sellised tingimused on soodsad hallitus- ja mädanikseente kasvuks ning erinevate ehitusvigade (seisev õhk, otsekontakt märgade pindadega jms) tõttu oli üks uuritud puitpõrandad nakatunud hallitus- ja mädanikseentega. Mädanikseened võivad sobivates tingimustes kiirelt edasi levida ning hävitada terve põranda. Paari viljakehaga põrandal (Joonis 1.43) võib välisel vaatlusel üldiselt olla kõik korras, aga konstruktsiooni avamisel selgub olukorra tõsidus. Avastatud kahjustustel tuleb nende täielik ulatus kiirelt kindlaks teha ning seente täiendava leviku vältimiseks (nii seeneniidistiku kui eoste kaudu õhus) need viivitamatult kõrvaldada. Nakkuse kordumise vältimiseks tuleb täpselt täita spetsialistide ettekirjutusi ning ühtlasi likvideerida probleemi tekkepõhjused. Lisaks põhjalikule tööle on vajalik ka järelkontroll.

Joonis 1.43 Mädanikseene kahjustatud puitpõrand pealt (vasakul) ja alt (paremal).

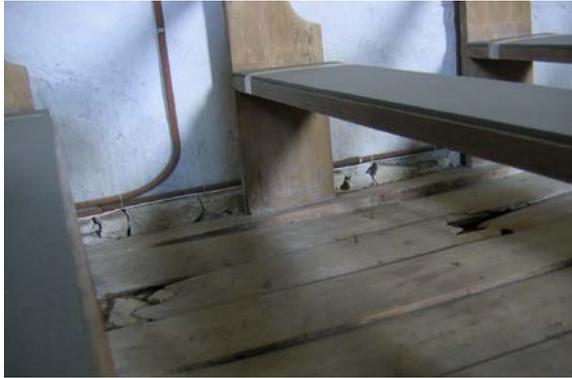
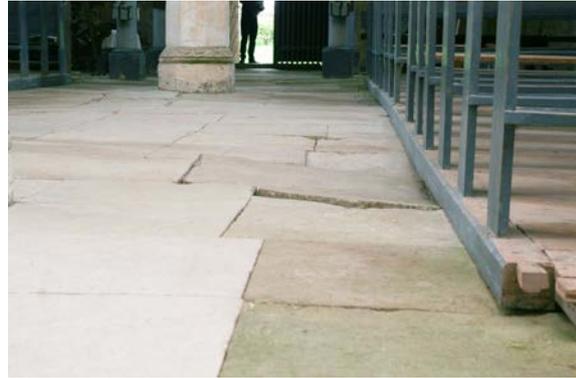
Kivipõrandatel põhiline puudus oli vähemal või enamal määral (Joonis 1.44 paremal) esinenud ebatasasus, mis raskematel juhtudel külustajate kukkumisi ja seeläbi vigastusi põhjustada võib. Pinkide ja muude puitdetailide paigutamisel kivi- ja kivist põrandale polnud alati arvestatud paeplaatide kapillaarse veejuhtivusega ning puidu kahjustusi esines nendelgi.

Joonis 1.44 Vasakul: seenkahjustustega puitpõrand.
Paremäl: suurte ebatasasustega paeplaatidest põrand.

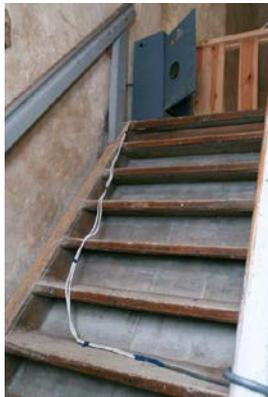
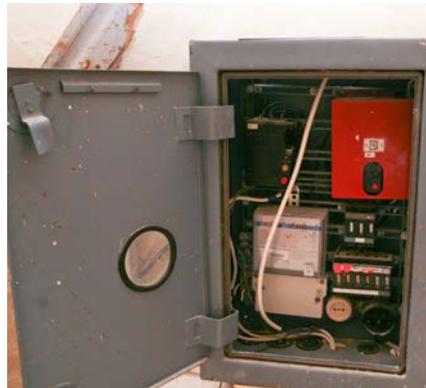
Joonis 1.45 Kirikute elektripaigaldised on sageli puuduliku dokumentatsiooniga ja tänapäevastele nõuetele mittevastavalt teostatud.

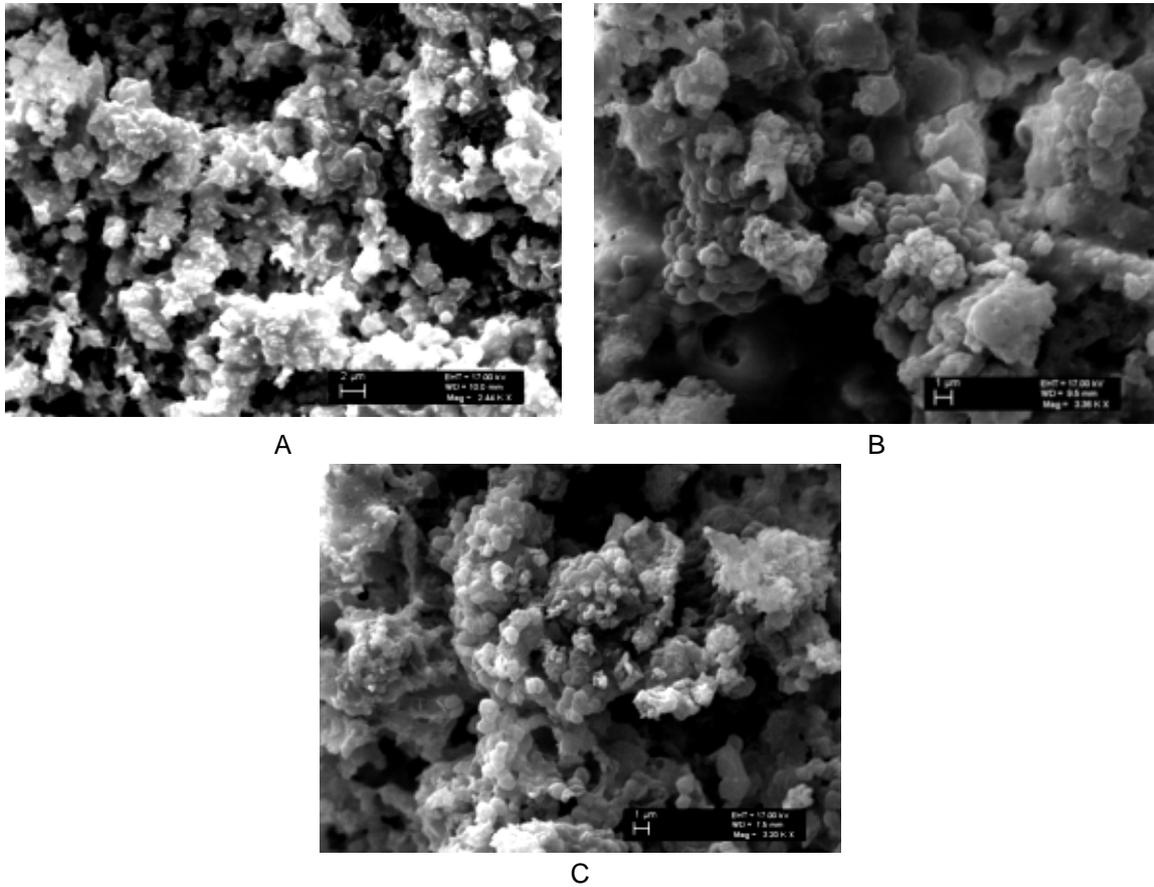
Figure 4.1 Evidence of colonies of round-shape bacteria on the surface and inside the plaster:

A: Muhu
B: Karja
C: Kihelkonna

In Karja, Kihelkonna and Muhu Churches, colonies of round-shape bacteria on the surface and inside the pink-coloured plaster were detected (Figure 4.1). There was no evidence of corrosive influence due to the metabolic products of microorganisms.

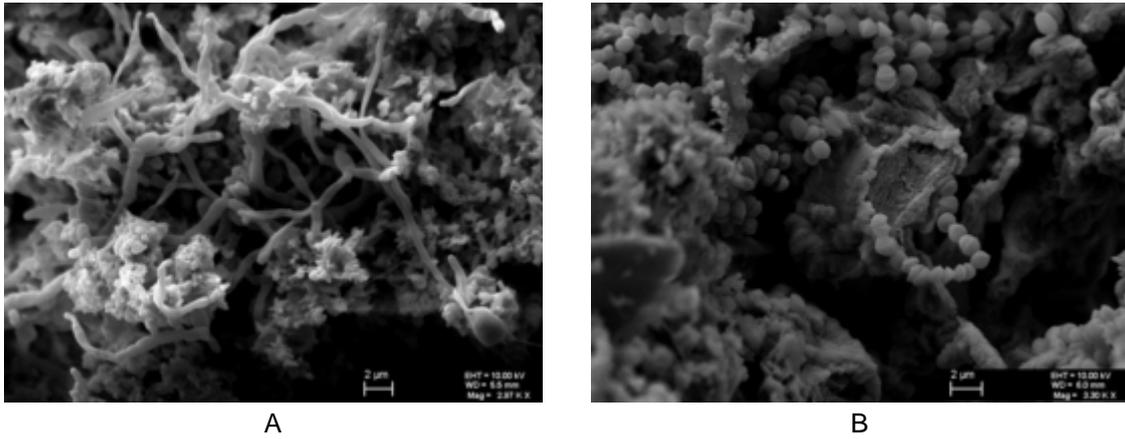
Figure 4.3 Different types of fungal and bacterial colonies inside the top painting at the Church of the Holy Cross in Risti.
 A: Fungal mycelium
 B: Bacterial threads

In Risti Church, different types of fungal mycelium and bacterial threads were detected where the plaster was painted with many layers of different paints (Figure 4.3 A, B). The growth of bacteria was probably facilitated by nutrients from the paint layers.

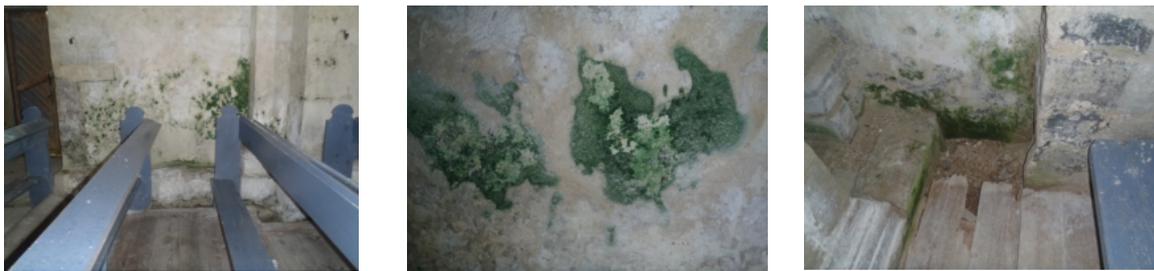
A: Algal growth on the walls
 B: Algal growth and salts
 C: Rot damage of the floor boards near the walls

Figure 4.4 Algae and wood rot are the main types of biodeterioration.

In Kaarma Church, an interesting phenomenon occurred where algae grow near a source of salt precipitation (KNO_3) (Figure 4.4 B). Algal growth is widely spread over the walls (Figure 4.4 A, C). So far, no pink-coloured areas were found.

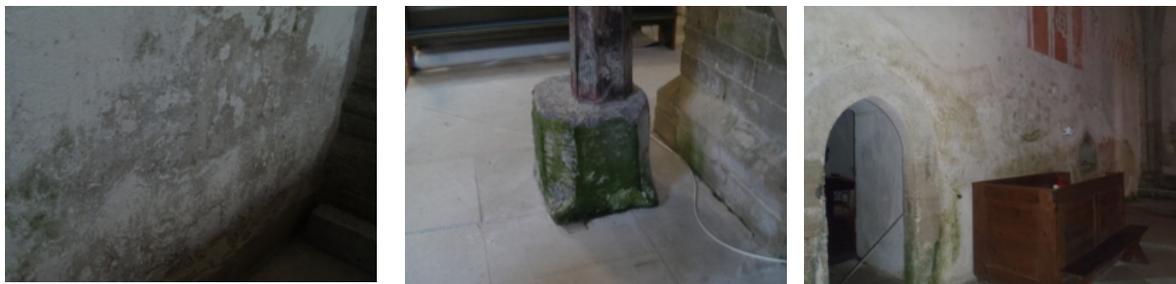
A: Salts deposition and algal growth
 B: Algal growth on the surface of post foundation
 C: Algal growth and pink coloration on the walls

Figure 4.5 Biodeterioration in St Catherine's Church in Karja. In Karja Church, algal growth and plaster discoloration resulting from pink bacteria occurred in large areas.

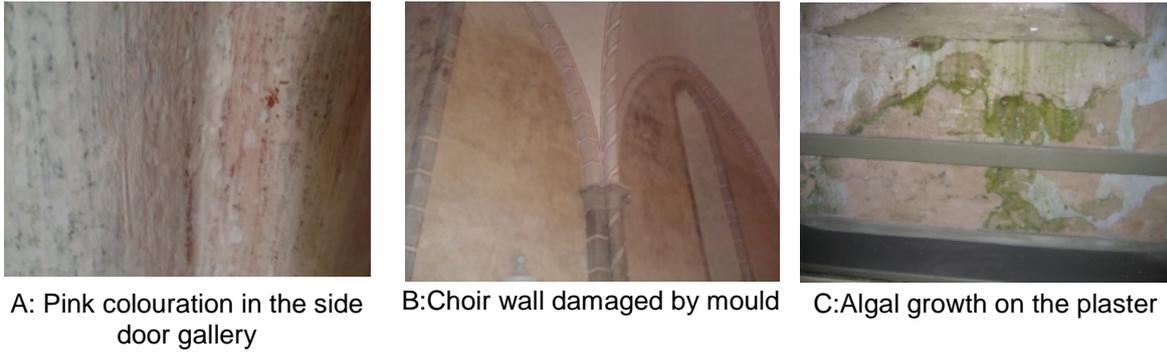
Figure 4.6 Biodegradation in St Michael's Church in Kihelkonna

In Kihelkonna Church, pink colouration of plaster (Figure 4.6A) in the gallery of the side door is rapidly developing. This is caused by bacteria. Mould damage also appeared on the wall of the choir cleaned in the process of restoration shortly after the work was concluded. Airborne mould *Cladosporium sp.* (Figure 4.6 B) was detected. Algal growth was detected particularly on the plaster layer (Figure 4.6 C), and very rarely on the stone wall.

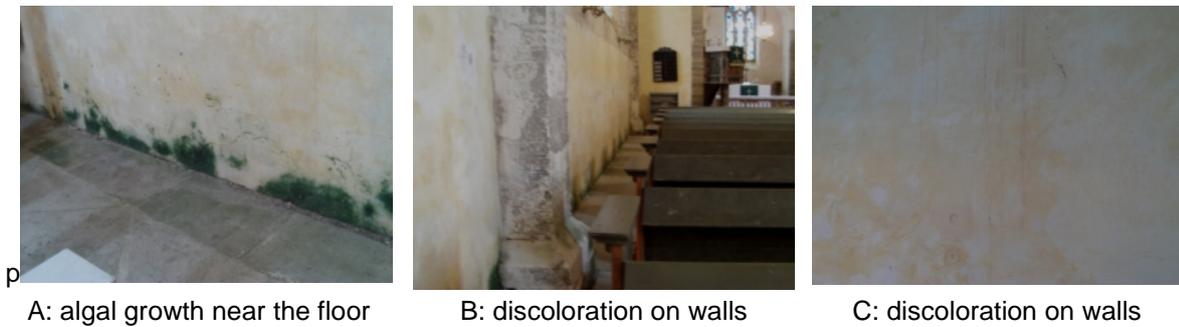
Figure 4.7 Biodegradation in St Catherine's Church in Muhu.

In Muhu Church, large areas of plaster discoloration were detected that were caused by bacteria (Figure 4.7 B, C). The areas of algal growth were mainly found near the floor level (Figure 4.7 A).

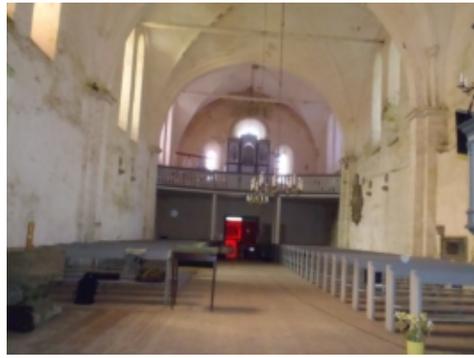
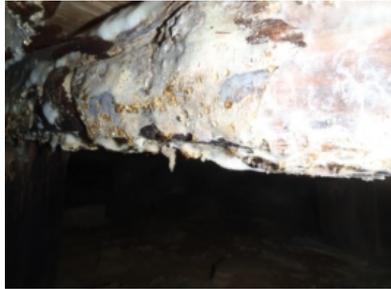
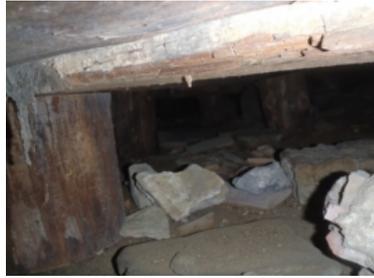
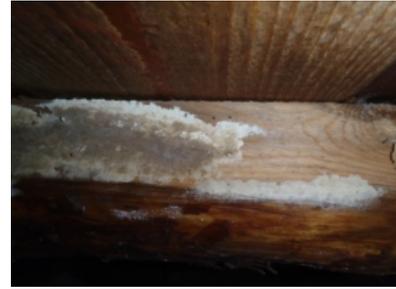
Figure 4.9 Biodegradation in the floor structures

A Top view of the floor

B Site B (Figure 4.8)

C Site C (Figure 4.8)

D Site D (Figure 4.8)

Wide-scale algal growth is facilitated by the high indoor moisture content spread on the internal walls. Even though from the outside, the floor looks fine (Figure 4.9), the main problem in this church is widely spread wood rot under the floor (Figure 4.8). The area is marked in blue. In site D, the fruiting body of *Coniophora sp.* was discovered. In favourable conditions, this fungus can quickly destroy the whole floor. Eradication of wood rot should be started as soon as possible.

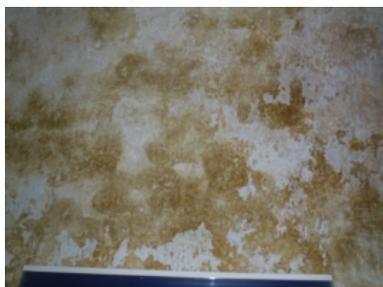
A: Yellowing of the Linseed primer

In Püha Church, a large area of algal deterioration was detected on the ground and loft levels (Figure 4.11B). In the entrance hall, linseed primer was found to be yellow and deteriorated by mould. In the loft, Anobium damage was detected on one bench. There was no sign of it spreading to other benches.

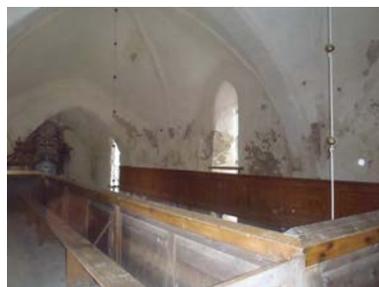
B: Algal deterioration on the loft level and higher

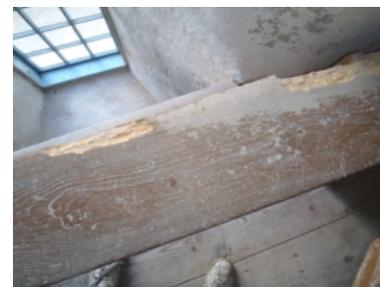
C: Anobium damage of the bench on the loft

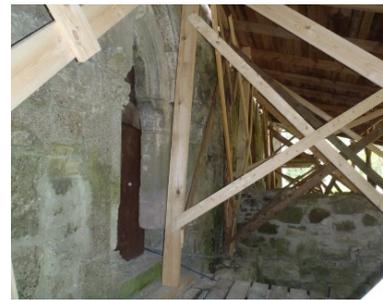
C: Northern side, 2013

Figure 4.12 Biodeterioration in St Mary's Church in Pöide.

Algae have spread widely both inside and outside the Pöide Church. The area of development of the algae inside (Figure 4.12 A) has not changed over the project period. Outside, on the northern side of the church (Figure 4.12 B), a temporary roof was built over the excavated area for archaeological excavations. That caused massive growth of algae on all stone surfaces under the roof. Over the project period, some reduction of the outside algae growth occurred (Figure 4.12 C).

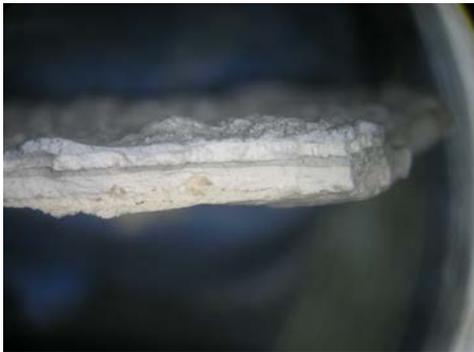
Besides algal growth, there was an interesting occurrence of threaded pink bacteria and mould (Figure 4.3) on painted plaster surfaces. The plaster was painted with at least 5 layers of paint (Figure 4.13 A) with different physical properties and that caused it to crack and separate. In the fractured spots, an old layer of oil paint was revealed (Figure 4.13 B).

A: 5 layers of finishing materials

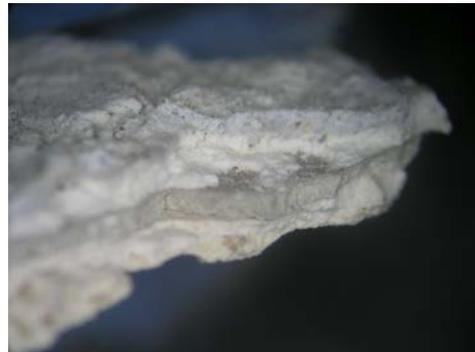
B: The darker central layer is a paint containing linen primer

The detached layer of paint created favourable conditions beneath it to maintain stable moisture conditions for the mould and bacteria to grow in. Bacteria coloured the plaster surface pink but did not colonise the upper blue-coloured layers of paint.

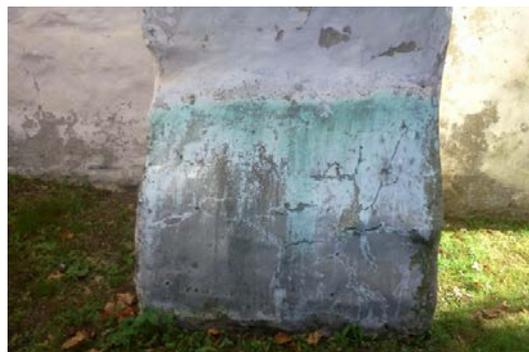
Figure 4.14 Copper salt deposit on the outside wall

Outside, at the front facade of the church, a bluish green copper salt deposit had formed due to rainwater flowing over the copper metal sheet roof.

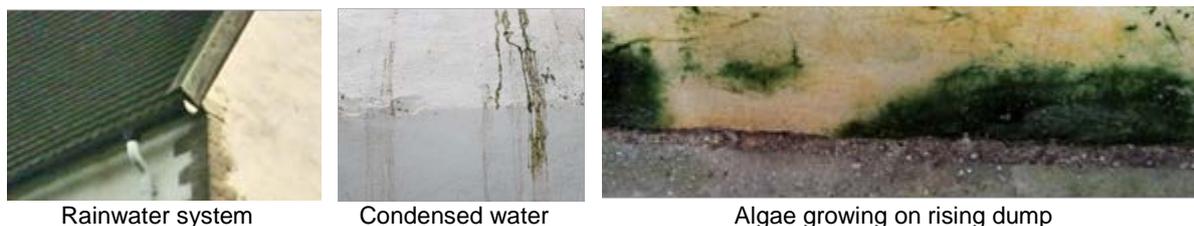
The main reason for this is that the church is equipped with a rainwater system and the church walls are in good condition on the outside. The main moisture problems include condensed water caused by high indoor humidity and upsoaring moisture (Figure 7.10).

Figure 7.10 Gutter and biological damages caused by condensed and upsoaring water

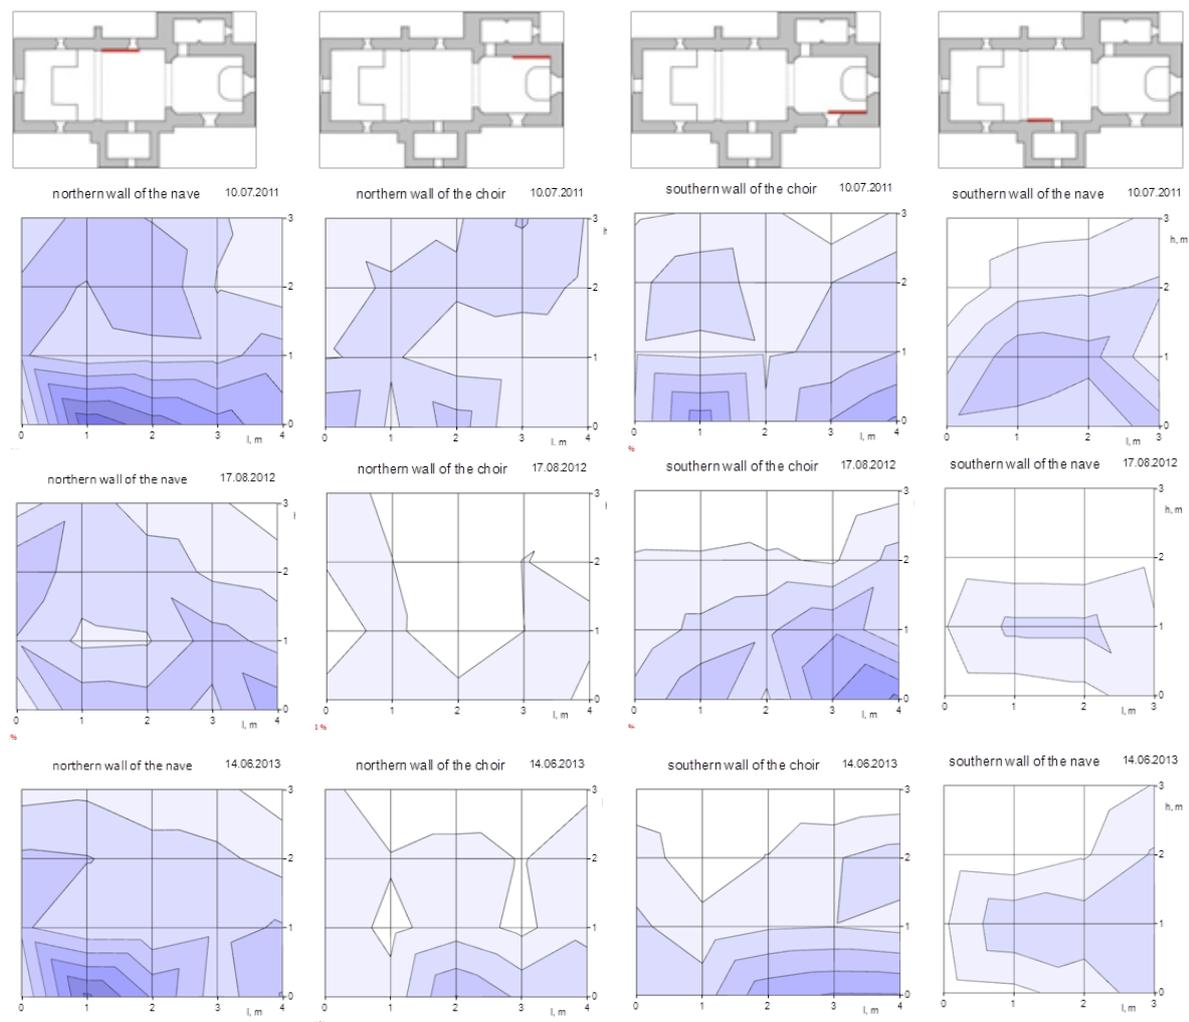
Figure 7.12 Moisture distribution in July 2011, August 2012 and June 2013

For comparison, old measurements from 10.07.2011 are presented in Figure 7.12. Average moisture content of the measured walls: 2011 – 4.7%, 2012 – 3.1% and 2013 – 3.6%, at the floor level, 7.1%, 4.7%, 6.1%, and at 3 meters from the floor, 3.0%, 1.5% and 1.2% correspondingly. We see some improvements after the construction of the new roof, mainly above the 2 m level from the floor.

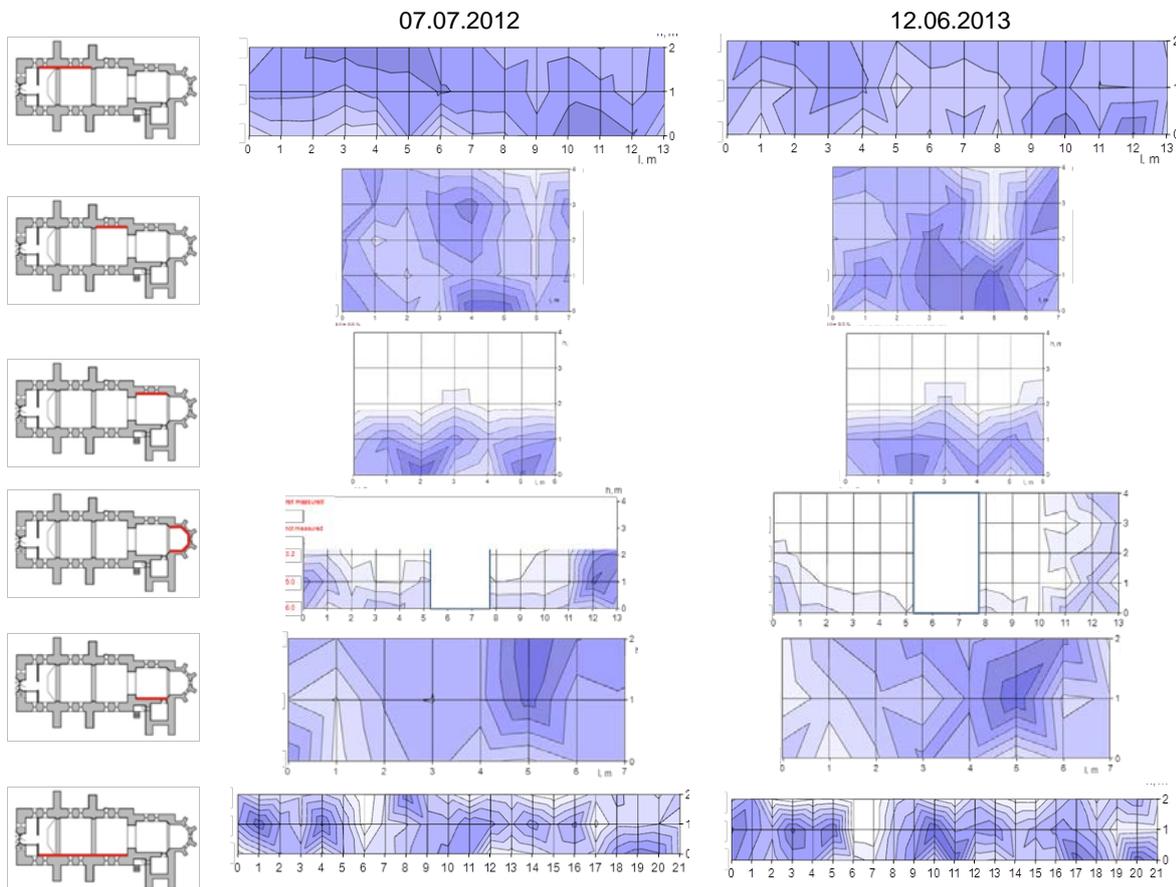
Figure 7.14 Moisture distribution in July 2012 and June 2013.

Only on the moisture maps of the northern and eastern walls of the choir we see the typical picture of upsoaring moisture (Figure 7.14). The other walls are wet at all measured heights. It means that moisture penetrates to the inside faces of the walls from the outside through the massive walls. The moisture picture remains unchanged over the year.

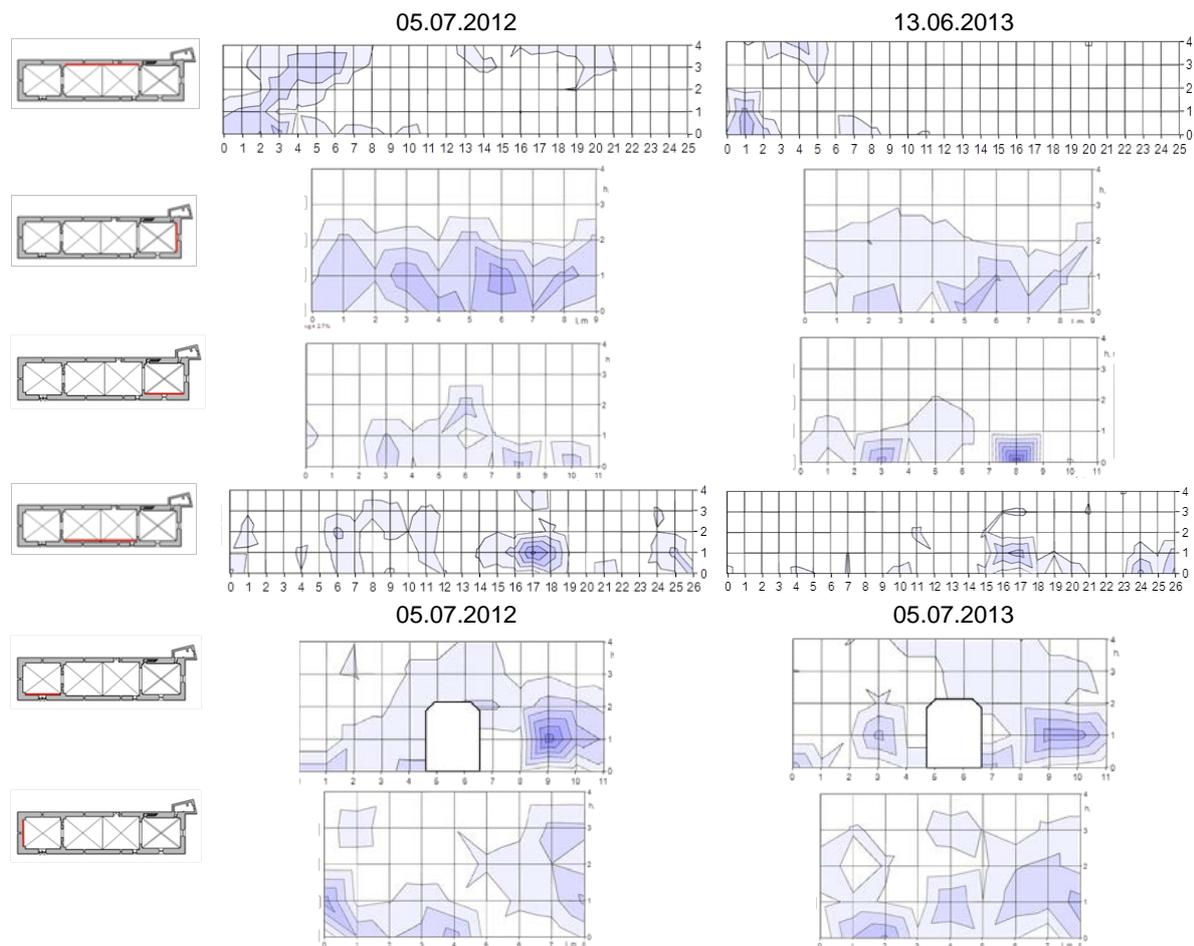
Figure 7.16 Moisture distribution in July 2012 and June 2013

Presently, part of the northern wall of the church is sheltered by a temporary awning. The moisture map of the inner wall behind the shelter shows relatively low moisture content. The walls higher and to the west from the shelter are wet. The eastern wall has a surprisingly high moisture content induced probably by capillary forces. The southern wall has a small wet area with an extremely high salt content. The salting points to high mobility of moisture in the mentioned region.

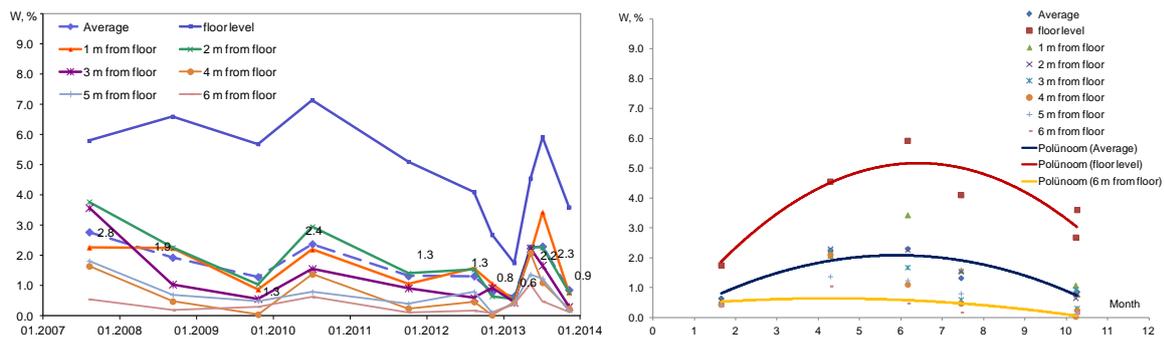
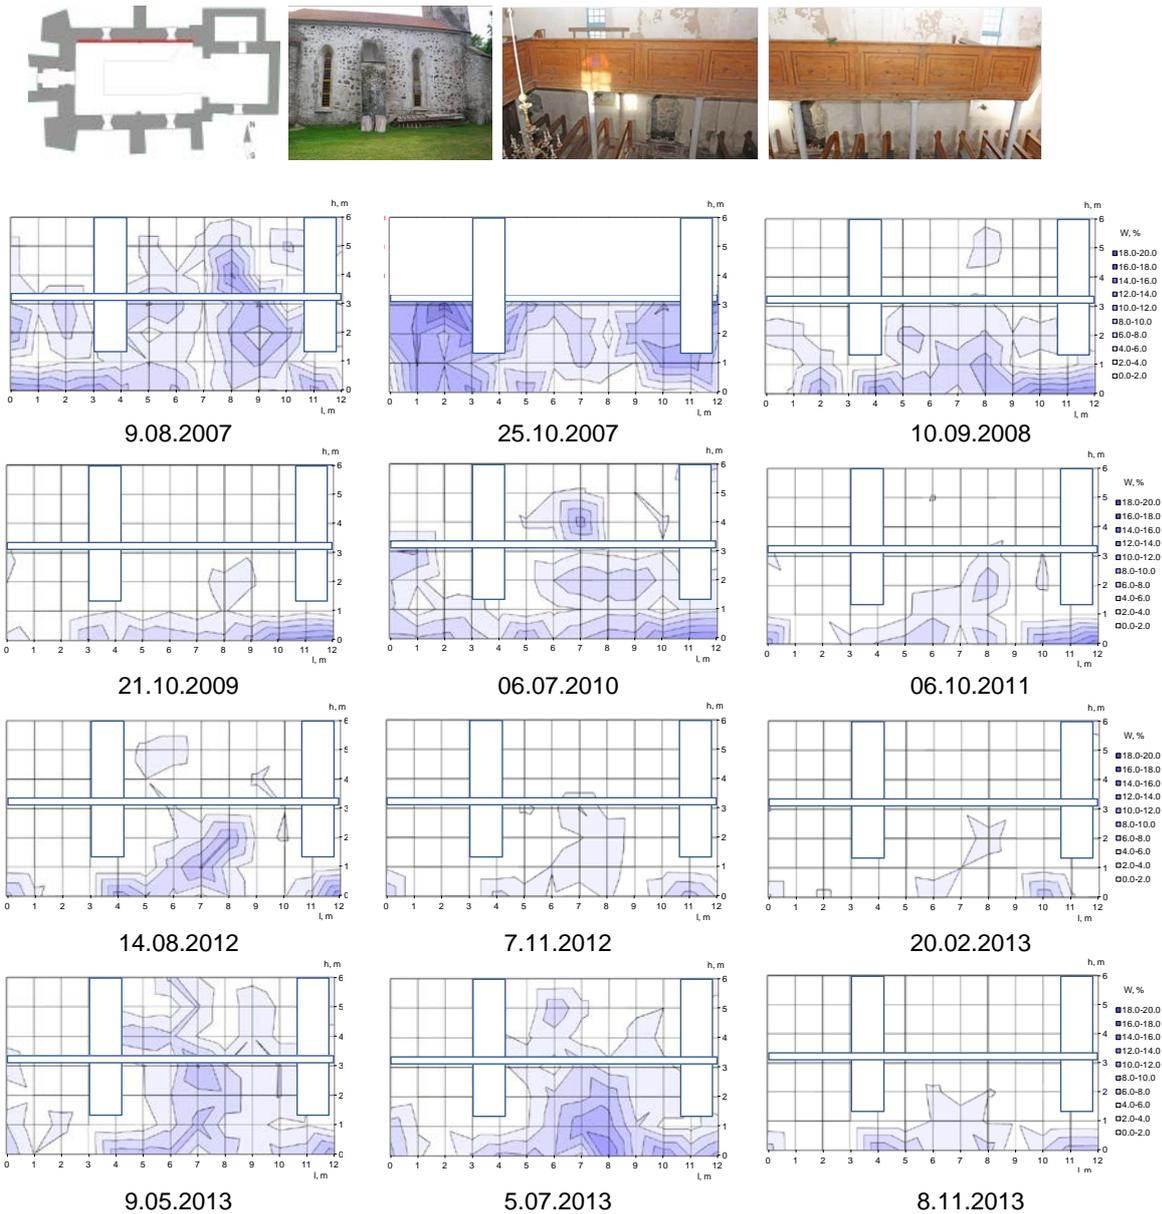
Moisture content decreased after the renovations in 2007, see Figure 7.18 and Figure 7.19. Big seasonal changes can be observed. The maximum moisture content occurring in July can be explained by the great relative importance of condensed moisture and hygroscopic moisture in the wall's moisture balance. Dampness rising from the ground can be clearly seen. The effect of the counterfort on moisture content can also be seen from the maps. The results obtained in winter 2013 may be distorted due to the partial freezing of the wall.

Figure 7.18 Average moisture contents of the northern wall of the nave

Figure 7.19 Moisture maps and the average moisture content of the northern wall of the nave

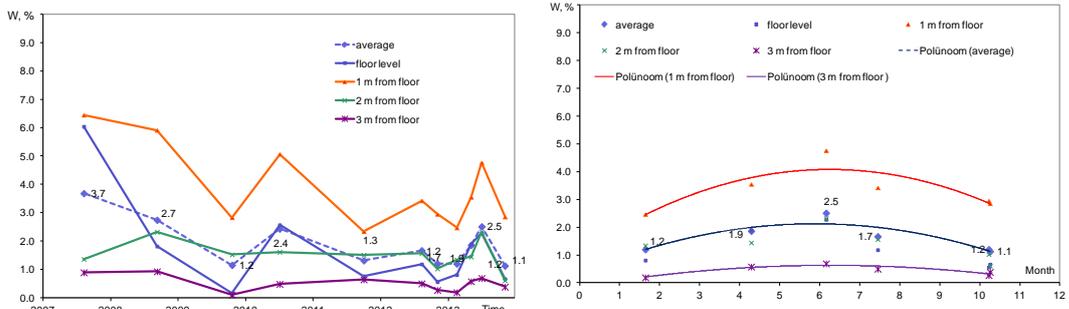
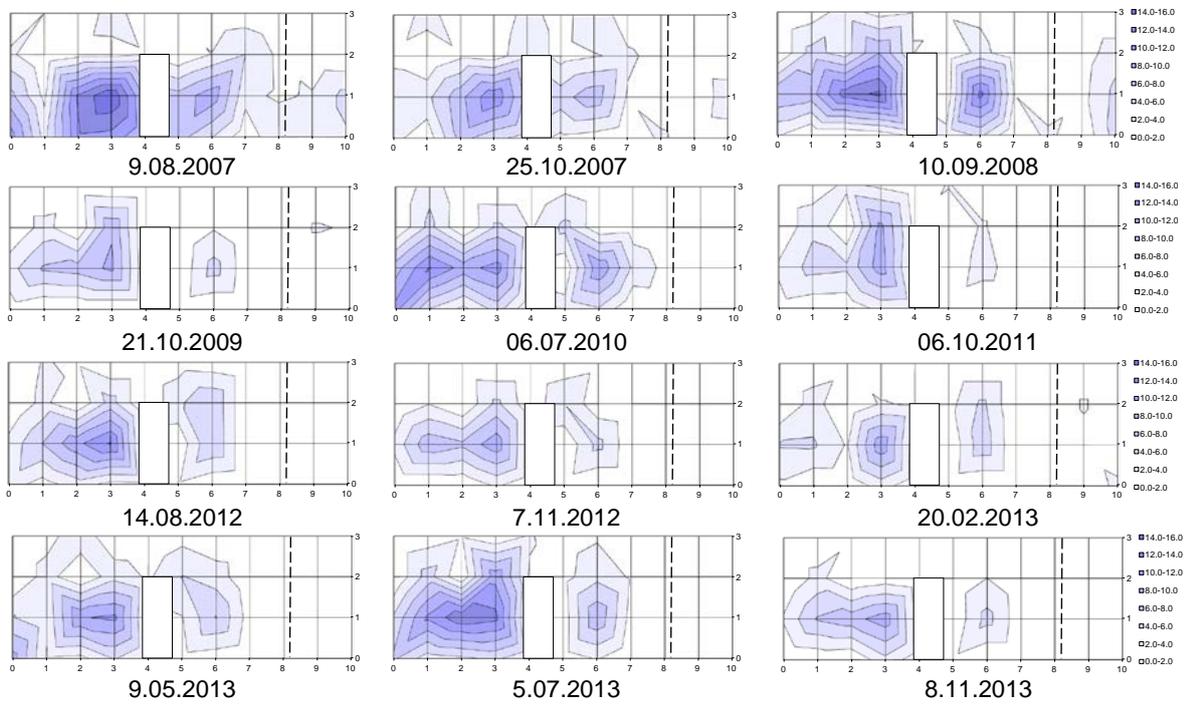
Seasonal changes in the moisture content of this wall are smaller (Figure 7.20, Figure 7.21), probably due to fact that it is an inner wall. One can observe an anomalous wet point that has not changed much in 7 years, the origin of which is not clear. Algae growth in that region shows that it cannot be an anomaly caused by some larger metallic object disturbing microwave penetration. There are several possible explanations: leakage of water from some higher location through cavities in the wall, some bigger building block in the wall with good thermal contact with the ground predisposing accumulation of condensed moisture, or an aquifer in the ground acting as a source of capillary moisture.

Figure 7.20 Average moisture content of the northern wall of the choir

Figure 7.21 Moisture maps of the northern wall of the choir

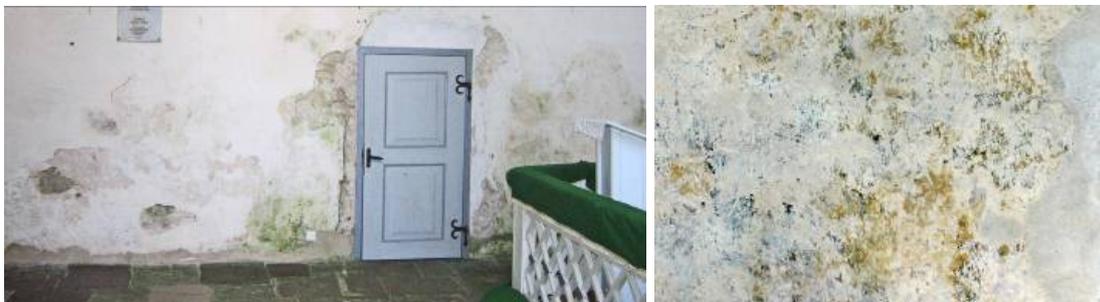
The state of the wall before restoration (algae blooming) is typical for the presence of moisture in capillary form so the last explanation is probably the most likely (Figure 7.22).

Figure 7.22 Northern wall of the choir before restoration in 2007 and mould on the wall in 2013

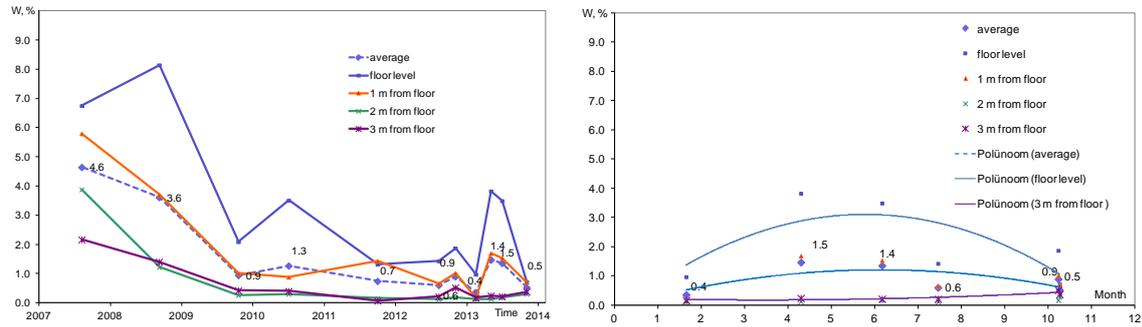
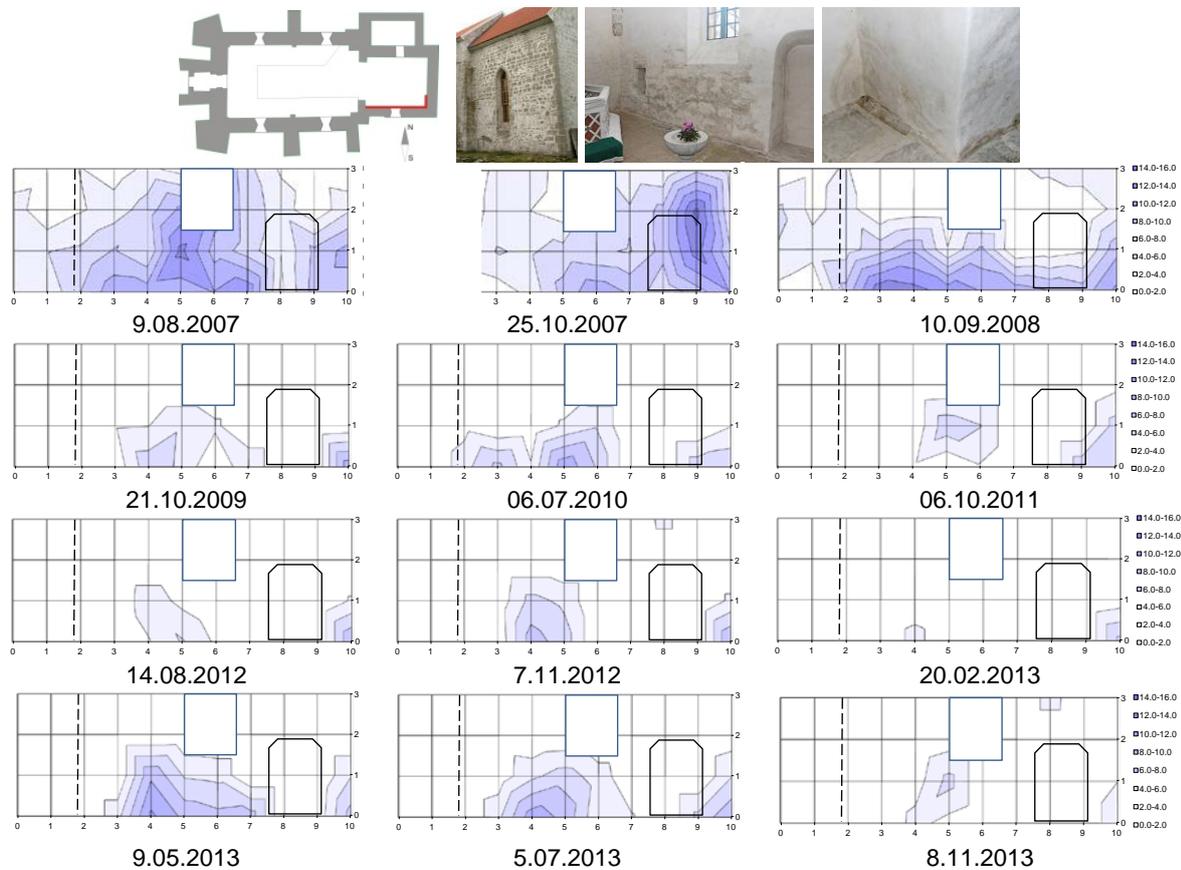
The condition of the wall has improved significantly; see Figure 7.23 and Figure 7.24. The wet region below the window is caused by moisture originating from the broken window-board and wall, see Figure 7.25.

Figure 7.23 Average moisture content of the southern wall of the choir

Figure 7.24 Moisture maps and the average moisture content of the southern wall of the choir

Significantly higher moisture contents can be observed in the parts of walls where the outer protective structures and joints are damaged (Figure 7.24). Rain water leaking into walls shifts the maximum of seasonal moisture content to the summer period or even later (see Figure 7.37, Figure 7.30).

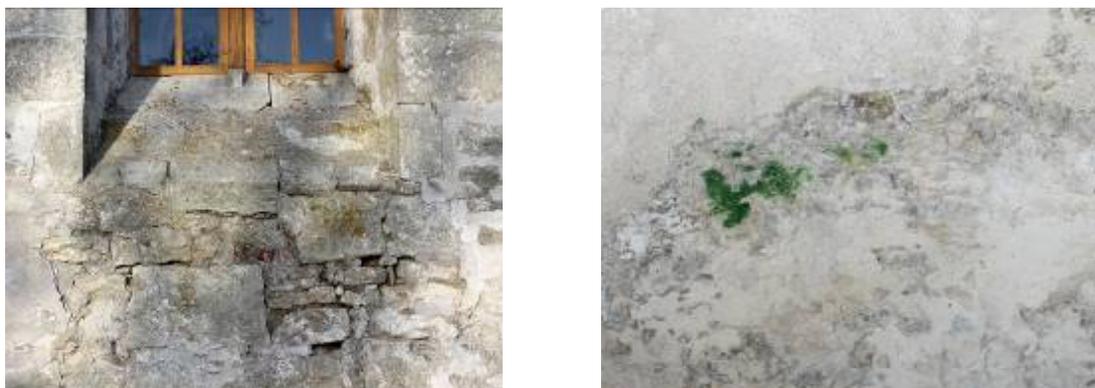
Figure 7.25 Broken window sill and wall, green algae in the same location on the inner side of the wall

- The moisture resistance of objects protruding from window sills or walls should be significantly improved. In winter, they will be covered with ice and snow, thus creating good conditions for moisture to penetrate. Possible solution: covering the mentioned surfaces with terne plates. Such covers have only a minimal visual effect since they cannot be seen from ground. On the other hand, their overall effect on the building's "health" is immense.

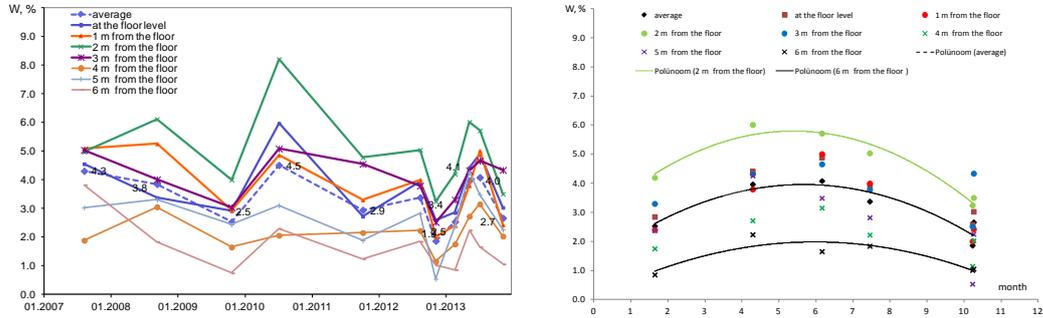
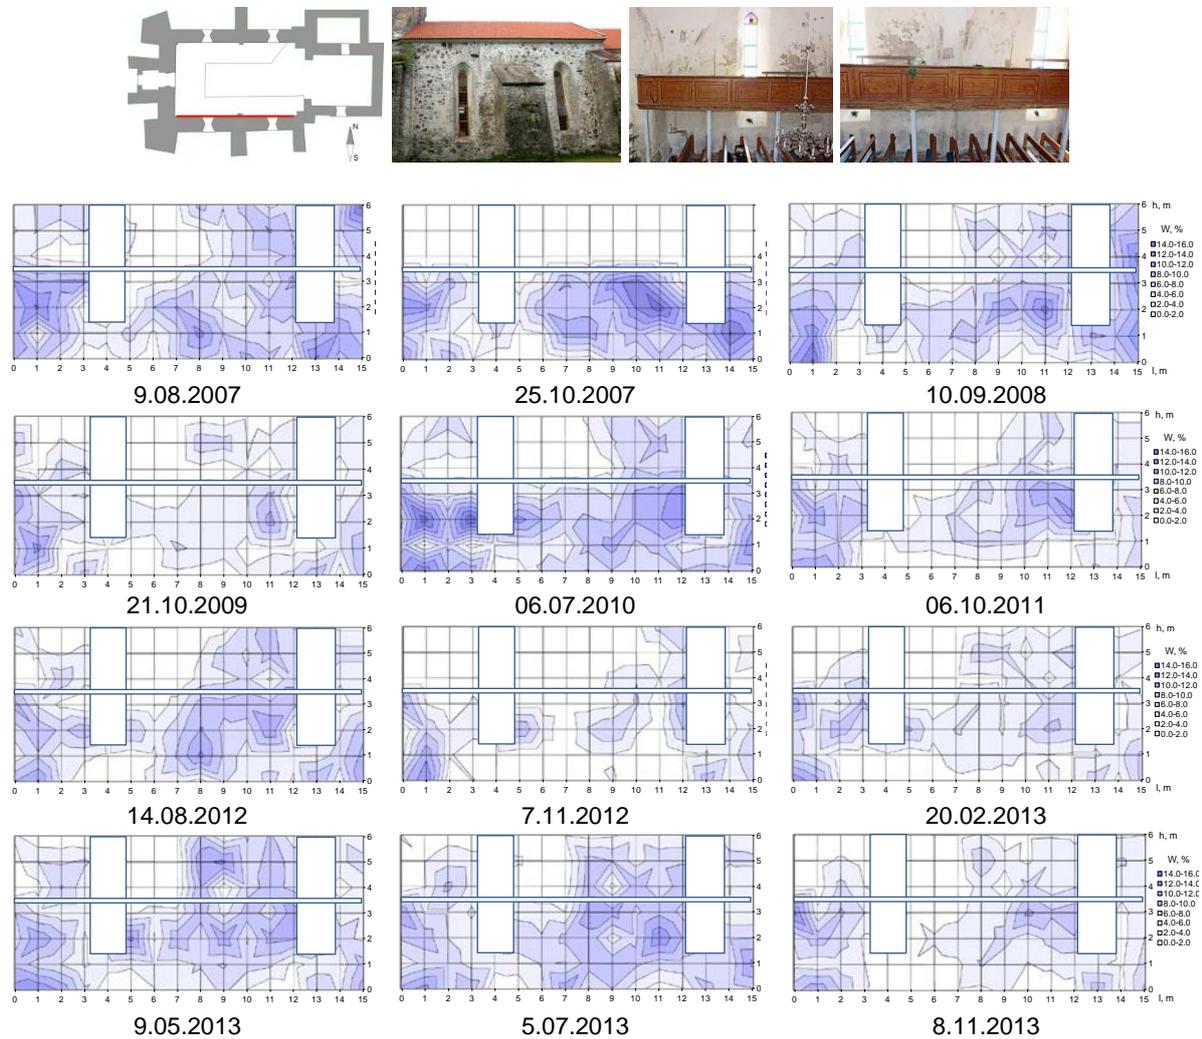
Relative moisture content is high, see Figure 7.26, Figure 7.27. It drops in the winter but is still relatively high. A distinctive feature of this wall is a relatively dry wall at higher altitudes to the east of the counterfort. Obvious reason: the counterfort prevents water brought by western winds and coming from the roof (inclined to the east) from reaching the walls. This proves the assumption that most of the moisture in the wall originates from the roof.

Figure 7.26 Average moisture content of the southern wall of the nave

Figure 7.27 Moisture maps of the southern wall of the nave

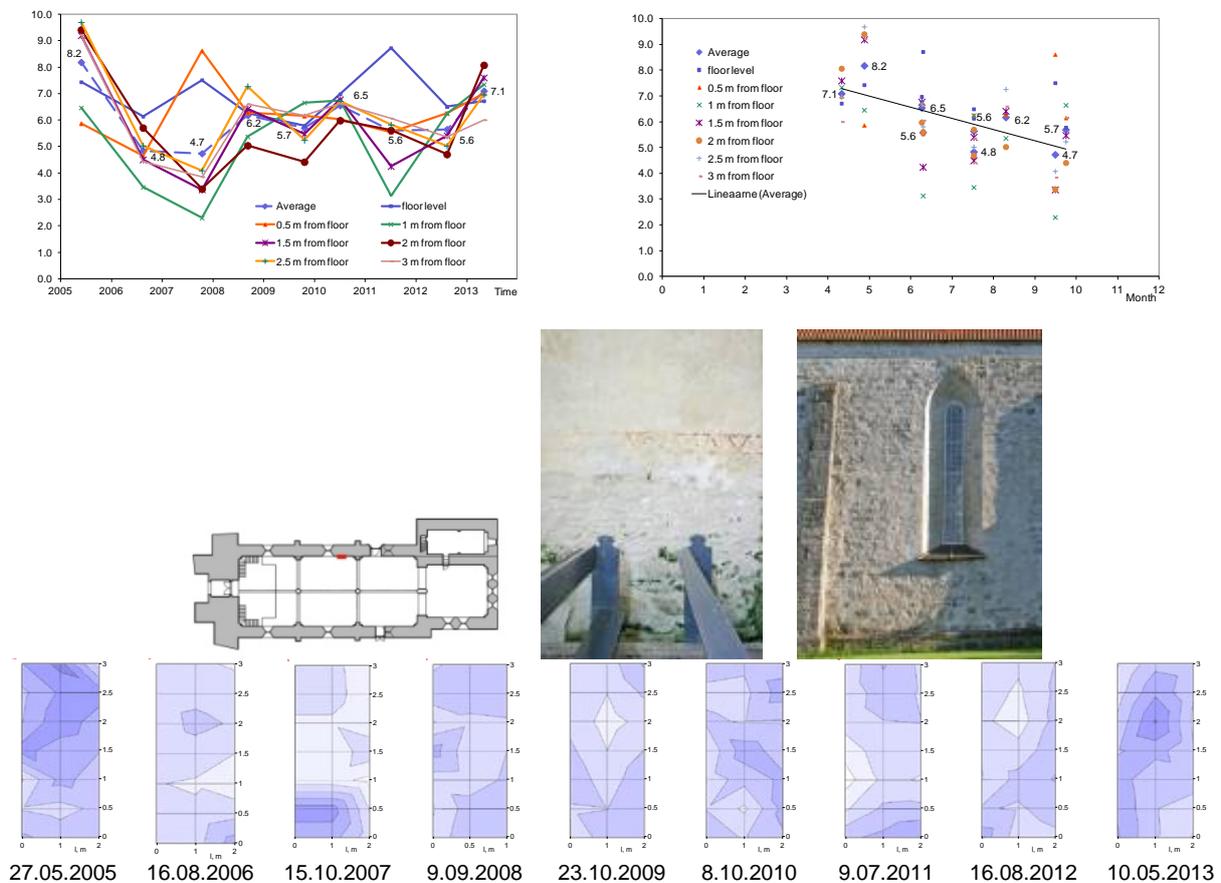
The moisture content of the walls has not changed much since 2005, although seasonal changes are still visible. Moisture reaches the highest point in May, suggesting that condensed water has a big role in moisture balance.

Excessive salt content and air movement in the church amplify these processes. Nevertheless, the main source of moisture is probably rainwater falling from the roof to the walls. The high level of moisture, its distribution (the higher, the more wet) and the accumulation of salts (salts have to get out from wall to its surface somehow) should confirm this assumption.

Figure 7.29 Average moisture content and moisture maps of the northern wall of the nave

- The building envelope (roofs, walls, windows, doors) of the church should be repaired / kept in good conditions;
- Churches should be equipped with rain water systems (gutters with tubing carrying the accumulated water further away). Different means for servicing gutters such as gutter cleaning robots are available.

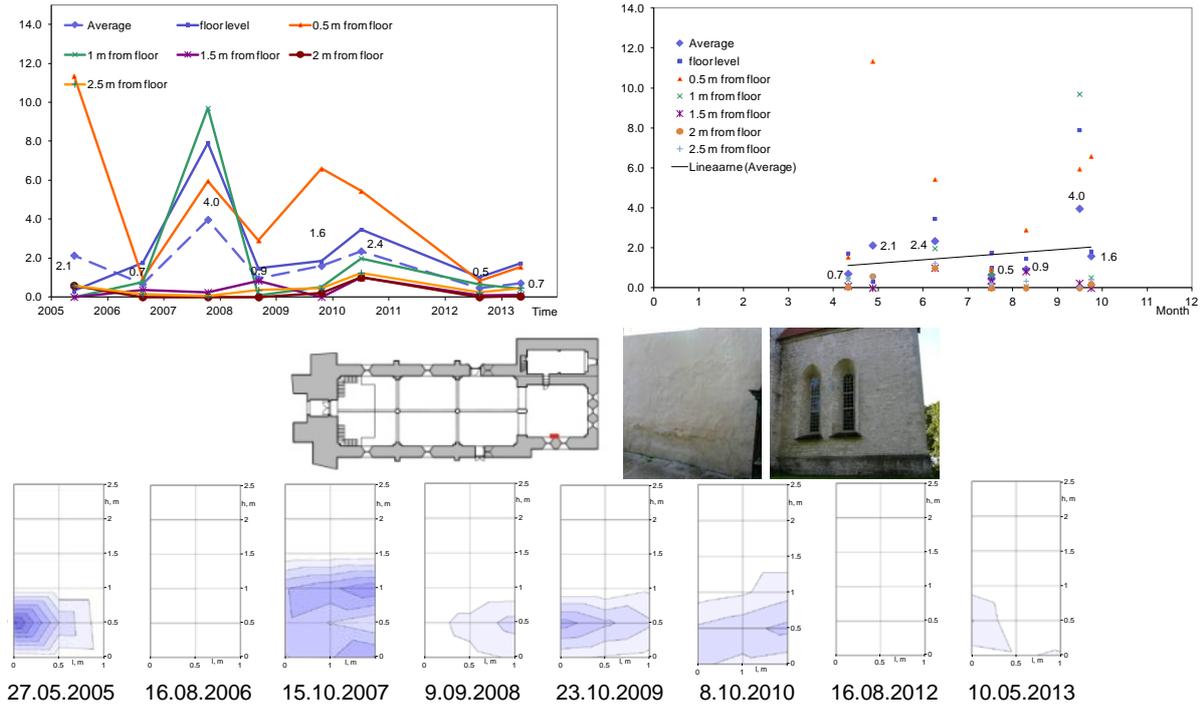
Figure 7.30 Average moisture content and moisture maps of the southern wall of the choir
