THE FINAL RESEARCH REPORT

‘Sustainable Management of Historic Rural Churches
in the Baltic Sea Region (SMC)’

The final report of research of project 'Sustainable Management of Historic Rural Churches in the Baltic Sea Region (SMC)'

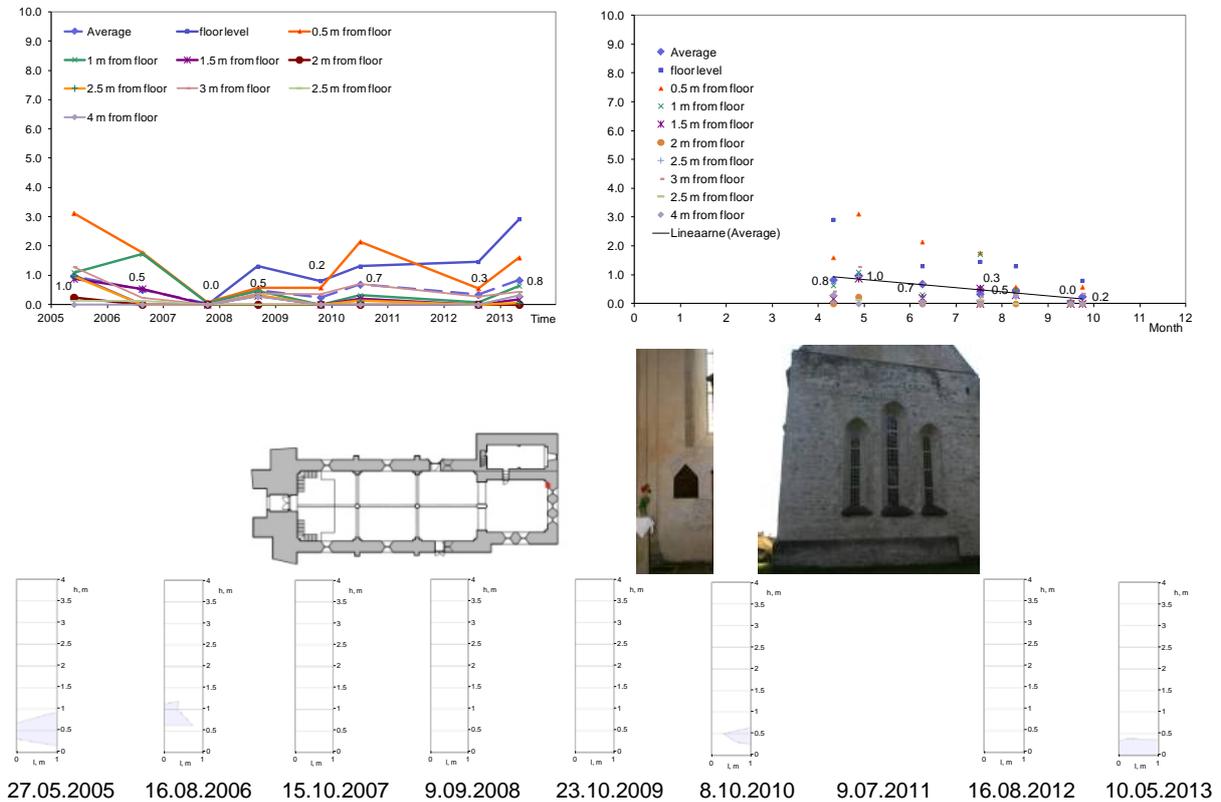
Overall moisture content is low with a clear maximum in the beginning of summer. Moisture originates mainly from water condensed on the walls. Since the roof of the church is inclined to the south and north, water from the roof cannot leak to the eastern walls. Capillary moisture is poorly defined, can be seen at a height of up to 1 m.

Figure 7.31 Average moisture content and moisture maps of the eastern wall of the choir

The eastern walls of the churches (Figure 7.31, Figure 7.32) generally not suffering from rain water falling from the roof, the parts of walls protected by gutters (Figure 7.9), and those located away from the direction of predominant winds are significantly dryer.

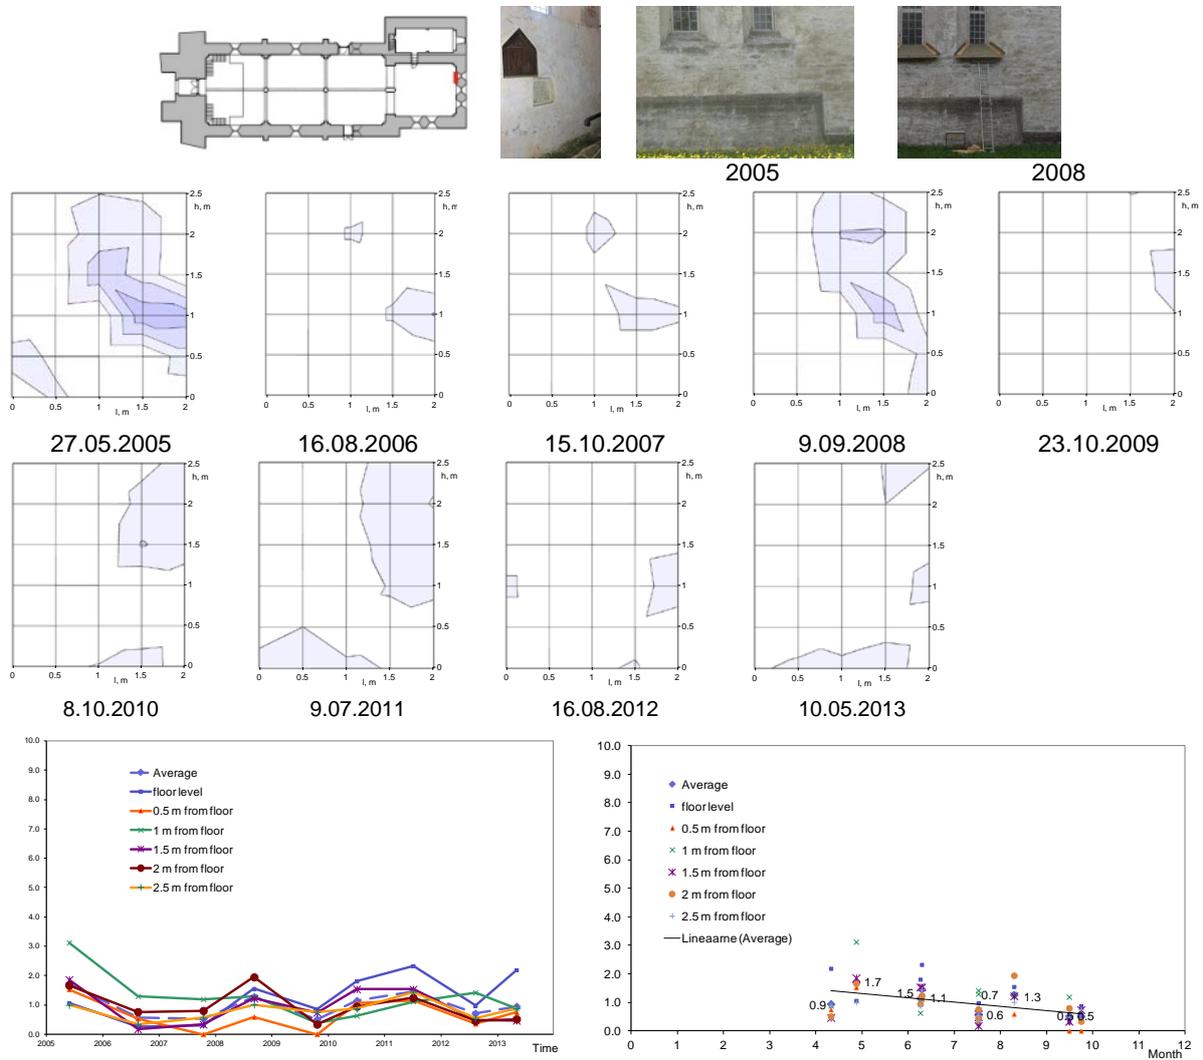
Moisture content of this part of eastern wall is also low. There is a clearly visible cranny in the wall that can be observed on moisture distribution map (especially up to year 2008, after which the window sill above the wall was coated with a temporary cover). Despite the low moisture content, a crucial crystallization of salts (mainly KNO_3) on walls takes place and damages the surface of the walls. The clear decomposition of a test patch made by restorers in 2005 can be seen in Figure 7.33.

Figure 7.32 Moisture maps and the average moisture content of the eastern wall of the choir

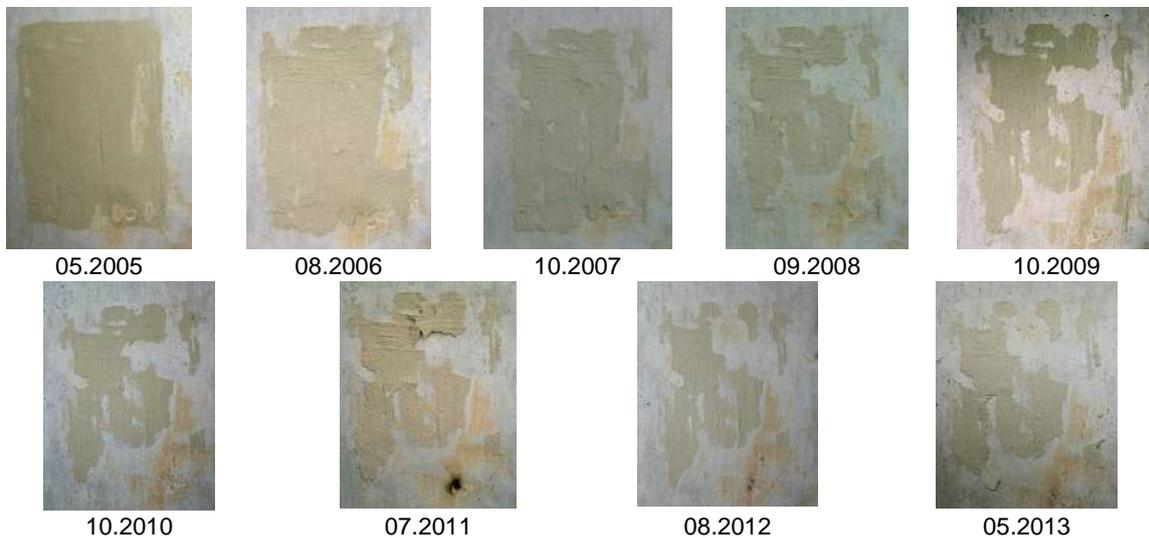
Figure 7.33 Lime paint test patch

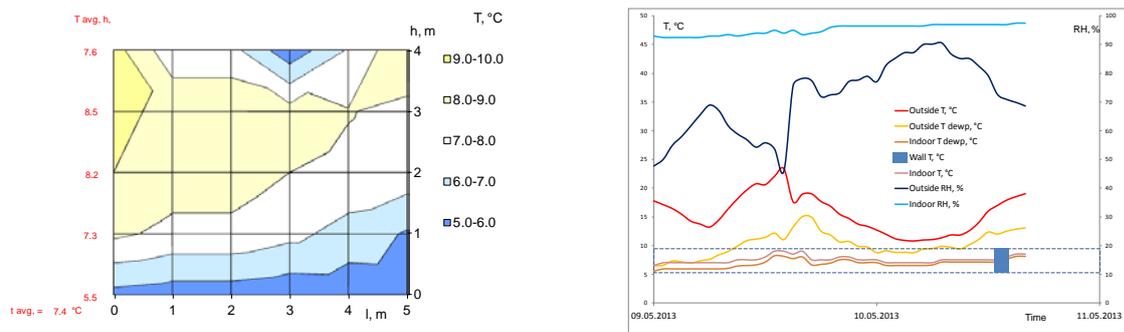
A temperature map (10.05.2013) of the church's northern wall is presented in Figure 7.35. The same data is shown on the indoor and outdoor climate graph. The temperature of a significant part of the wall is below the dew point for air both in and outside the building, making the conditions very favourable for water vapour condensation (on the wall). Moisture content deep inside the wall is lower than in surface layers (Figure 7.34) (except at 7 cm where the calibration is not very accurate for plaster). It means that condensed water is the main water source for this wall.

Figure 7.35 Northern wall under the window, 10.05.2013

- The air-tightness of the doors and windows should be improved; ventilation should be increased, especially in the spring–summer period. The simplest solution would perhaps be installing electronic devices for measuring humidity/temperature and giving recommendations (on the basis of the measurements) for when it is safe open church doors and/or windows.

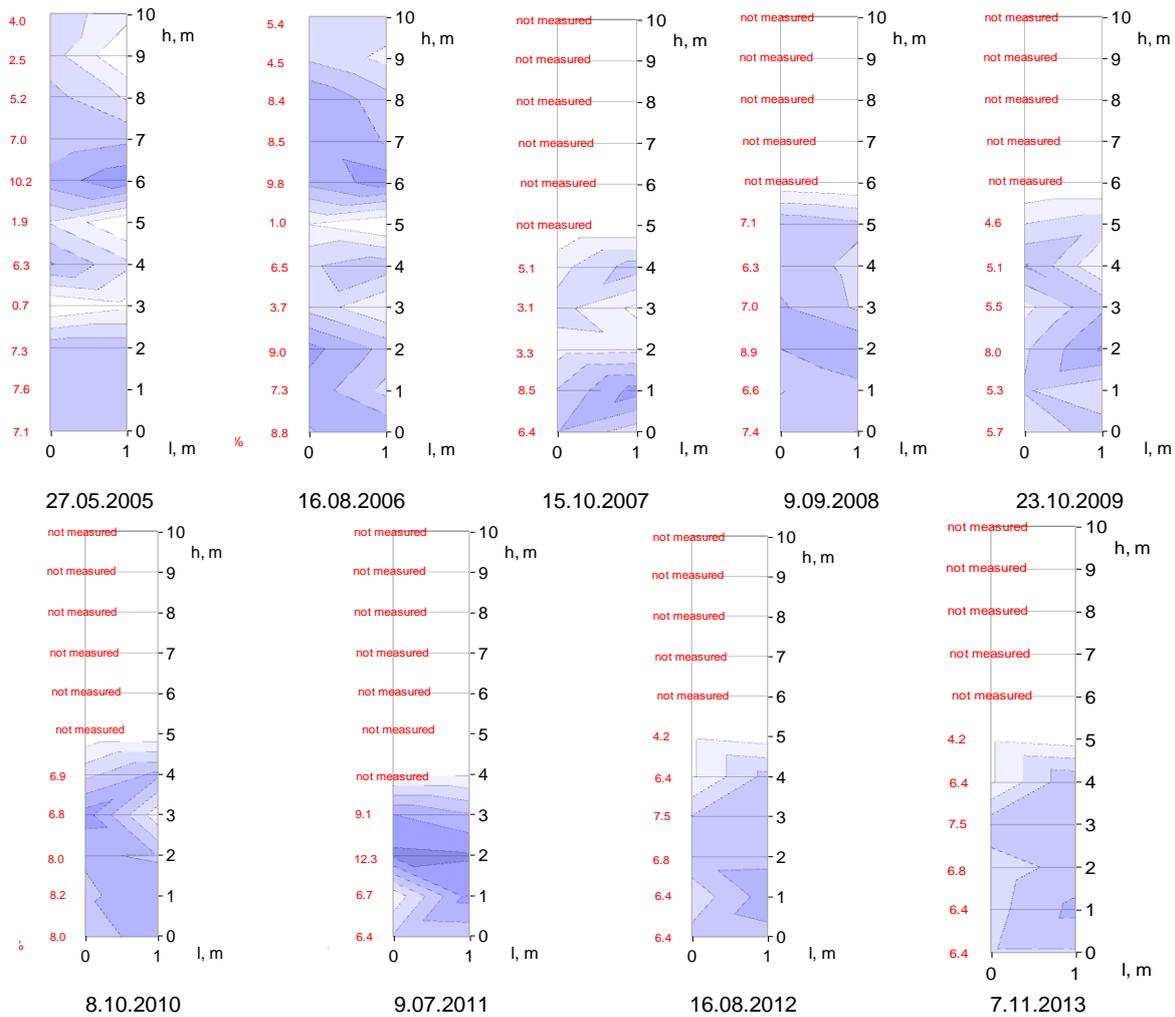
Figure 7.37 Moisture maps of the southern wall of the nave

The measurements carried out in churches in Saaremaa show some general trends. The main source of moisture in the churches included in the present study is water condensing on walls in late spring–early summer. This common problem of all non-heated churches was confirmed by the analysis of the dynamics of the moisture content of walls. Moisture reaches the maximum level in May/June/July, decreasing first in higher locations (of walls) where the temperature is higher (see Figure 7.18, Figure 7.29, Figure 7.32). Moisture content is also higher in places where large quantities of rain water fall on the walls (see Figure 7.37, Figure 7.29, etc.).

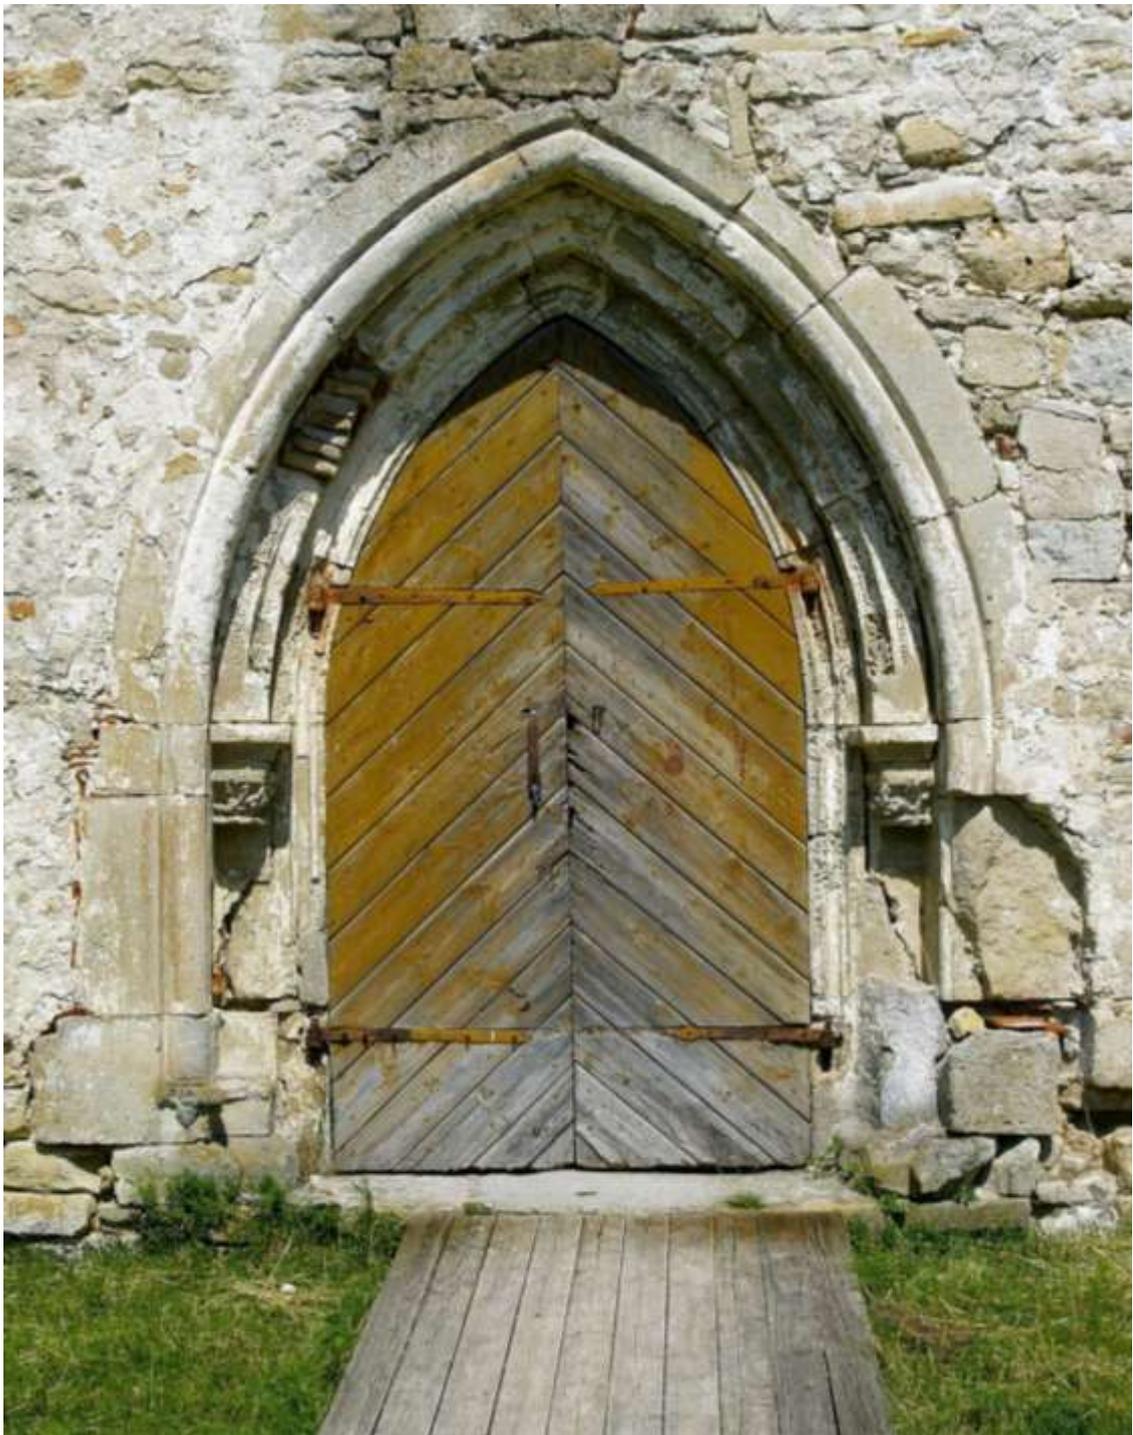
3.1 Põide kiriku lõunaportaal ja välisuks väljast (foto: P. Säre)

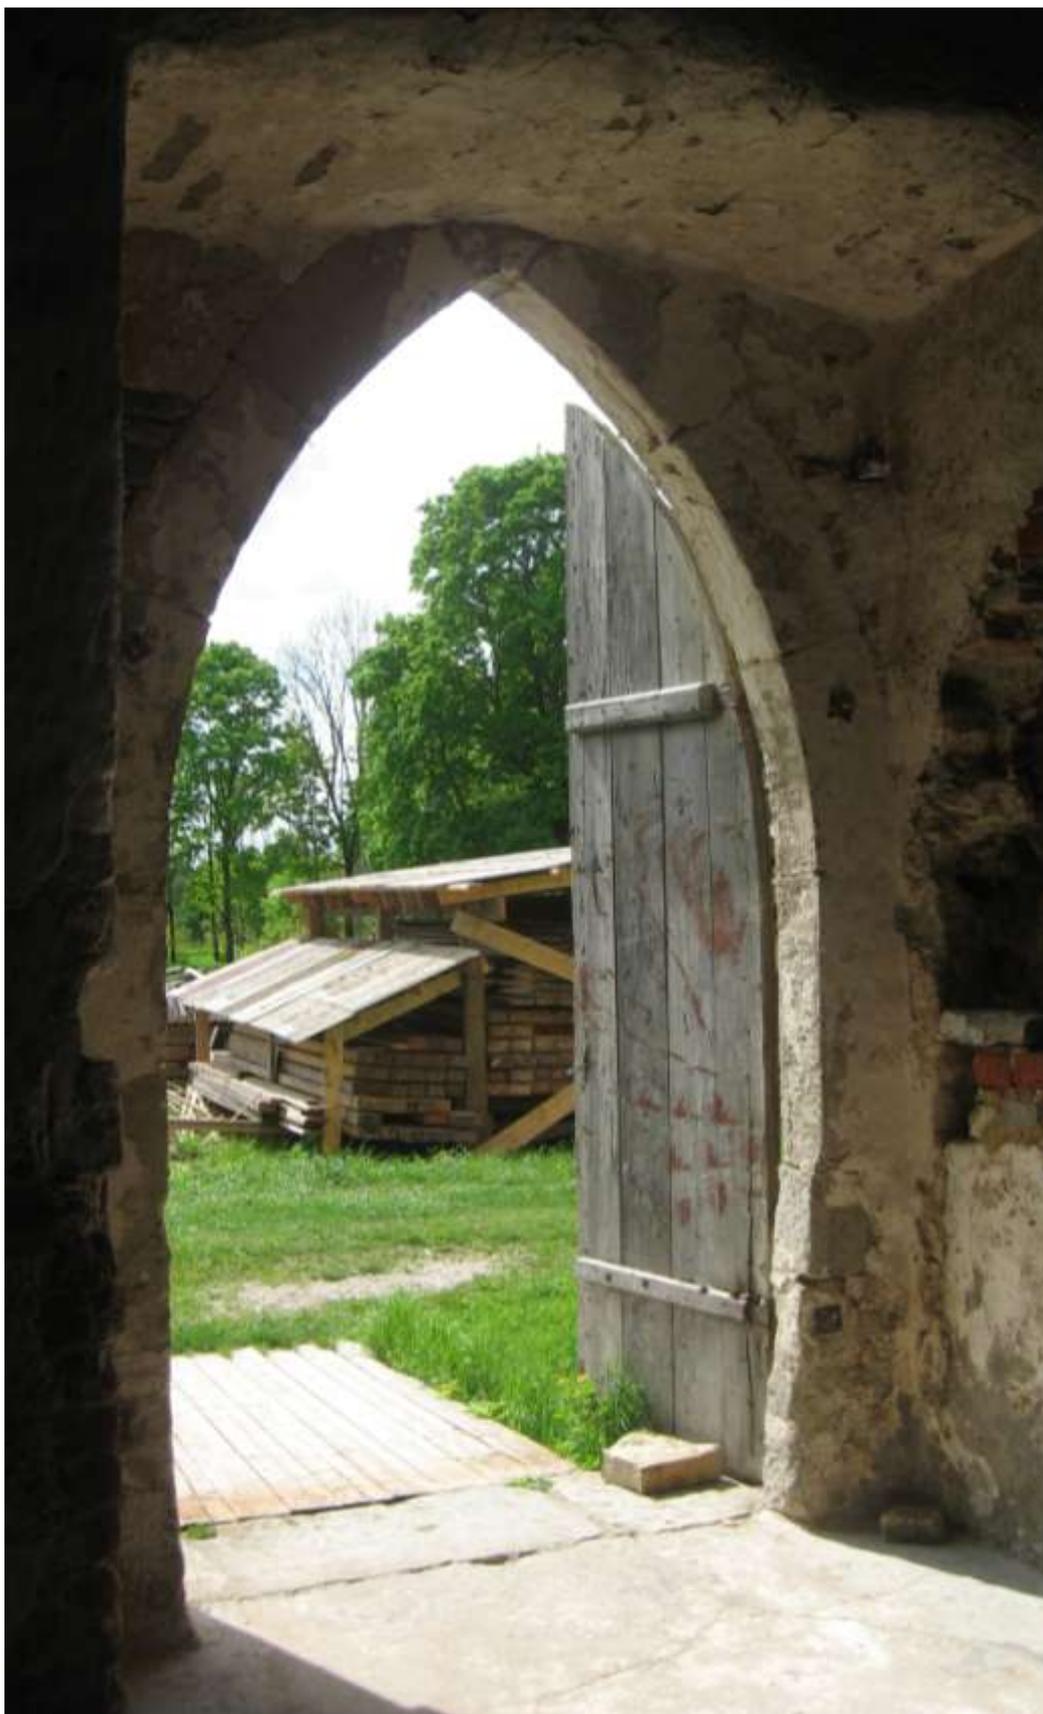
3.2 Põide kiriku lõunaportaali välisuksest (foto: E. Sova)

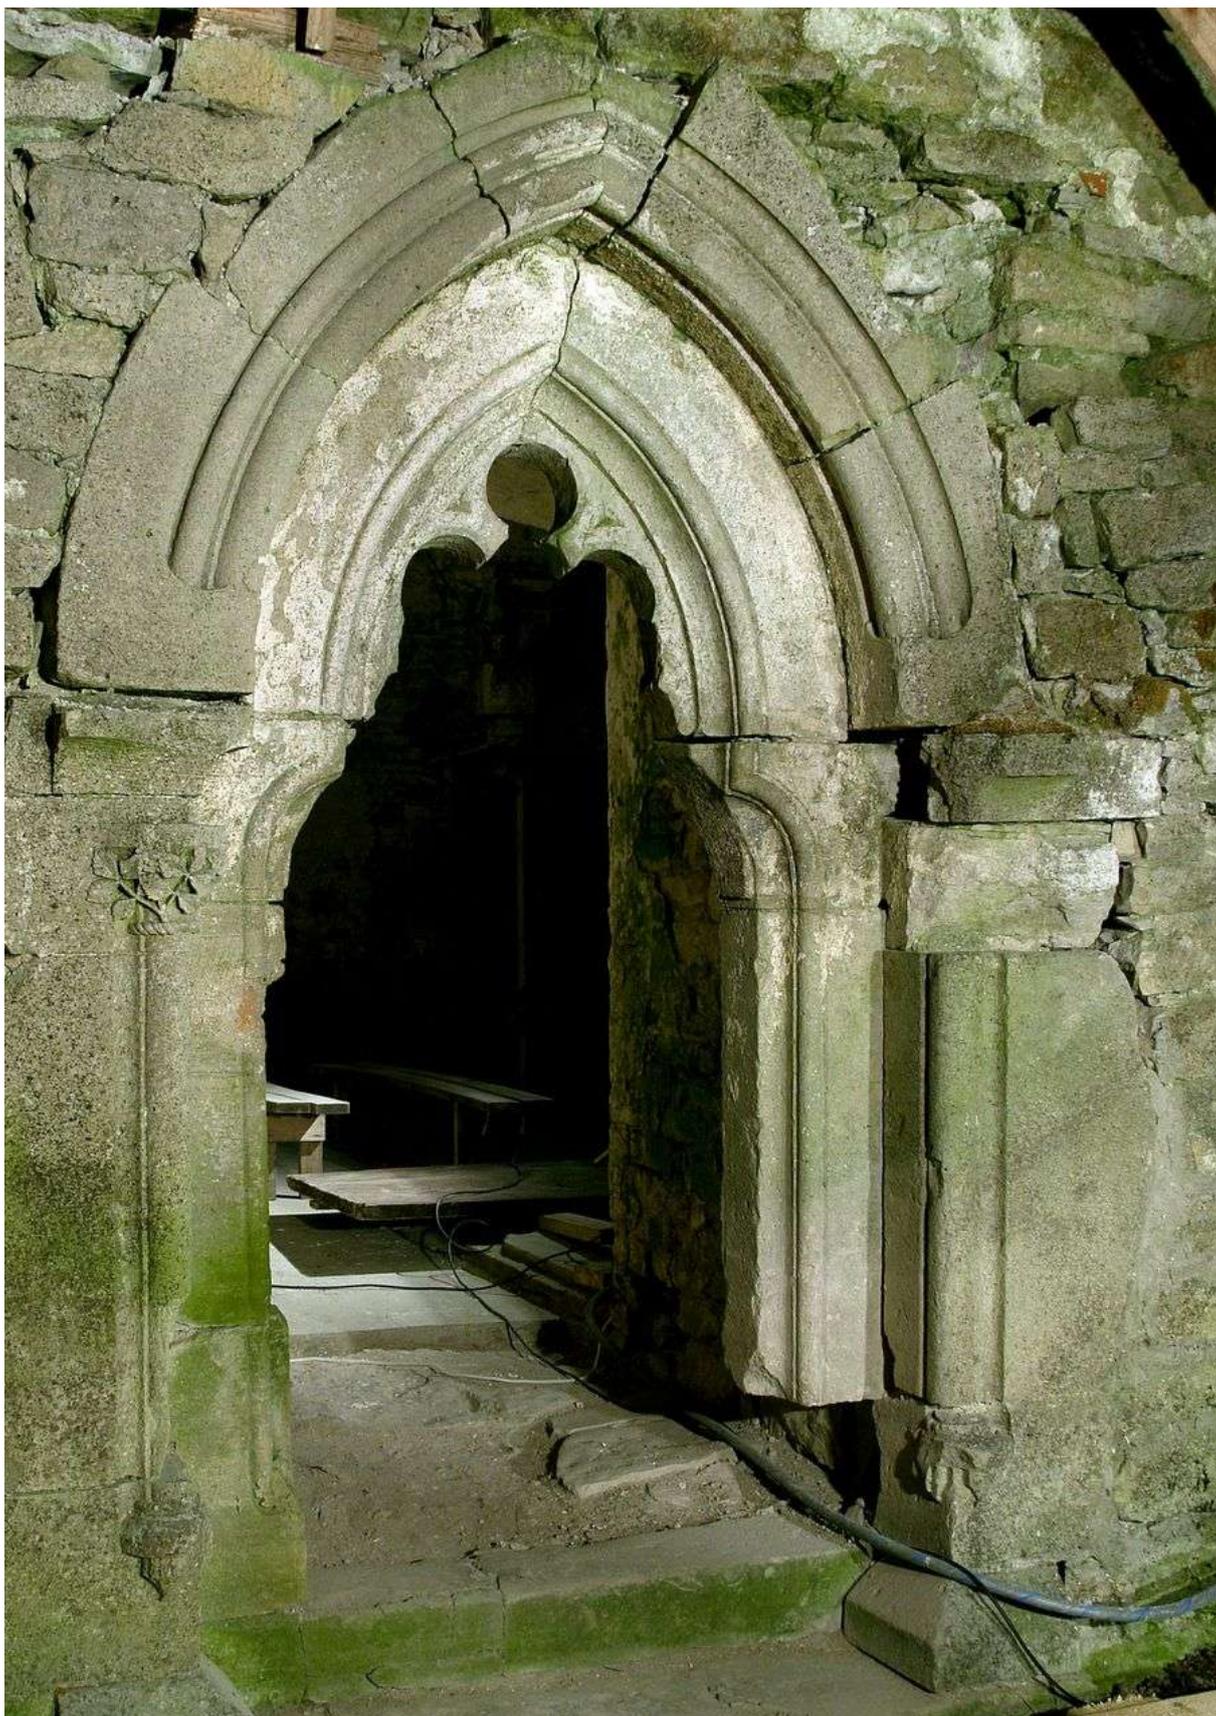
3.3 Põide kiriku põhjaportaal väljast (foto: P. Säre)

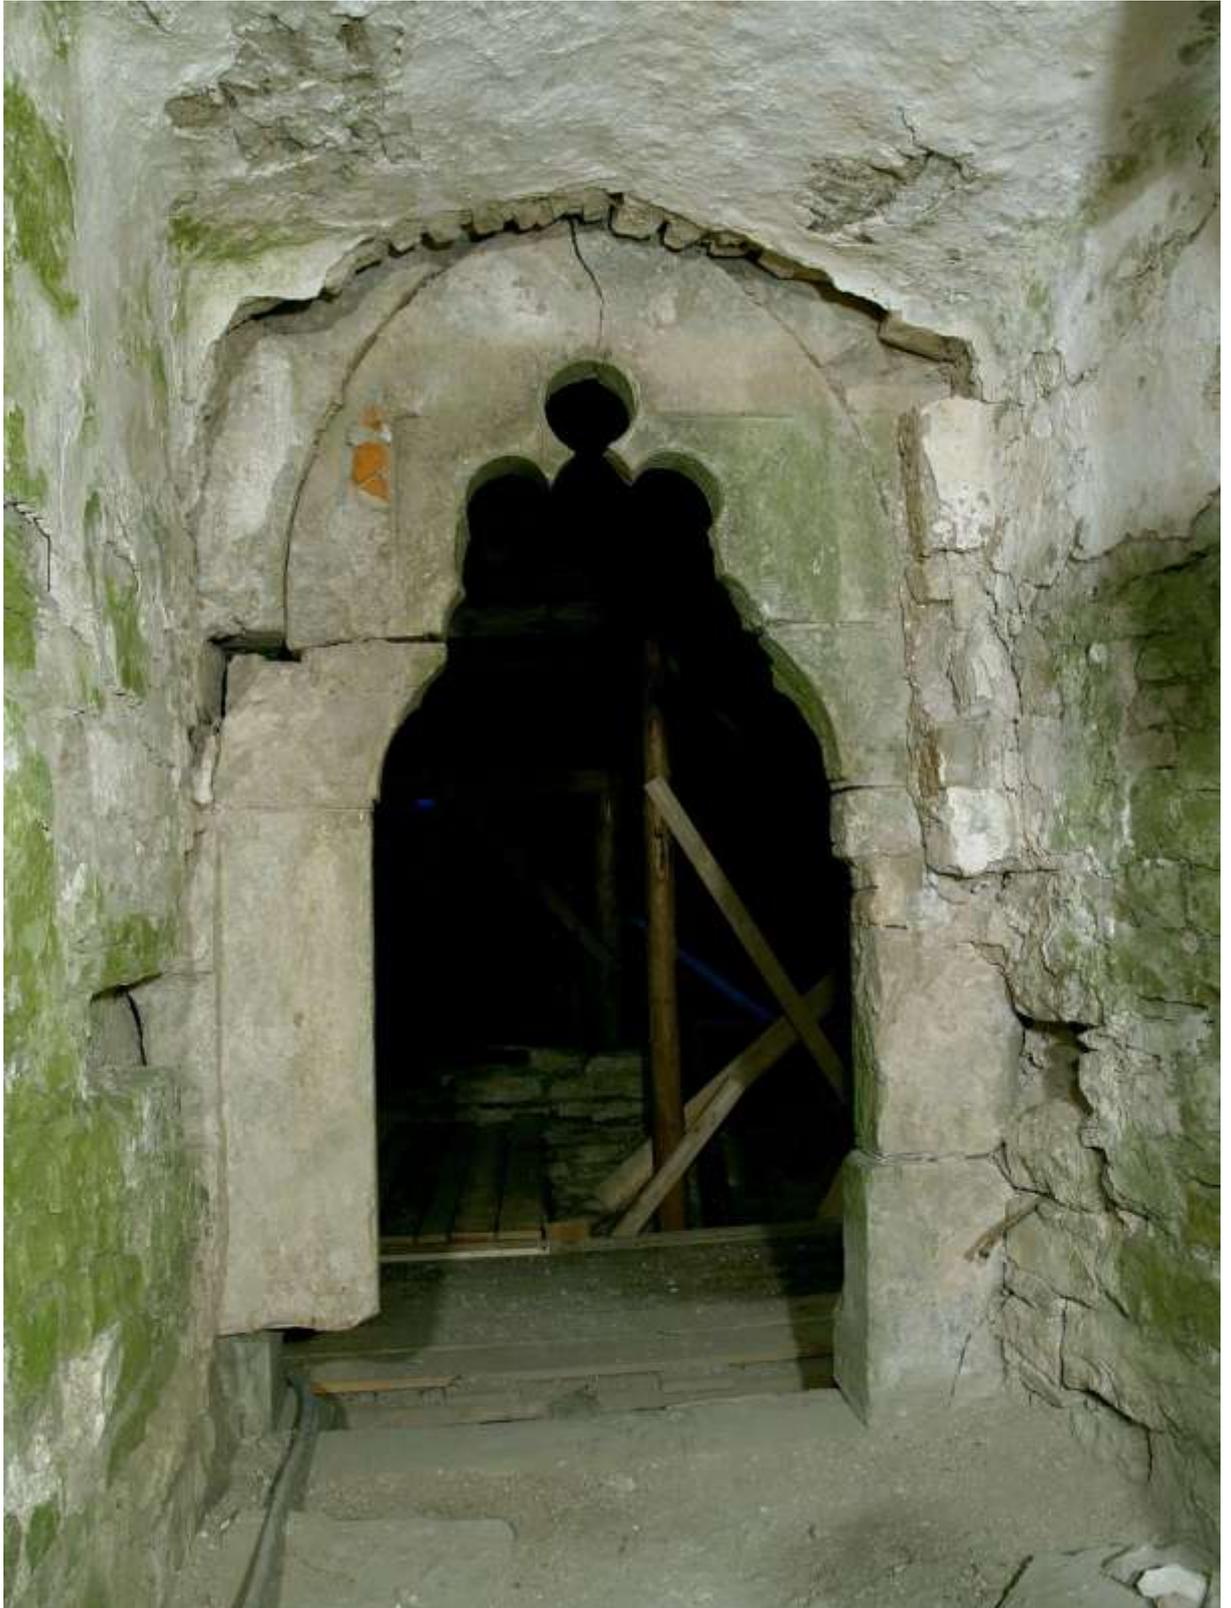
3.4 Põide kiriku põhjaportaal seest (foto: P. Säre)

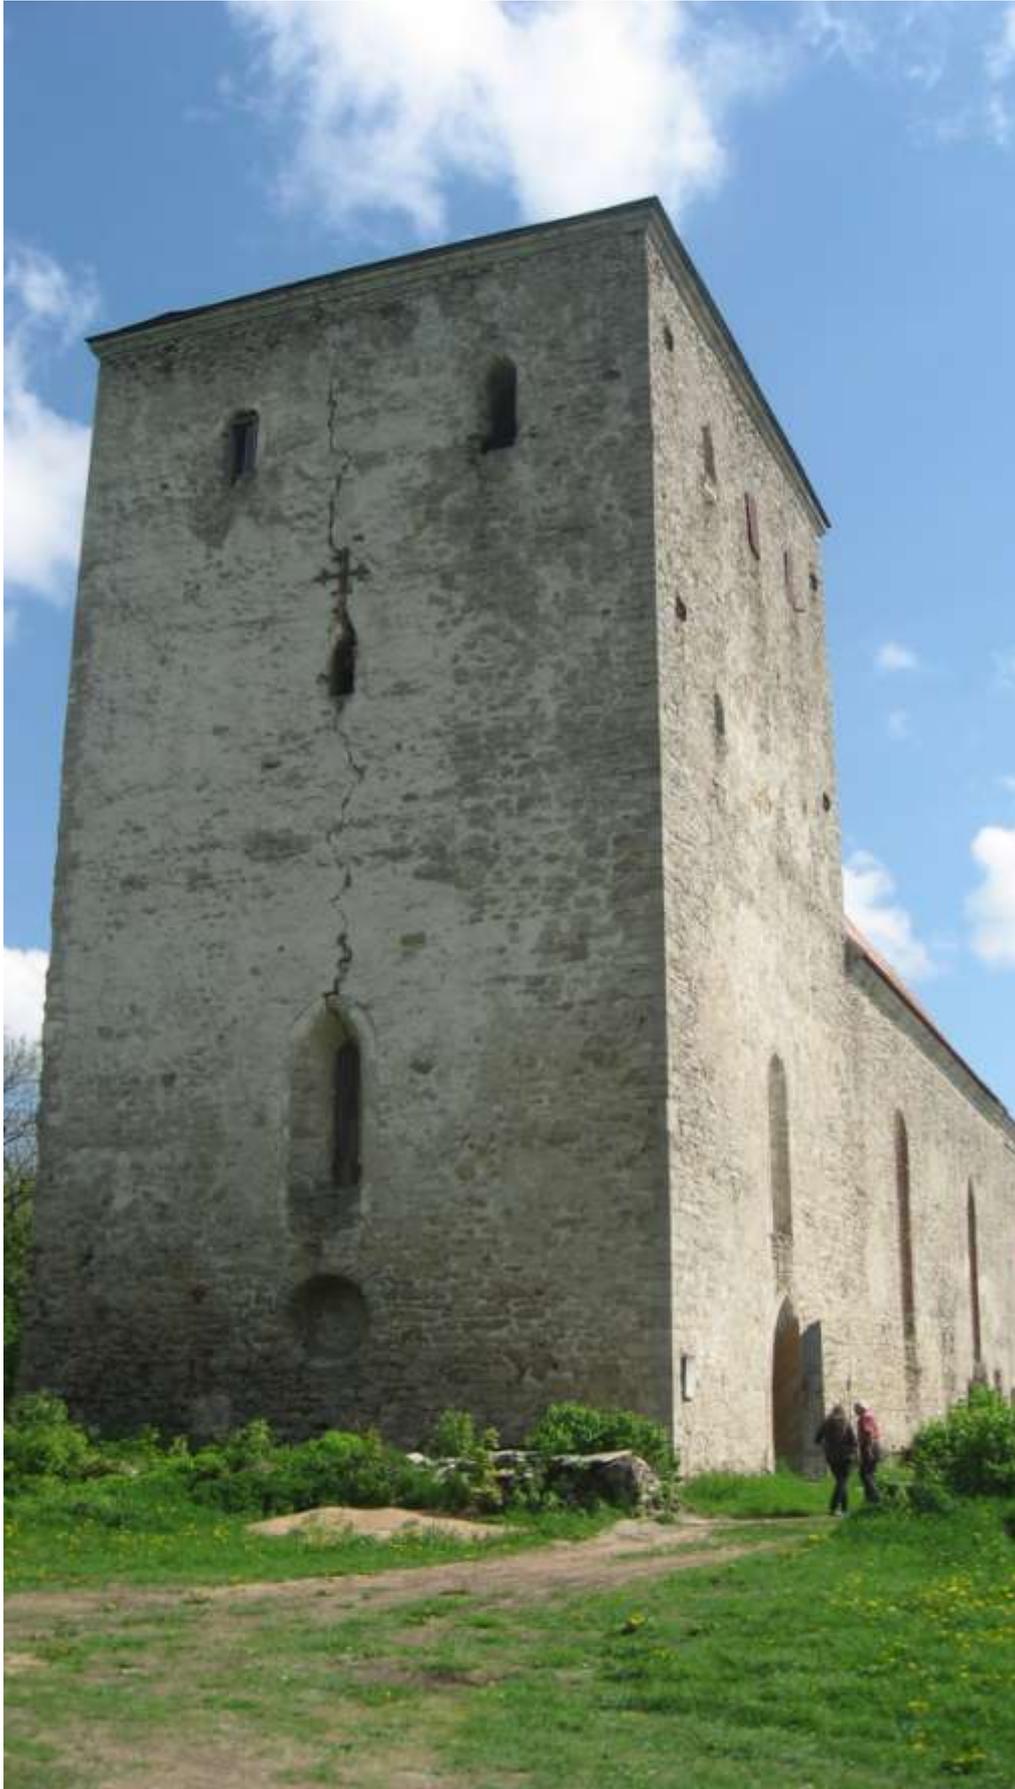
3.5 Vaade Pöide kirikule edelast
